Post-Earthquake Wharf Evaluation and Design of Reconstruction of Damaged Wharf Agana, Guam

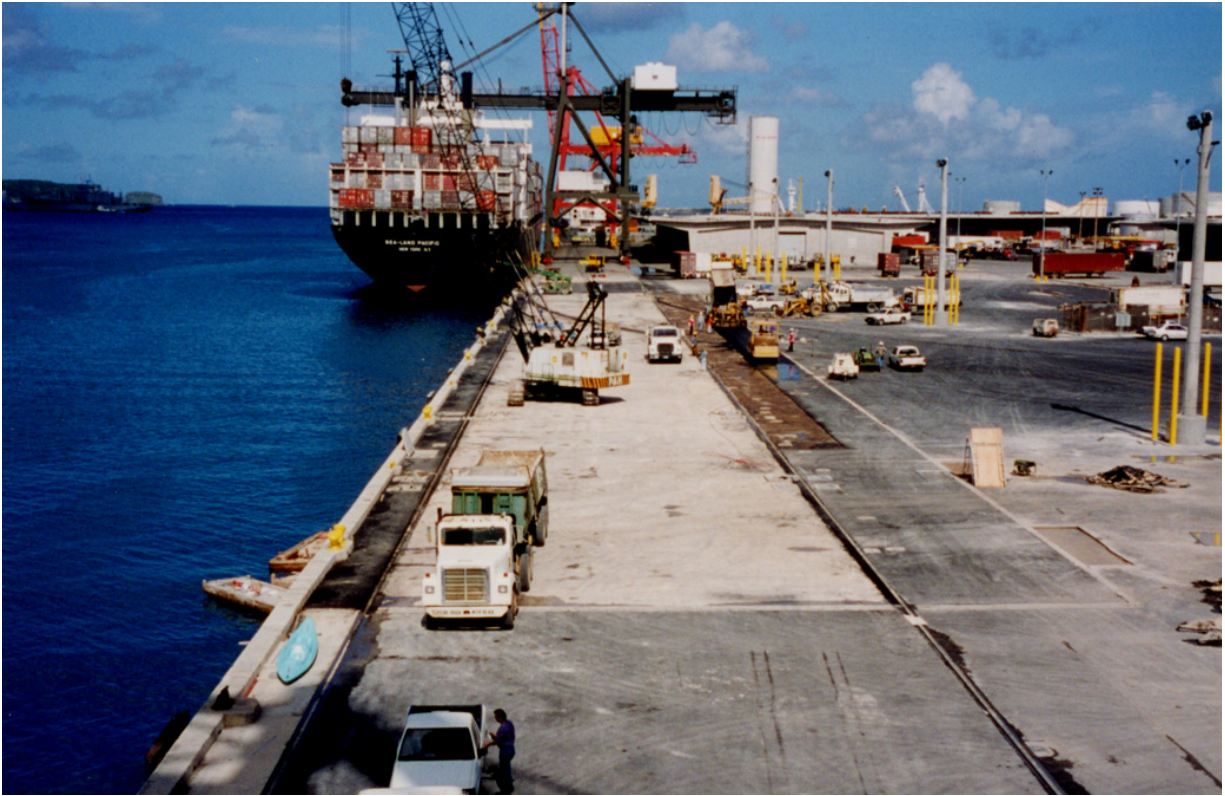
The original 1900 foot long wharf consisted of a waterside sheet pile bulkhead tied back to sheet pile deadmen and an independent crane runway supported on steel H piles. The 1993 earthquake induced soil liquefaction, settlement, and lateral spreading. The entire length of wharf and crane runway rotated and translated with significant damage to about 560 feet of the middle portion.

The damaged section was replaced with a concrete deck on pile structure. The finished soil slopes under the wharf and portions of the backland were stabilized with vibro replacement stone columns.
