February 27, 2010 Earthquake Data  
Port Facilities and Damage  
Typical Container Berth Quay Construction  
Quay and Crane Seismic Design  
Other facilities

## San Antonio Port

## STI - San Antonio

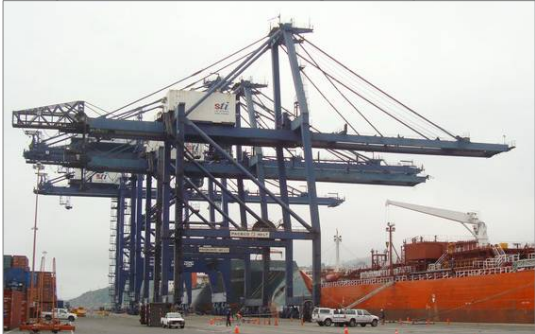
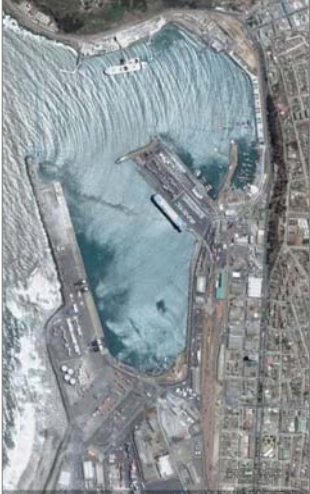
3 Berths - 6 gantry cranes  
2 Gantry cranes damaged  
(not from earthquake)
