Container crane boom collapse: Cause and prevention

Erik Soderberg, SE, Principal, Liftech Consultants Inc., Oakland, CA, USA

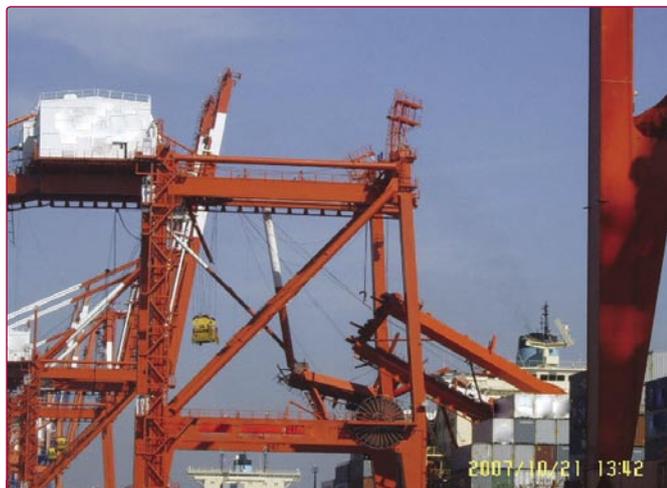
Figure 1. Crane boom failure. Asia – October 2007.

No cause has been definitively identified in either of the failures shown in Figures 1 and 2. Some of the usual suspects have been identified though: rope failure, sudden drop due to rope bird nesting, gusset plate failure, or other connection failure. Since the failures occurred when the booms were supported by the hoist ropes, and the maximum stresses in the boom support structure occur during vessel operations, the most likely cause was boom hoist rope failure.

In the Asian boom failure, the hoist rope may have failed due to previous damage or overload. We will never know the cause.

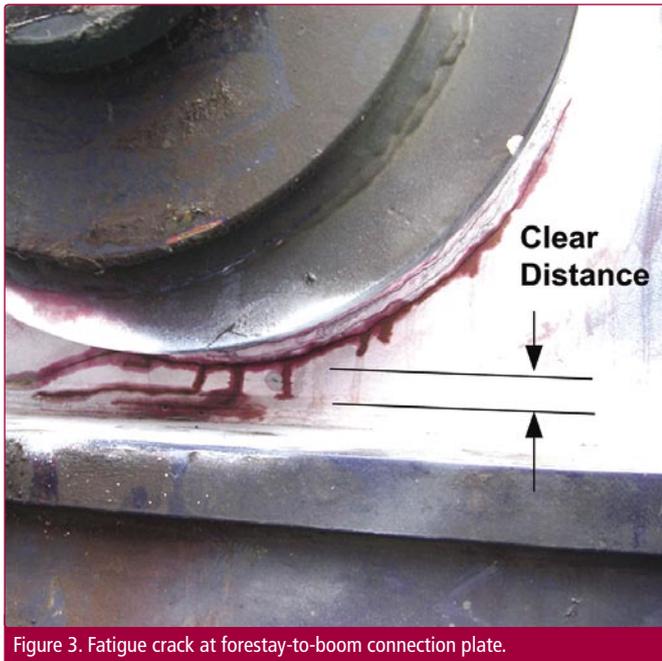
Figure 3. Fatigue crack at forestay-to-boom connection plate.

As discussed above, weak axis bending in gusset and link plates in the boom support system can result in significant stresses. Inadequate clear distances between welds have resulted in extensive cracking and failure at the forestay-to-boom connection plates. Refer to Figure 3 and Diagram 1. The weak axis bending stresses are linearly proportional to the plate thickness and inversely proportional to the plate clear distance squared. Doubling a plate thickness will double the weak axis stress; tripling the clear distance will reduce the stress by a factor of nine.

The distance between the weld toes should be enough to keep the weak axis fluctuating stresses below the fatigue threshold.

If this is done, the weak axis stresses are negligible and need not be considered with axial stresses. Detailed calculations are needed to determine the minimum distance. In most cases a distance of five times the plate thickness is adequate. If the clear distance is less than three thicknesses, calculations should be made to ensure the effect of lateral stay motions has been accounted for in the design. Of course, each situation is different; sometimes a clear distance of five thicknesses is more than adequate and sometimes it is not.

For an existing crane with plates that have clear distances less than three times the plate thickness, increase the inspection frequency as needed to maintain the required reliability, modify the structure to increase clear distances, or both.

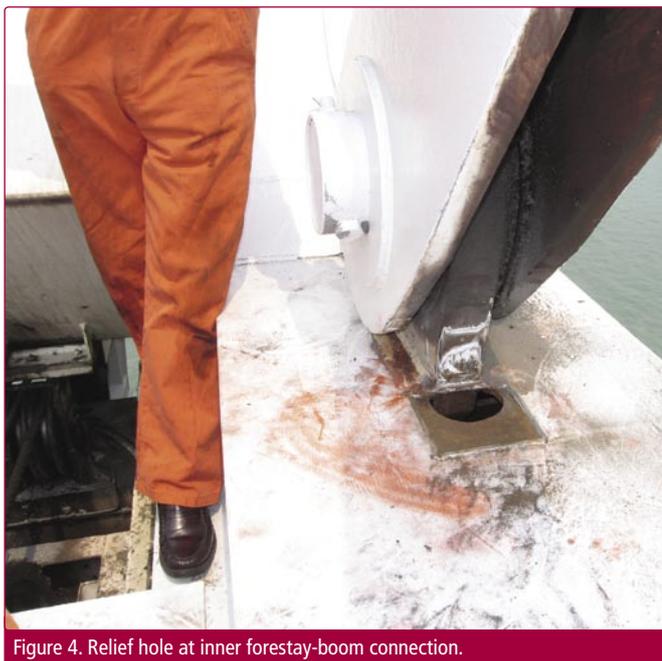
Figure 4. Relief hole at inner forestay-boom connection.

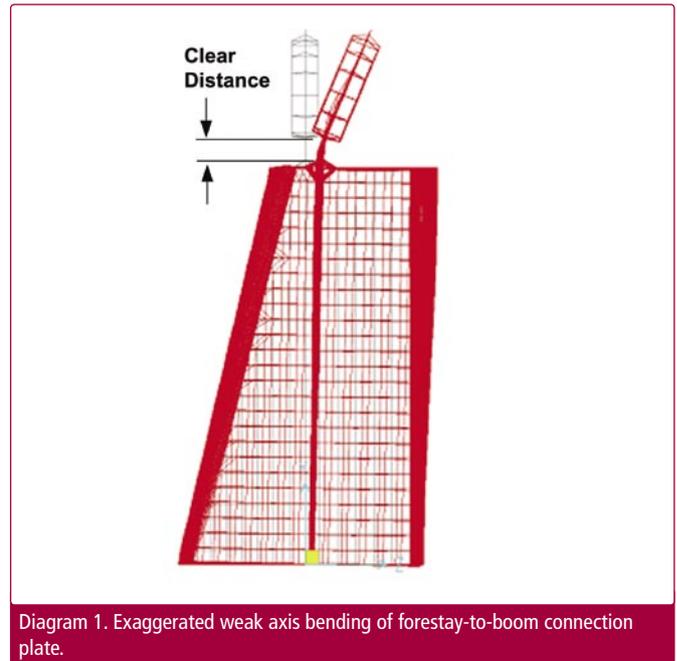
Diagram 1. Exaggerated weak axis bending of forestay-to-boom connection plate.

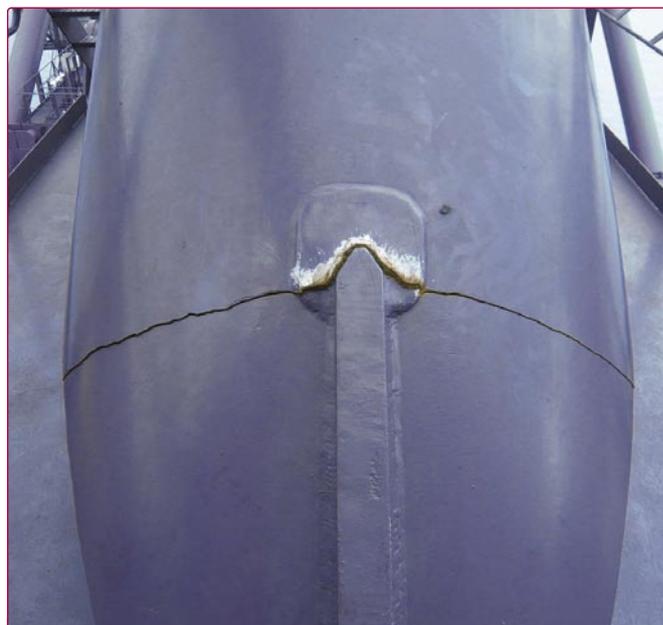
Large stress concentrations at plate connections may occur if the gusset plate is slotted into another plate. Serious fatigue cracking has occurred in these areas due to inadequate design, fabrication, or both. Special care is needed at locations where plates are contoured for smooth stress flow. If the contours are not smooth, the stress flow will not be smooth. Refer to Figure 5 for a crack caused by poor fabrication.

Recent cracking on two different crane designs resulted in dangerously long cracks in fracture critical members (Figure 5). Fortunately, failure did not occur because the materials are significantly tougher than specified and because inspections detected the cracking.

Figure 5. Fatigue crack at upper diagonal stress relief hole.

The plate-in-a-slot connection detail must be carefully designed and fabricated since this connection detail has many localized discontinuities that affect its fatigue performance. Some considerations include the following:

1. Relief hole geometry and surface texture.

2. Cover plate geometry, surface texture, and weld geometry, quality, and inspection.
3. Consider the fracture critical crack length when designing the cover plate. While it is desirable to keep the cover plate weld away from the high stresses at the relief hole, it is also undesirable to cover a crack emanating from the relief hole.

If necessary, provide a relief hole cover plate with a removable plug to permit inspection using a Boroscope.

For an existing crane, an owner should increase the inspection frequency as needed to maintain the required reliability, modify the connection relief hole and cover plate, or both.

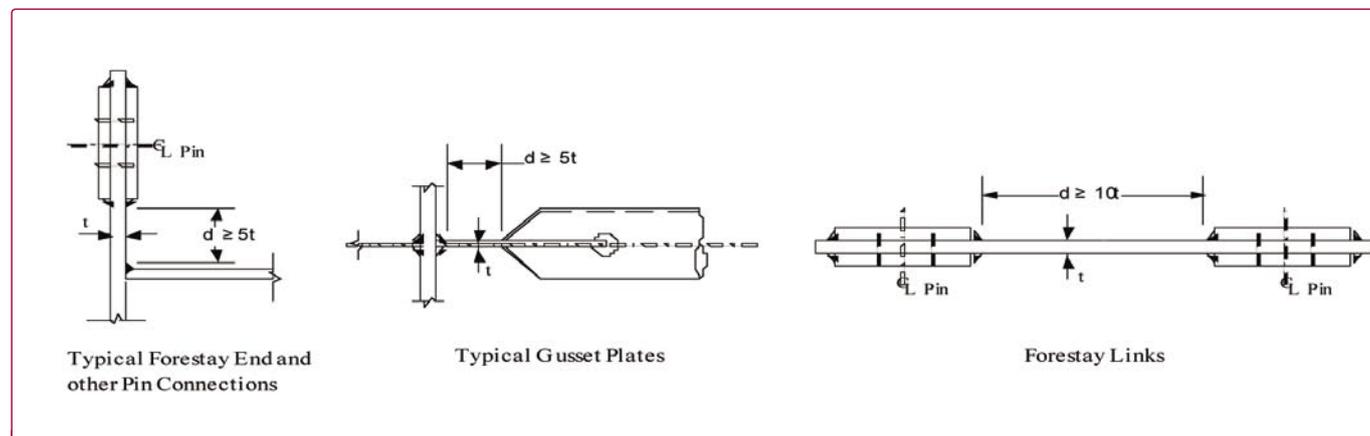
Diagram 2. Recommended minimum clear distances – Liftech Crane Specifications, 2008.

Consider weak axis bending in plates due to wind and other lateral loads. The effect of tension on the bending stresses must be considered. Some guideline minimum clear distances are provided in Diagram 2 that are acceptable for most connections. Of course each situation is different; sometimes a clear distance of five thicknesses is more than adequate and sometimes it is not.
