Quay Crane Accidents Lessons and Mitigation

Port and Terminal Technology 2010

Arun Bhimani, SE
President
Liftech Consultants Inc.
www.liftech.net

October 2010

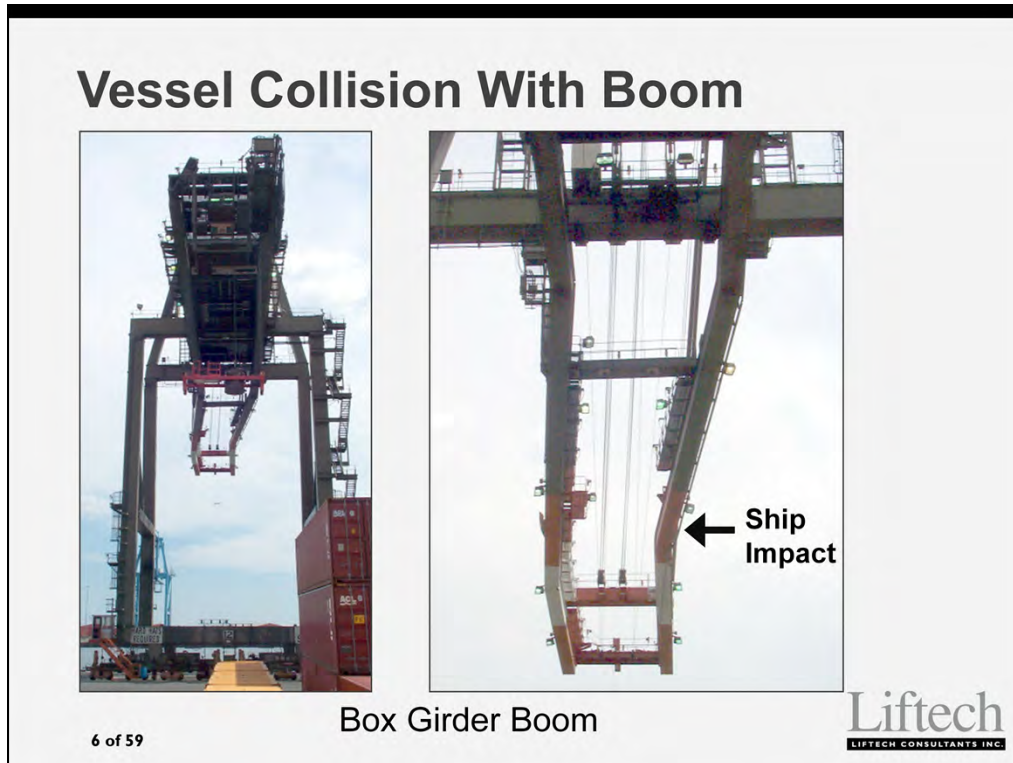
This collision occurred in New Jersey when a vessel berthed out of control. This type of collision causes severe damage.

The ship impacted the right girder pushing the boom laterally. Despite the severity of the damage, the crane frame was undamaged and the crane did not derail.

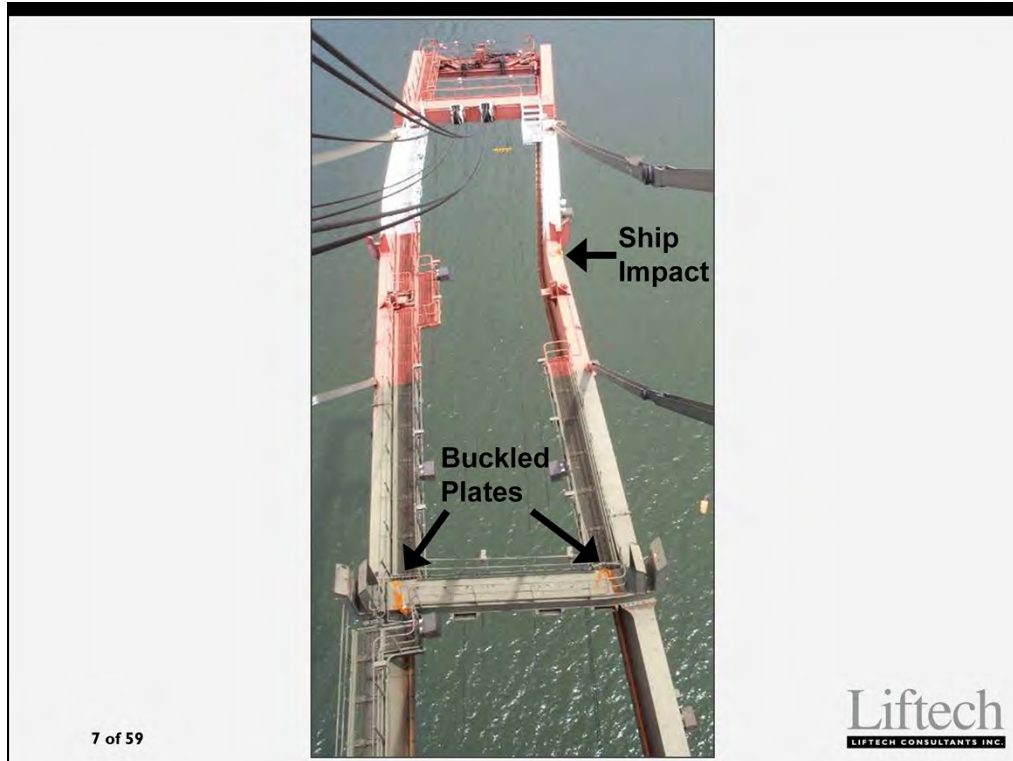
The right girder is bent plastically at the impact location. The landside cross beam buckled plastically on either end.

In this instance, the forestay connection plates on the boom and at the apex had permanent lateral deformations.

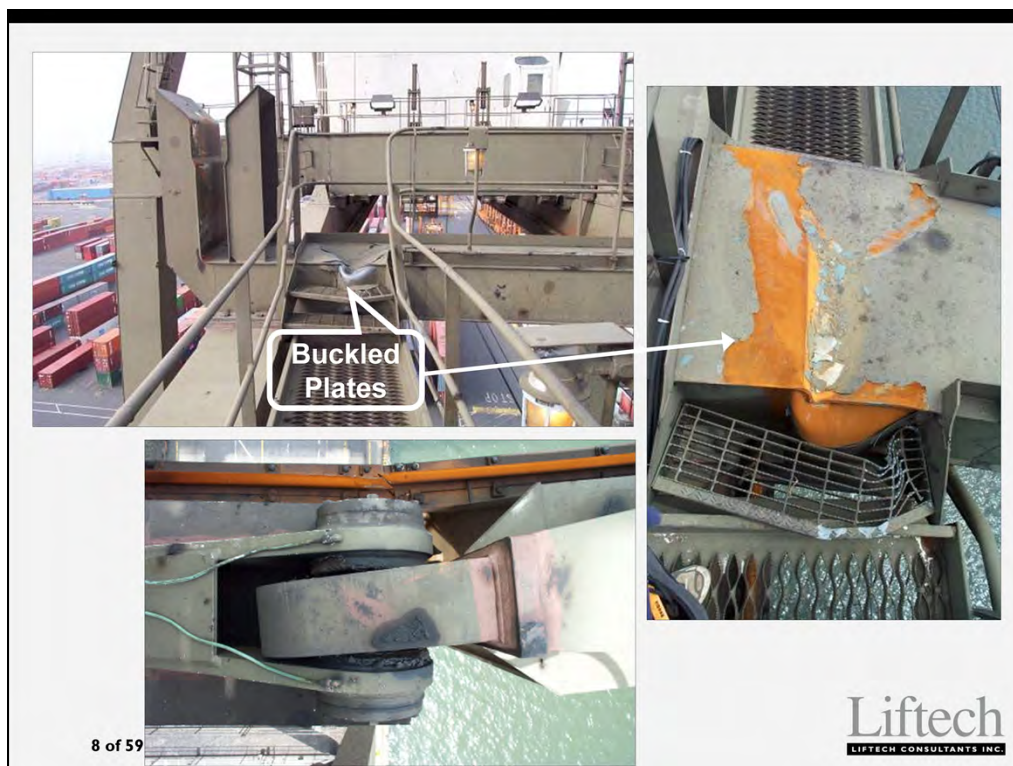
This slide shows a close-up of the buckled portions of the landside cross tie, and the residual rotation at the upper boom hinge (lower left).

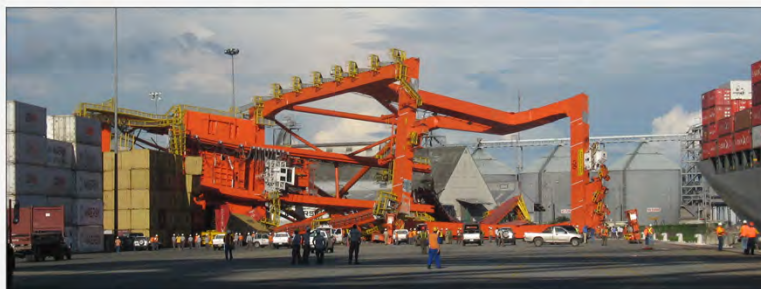
Out of Control Vessel

This crane in Ecuador was knocked over by a ship this year.

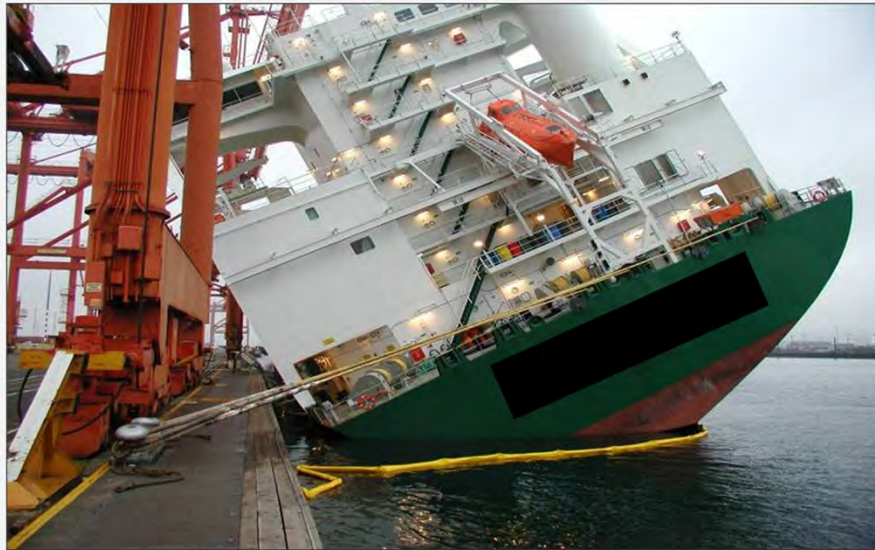
Ballast System Failure

A ballasting system failure caused the vessel to list. Fortunately, the ship structure missed the adjacent cranes and caused only minor damage.

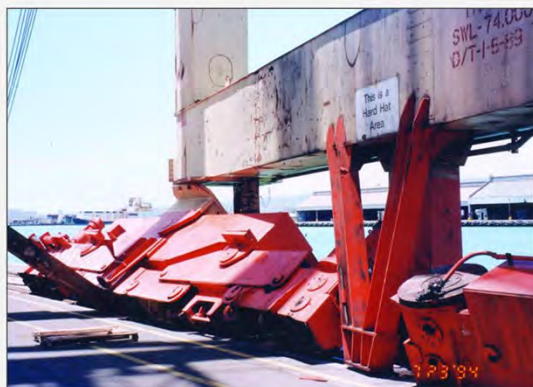
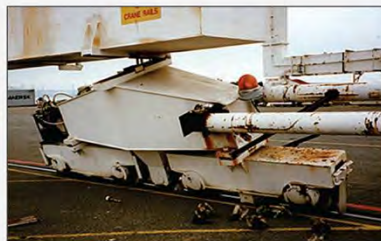
Consequences – Not Catastrophic

Many collisions are not catastrophic. In these instances, the gantrying system broke from the crane but the cranes did not collapse.

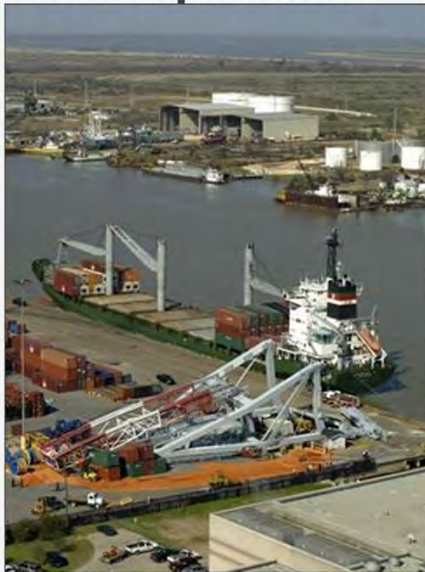
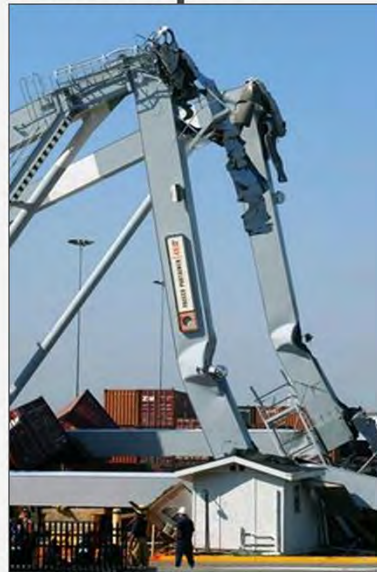
Consequences – Catastrophic

Sometimes the collisions are catastrophic.

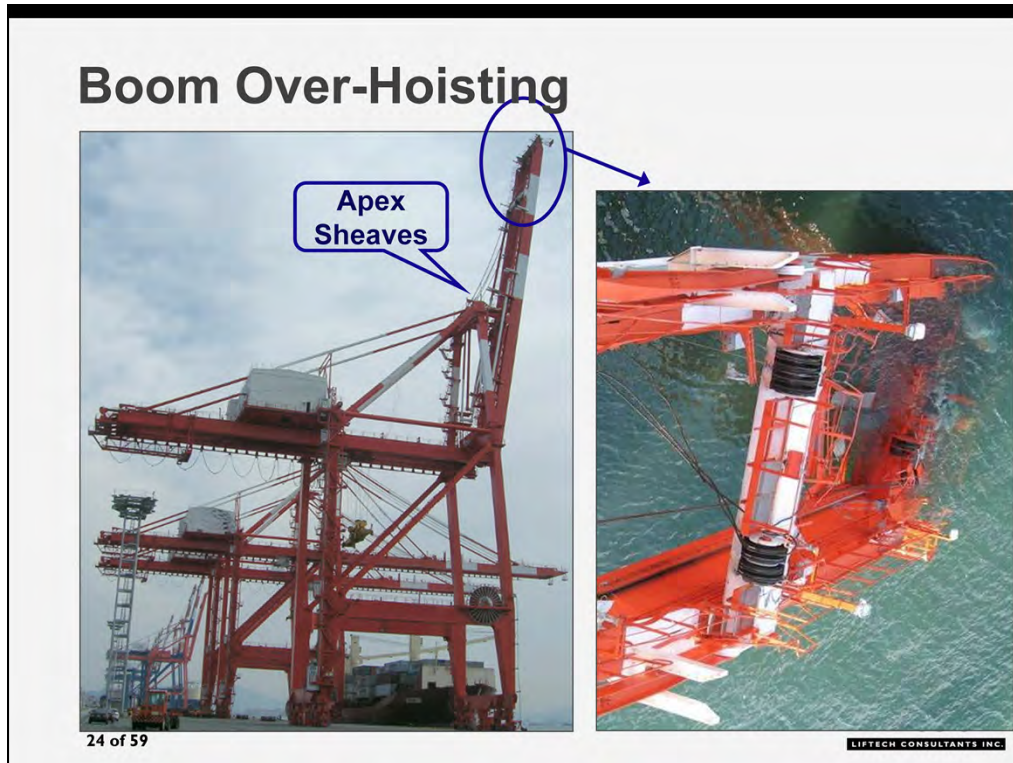
Over-hoisting is when the machinery raises the boom more than intended, resulting in larger-than-expected loads on the boom, the crane frame, and the hoist ropes.

In this instance, over-hoisting resulted in failure of the hoist ropes.

The photo on the left is of an adjacent crane. Notice the apex sheave.

The hoist sheaves on the boom are shown on the failed boom nearly in the water. There was no damage to the sheaves. The rope is damaged.

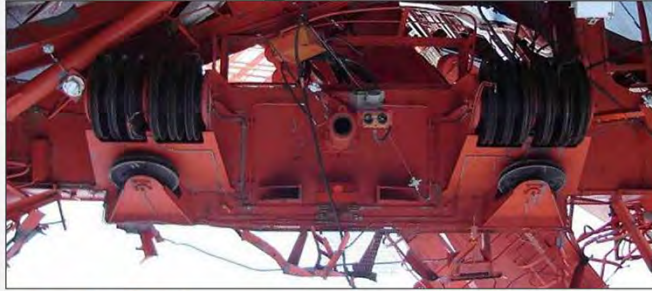
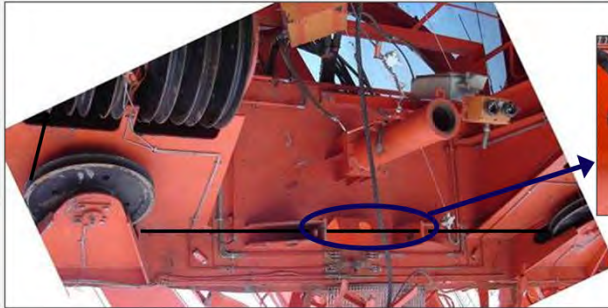
Apex Sheaves: Damaged

On the failed crane, the rope on the side of the reeving failed. The exact cause of the rope failure is unknown. The rope may have jumped the sheave. The stop clamp did not hold the rope after the rope broke. The clamp was probably installed improperly.

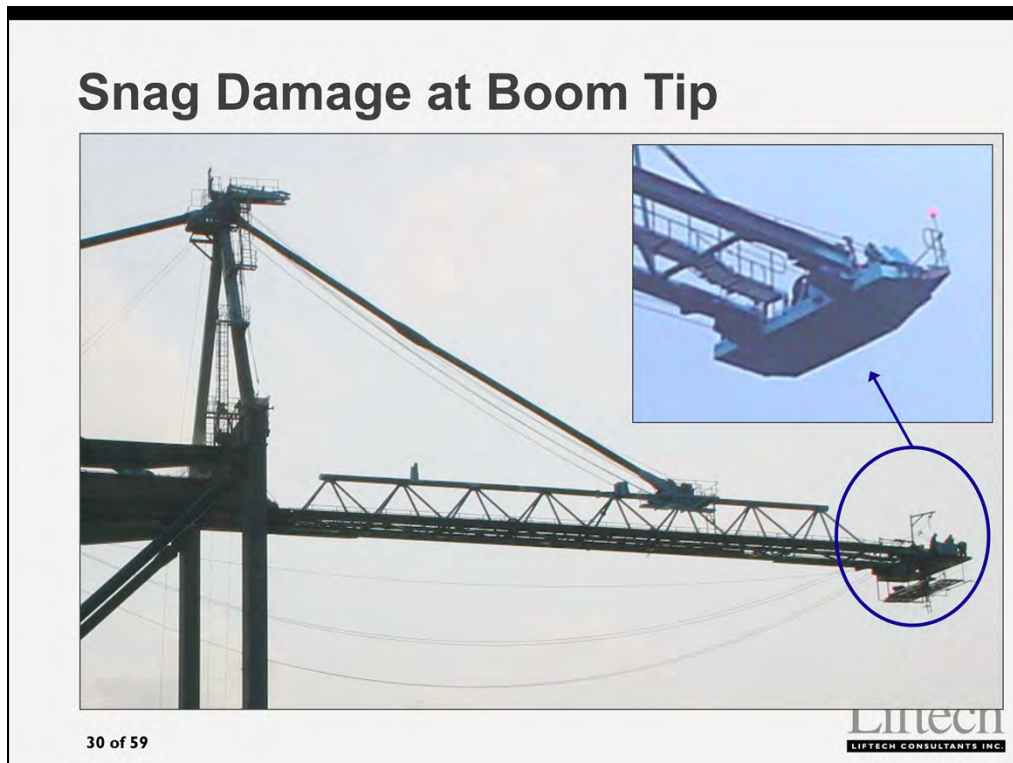
This crane experienced a snag loading that resulted in significant damage to the waterside end tie of the boom where the hoist sheaves are located.

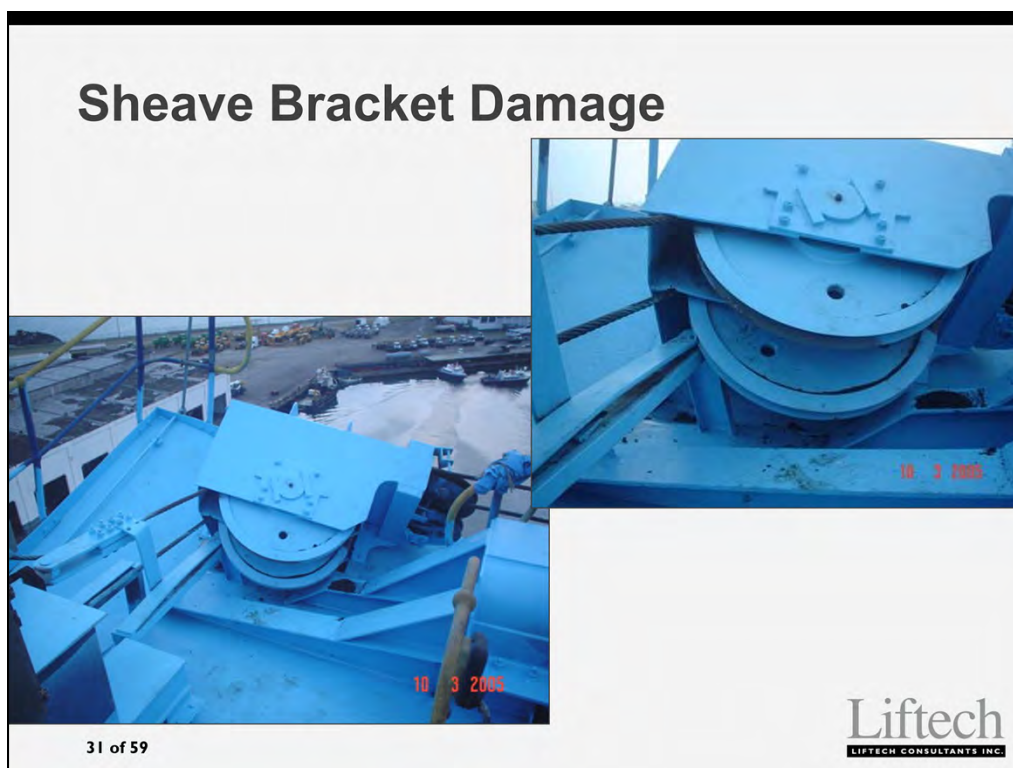
Damage to the end tie is shown here. The sheave brackets did not pull from the boom structure, but pulled the boom structure up.

The damage was caused by the severe loading and significant corrosion of the end tie structure.

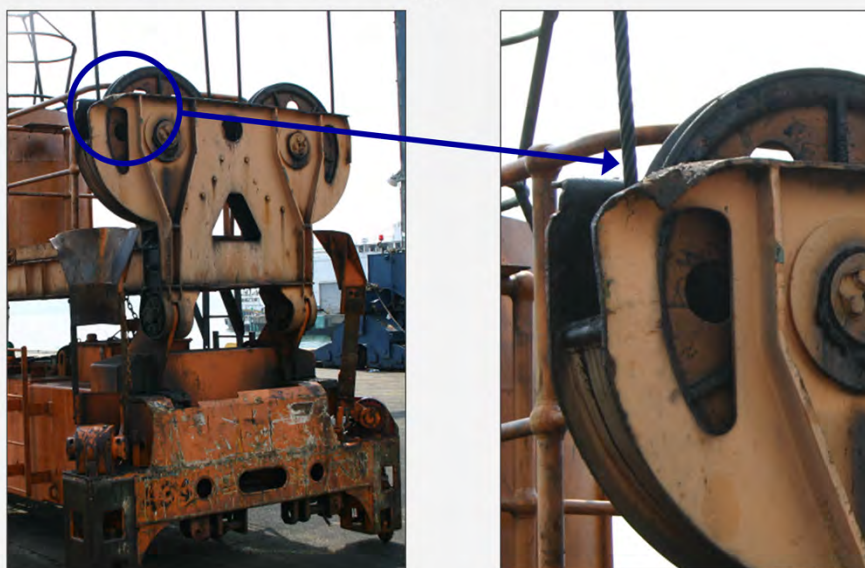
Headblock Damage

This slide shows damage to the headblock during the snag event.

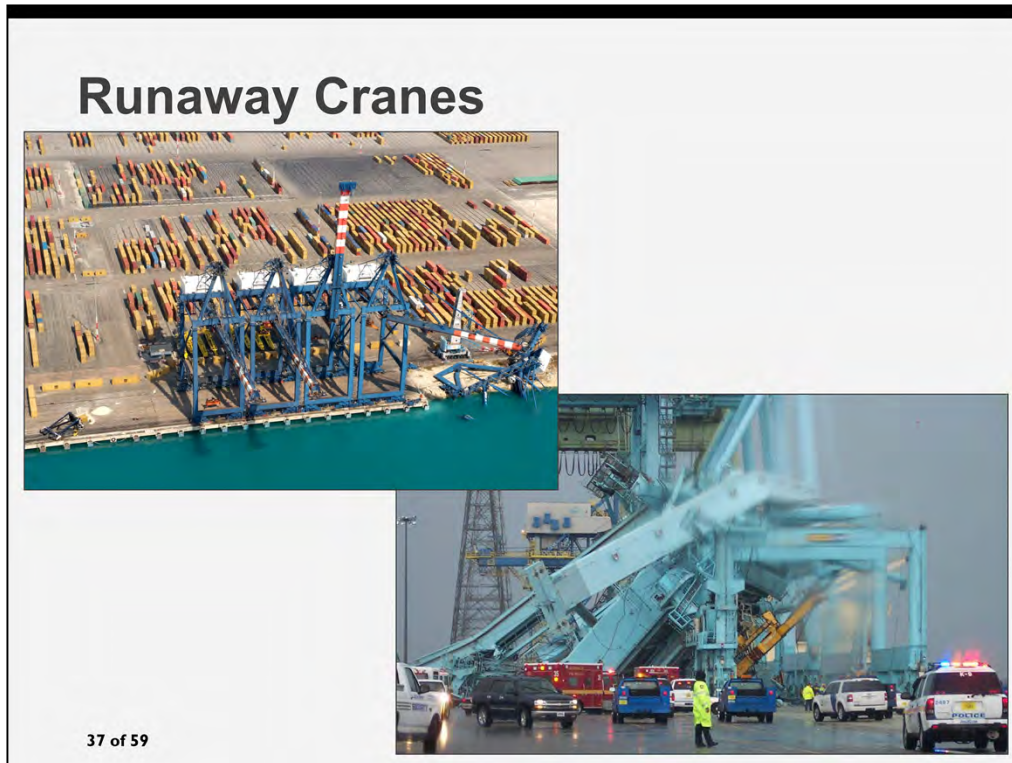
Runaway cranes typically occur due to sudden severe winds on unsecured cranes.

The photo on the left is of cranes in the Bahamas that experienced a sudden tornado. The cranes were not stowed and were pushed down the wharf by the tornado. The cranes collided with the end crane pushing it through the crane stops and off the wharf.

The photo on the right is of cranes in Jacksonville that experienced a microburst, a sudden severe wind that overpowered the gantry braking system.

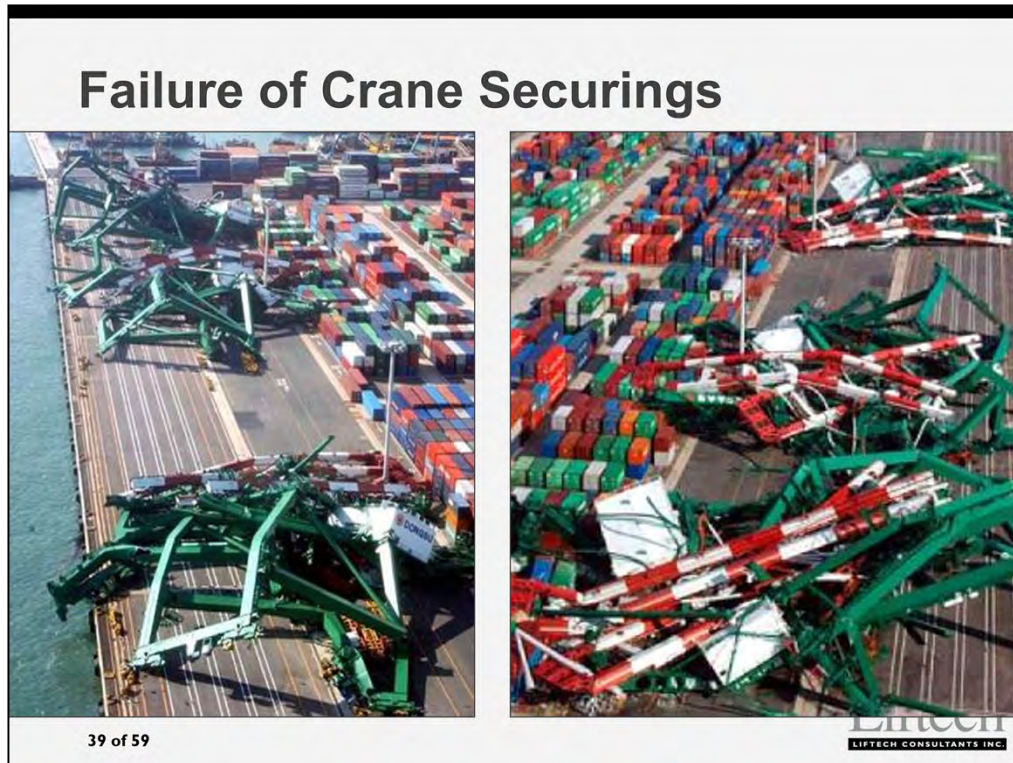
These photographs show six collapsed cranes due to Typhoon Maemi in Pusan, South Korea. The two photographs are taken from each end of the wharf.

Tie-downs failed. After failing, progressive failures ensued as cranes collided with each other.

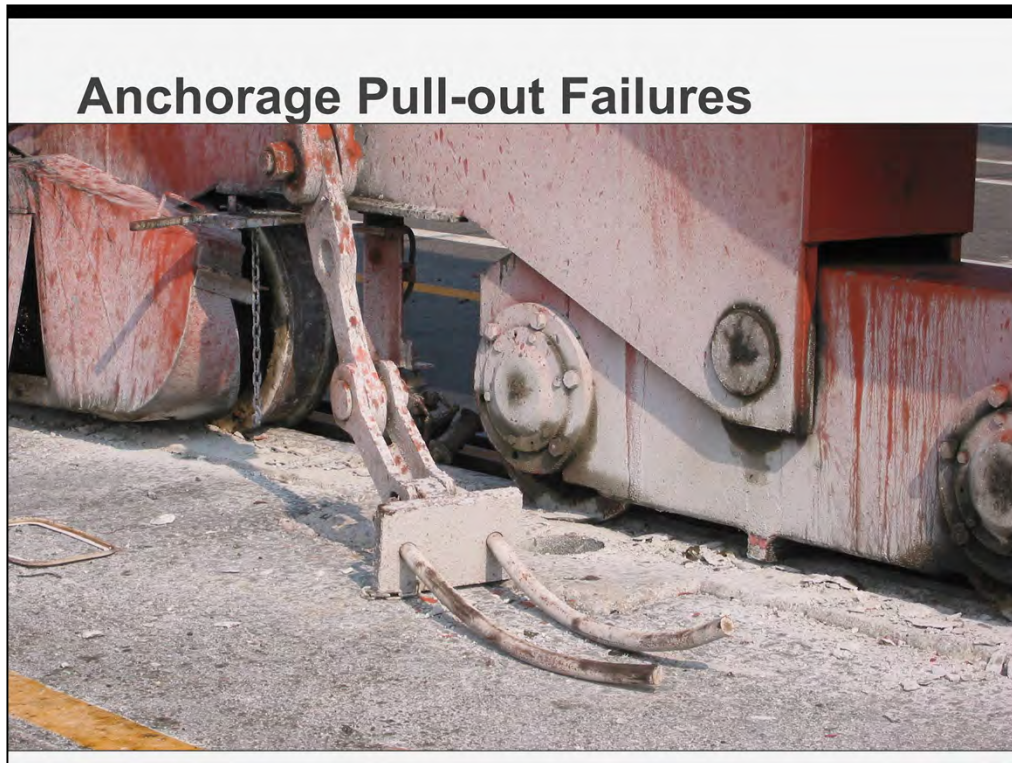
There were multiple types of failures during Typhoon Maemi. Tie-down anchorage was one failure type. Smooth anchors pulled out of the wharf.

Design = headed anchorage

Fabricated = no head

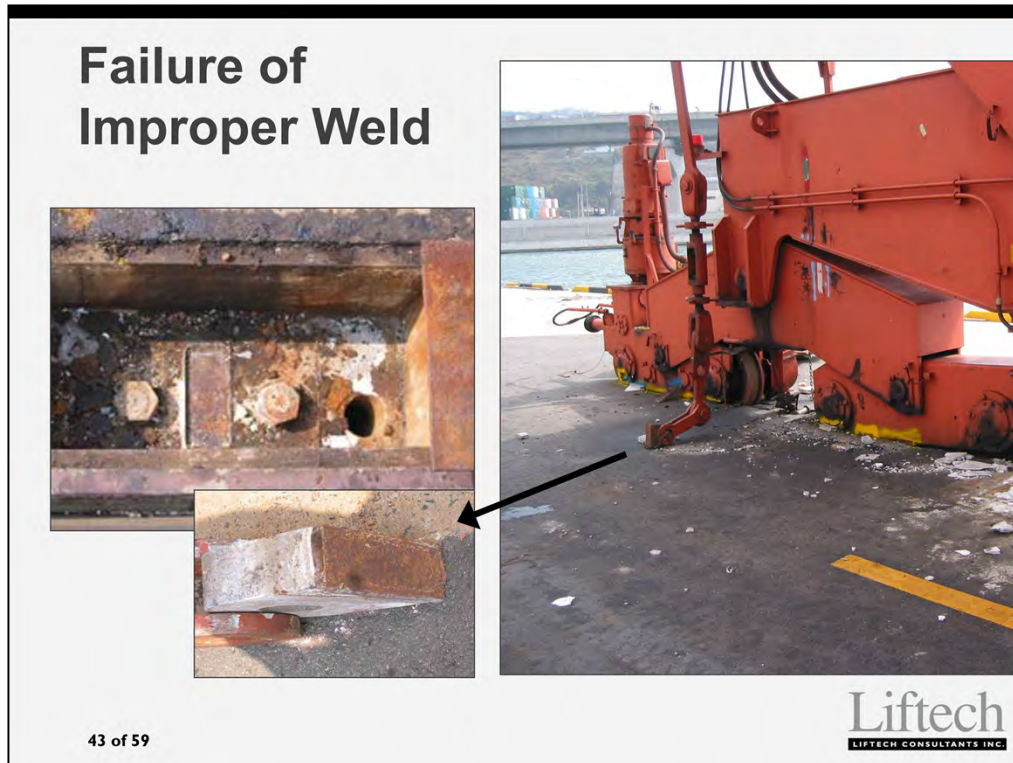
Improperly made and undersized welds failed at tie-down brackets.

Tie-down wharf bracket failure was due to improper fabrication--**4 mm** (3/16 inch) fillet weld between **base plate** and **60 mm** (2.5 inch) lug.

The fabricator also used a **filler plate** between the lug and base plate!

The design called for a complete joint penetration weld that would have developed the strength of the ear plate. The specified weld would have been many times stronger than the provided weld.

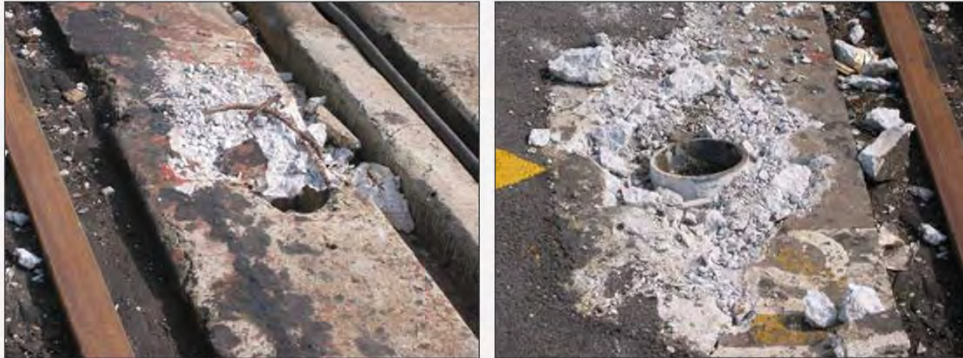
Stowage Pin Socket Failure

Local concrete bearing failures occurred at stowage sockets. The design did not consider the large bearing stresses that occur. This was exacerbated due to crane uplift and localized bearing of the stow pin on the upper end of the cast-in-place tube.

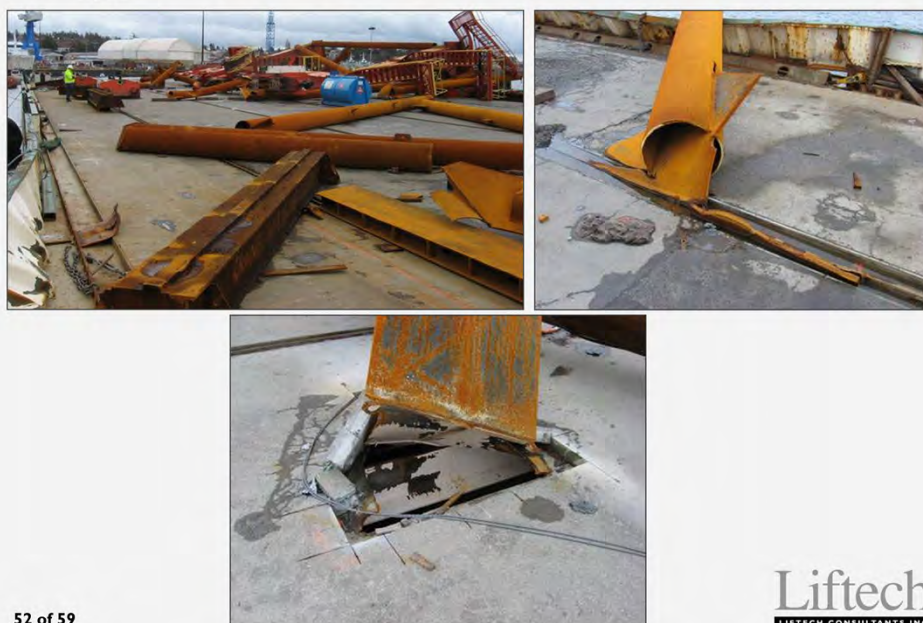
Barge: Two Cranes Overboard

This is a photo of a barge deck after two cranes fell overboard. We do not know the circumstances of the accident, but notice that the braces are not aligned with the internal structure of the barge.

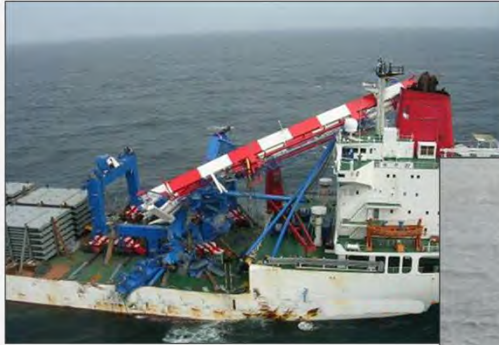
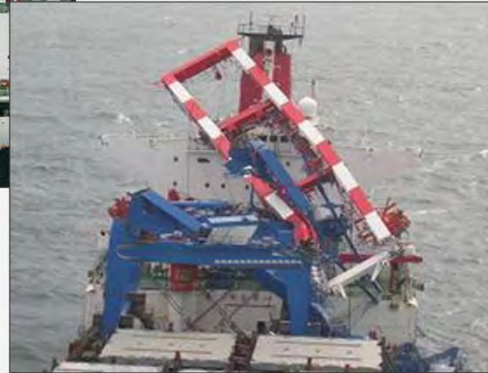
Heavy Lift Vessel Collapsed Crane

In this accident, the bracing connecting the crane to the vessel held; however, the bracing within the crane structure itself did not. It is important to perform an appropriate finite element analysis to correctly estimate the design forces within the crane structure and added bracing.

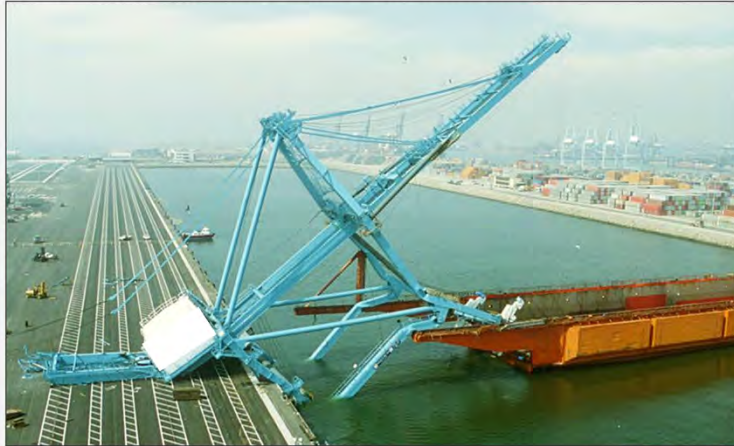
Just prior to delivery, the ship's captain decided to begin moving the crane without installing the "hold back" lines.

The ship pitched and the crane rolled off the ship.
