# On the Mend

# Damaged Crane Boom Repairs

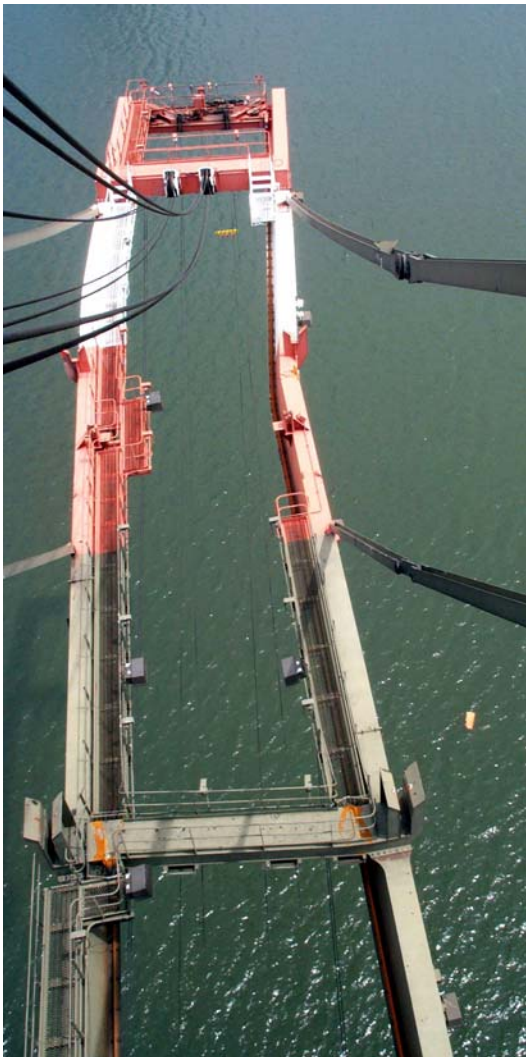
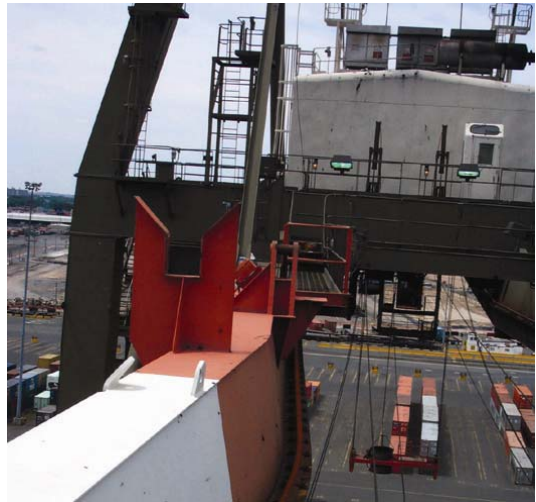
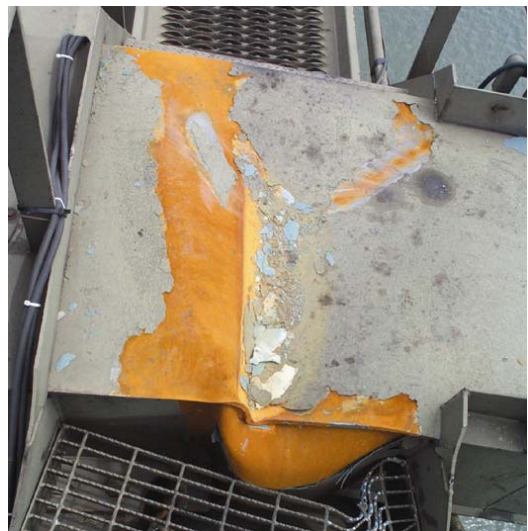
Container crane booms are frequently damaged due to ship collisions.

Repairs range from rebuilding, or stiffening, damaged sections to heat straightening damaged sections.

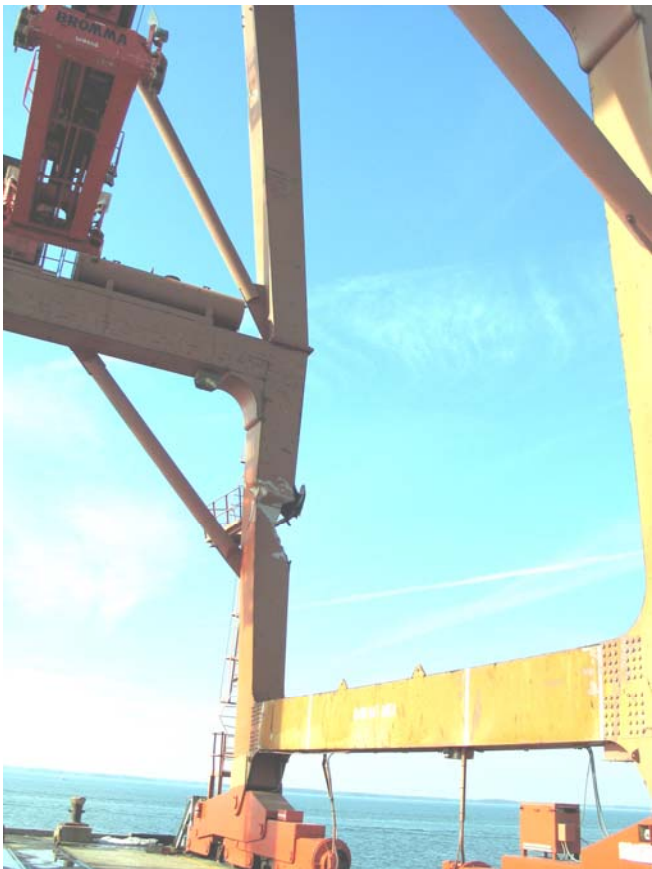
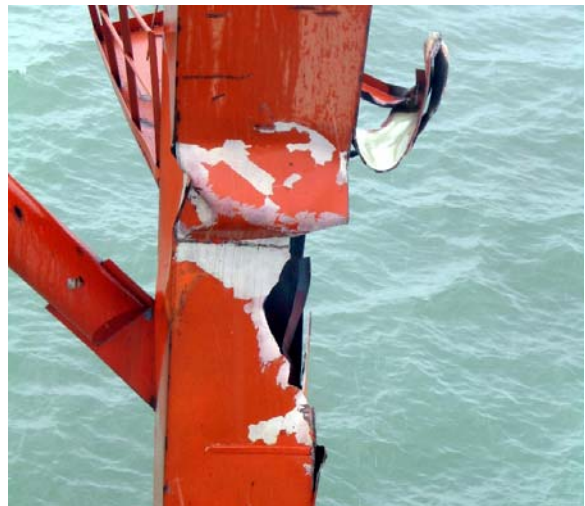
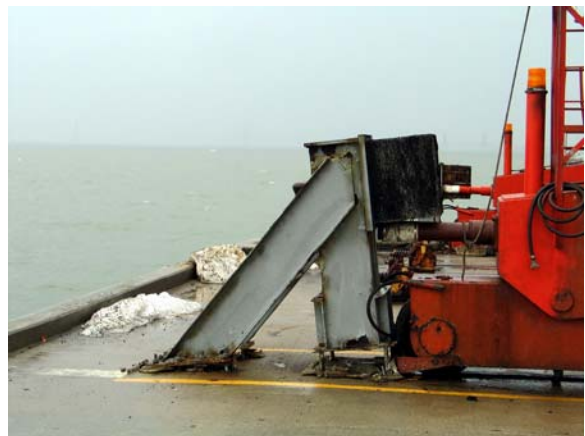
Virginia International Terminals  
Newport News Marine Terminal, Virginia  
2004

A departing ship struck Paceco Crane 313 on January 31, 2004. Virginia International Terminals retained Liftech to review the damaged crane and wharf, design temporary bracing to stabilize the crane, and design repair details for the damaged crane stop.

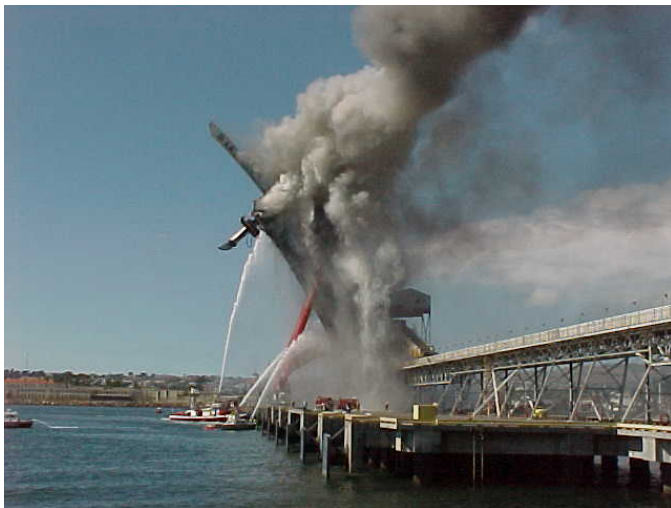
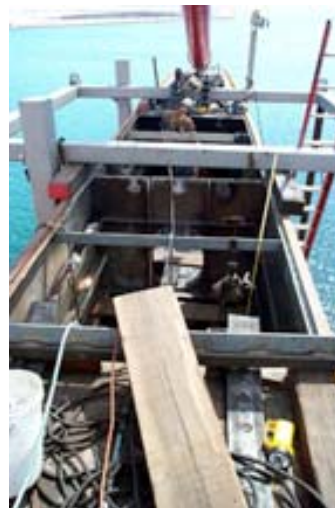
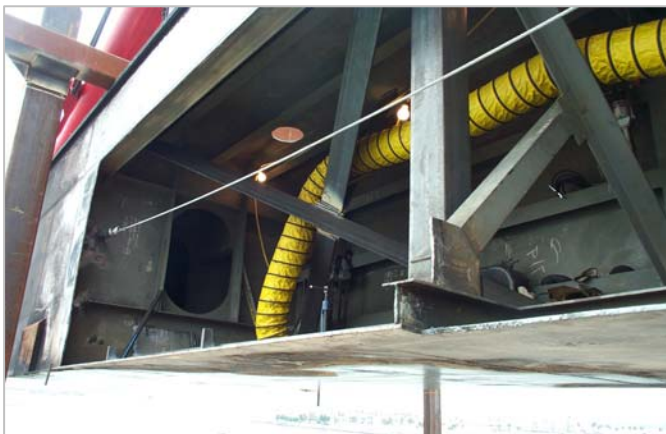
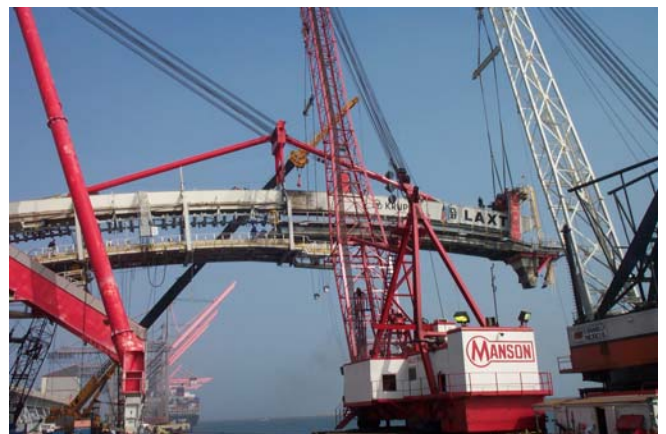
Port of Los Angeles,  
California  
2000 and 2001

A coal loader built by Krupp was severely damaged in two fires and suffered significant damage during a ship collision.

After each incident, Liftech provided on-site engineering to assist with repairs. Repairs consisted of replacement or stiffening of buckled sections,

restoring the geometry of the boom and shuttle structures to mitigate operational problems, and development of a structural maintenance program to ensure long-term reliability of the repaired structure.

The loader was returned to operation within five weeks of the first fire, within four weeks of the second fire, and within days of the ship collision.

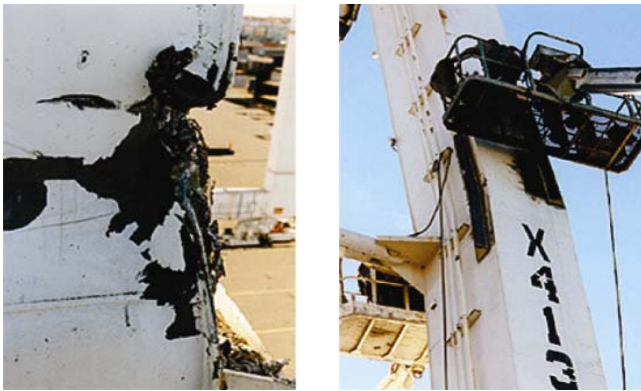
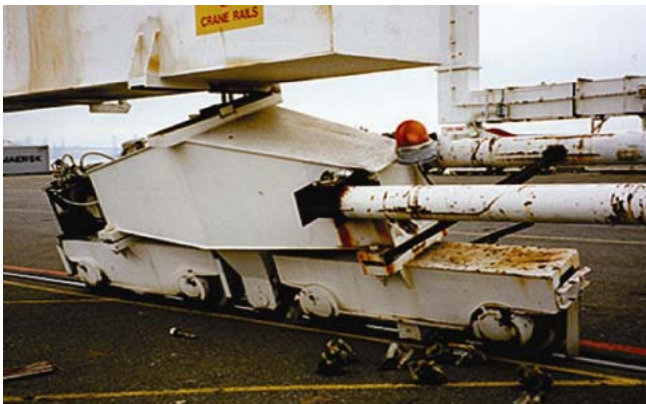
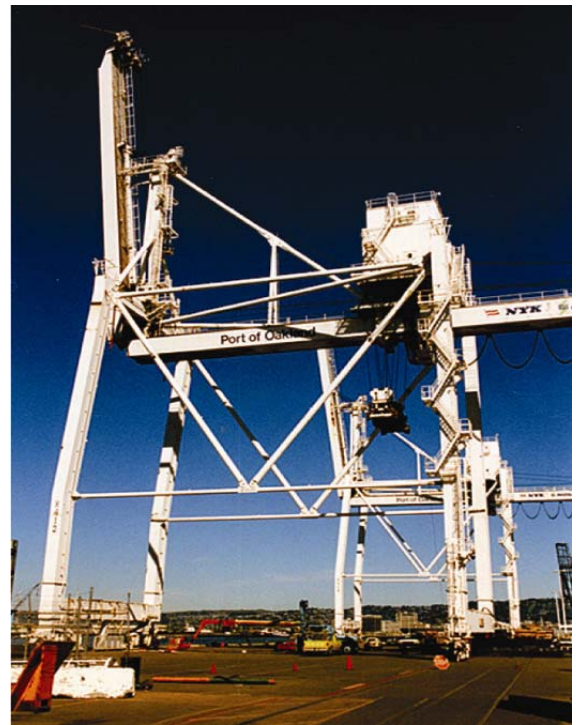
Port of Oakland, California  
1997

A ship struck a Krupp crane at the Port of Oakland. The bow hit one of the waterside legs just above the portal beam, about 45 feet above the gantry rail. This impact pushed the waterside legs 35 inches to the right and 30 inches toward the land. Because the wheels remained on the rail, the waterside and landside sill beams partially separated from the equalizer beams.

Liftech helped the Port of Oakland temporarily secure the crane, then reposition and repair the damage. The crane was secured by installing posts at two corners and a crib pile under the sill beam near one corner. The crane was repositioned by lifting the waterside legs with a mobile crane, jacking up the landside legs, and jacking the landside horizontally until it could be placed back down on the equalizer assemblies. Replacing the buckled plates in the area of ship impact repaired the damaged leg.

The crane was recommissioned one week after the accident.

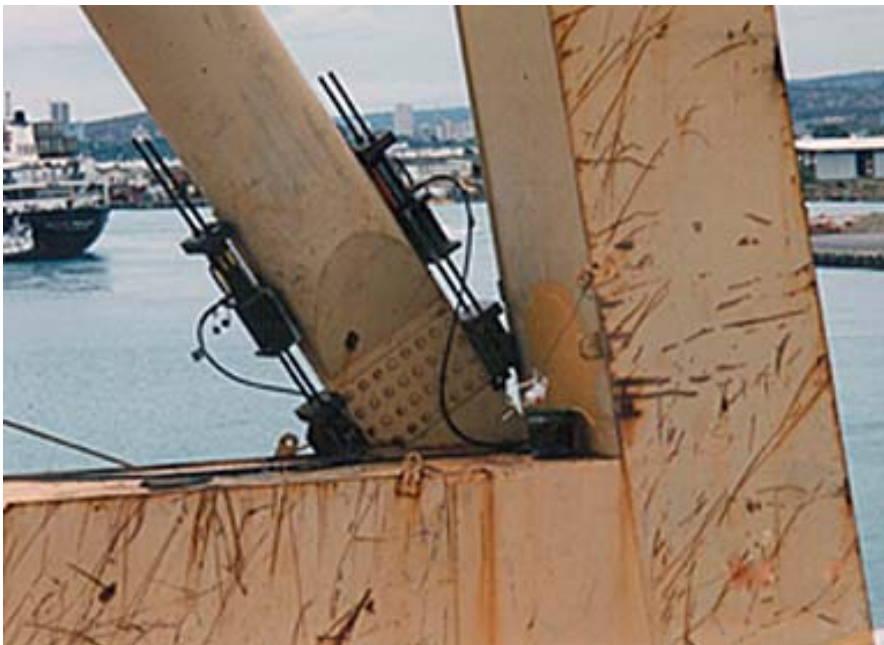
Sheedy Drayage Company  
Matson Terminal  
Sand Island, Hawaii  
1995

The Paceco crane truss boom rotated and was pushed into the bumper stops when it was struck by a barge-mounted crane. The landside and waterside gantry equalizers were torn from the legs, the boom tip was severely distorted, and the upper and lower boom chords buckled. The crane wheel gage shortened four inches (100 mm) and several plates on the waterside legs and sill beam buckled.

The boom and frame were temporarily secured against collapse, and the crane was transported to the backlands for repairs.

For the frame repair, the buckled leg and sill beam sections were heat straightened. Using heat straightening, the shortened wheel gage was corrected to within 1/8 inch (3 mm) of the acceptable gage tolerance.

The boom was removed, a section of the boom tip was replaced, and the salvageable portions of the boom structure were heat straightened. The repaired boom was raised into position, and the entire crane was transported to the rails. At this point, the boom was straight, but misaligned. The boom alignment was restored by adjusting the length of the lower frame diagonals. The lower end of each diagonal was disconnected from the gusset plate, pushed or pulled using jacks, and reconnected to the gusset plate.

The heat straightening was completed in ten days. All required repairs were completed in 60 days.

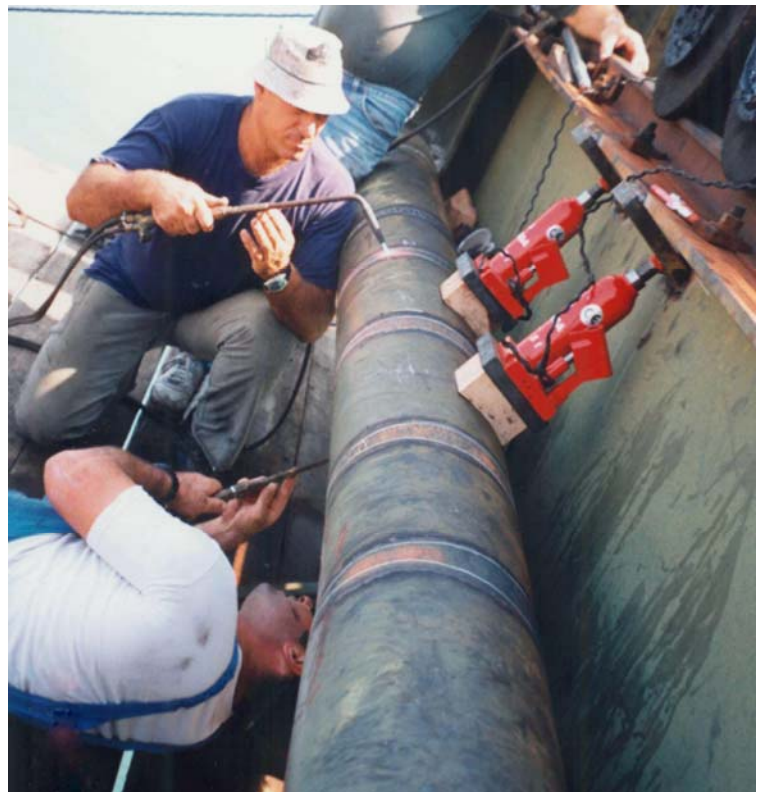
Israel Ports and Railways Authority  
Port of Haifa and Ashdod, Israel  
1995

The lower chord of a Paceco crane's truss boom in Haifa was damaged when the boom struck a berthed vessel. The lower chord pipes were bent inward and the pipe buckled approximately four inches at the point of impact.

Using the rail girder to provide restraint during the repairs, the damaged length of pipe was heat straightened to within 1/8 inch (3 mm) tolerance. The local buckles were also repaired by heat straightening. A cover plate was welded over the local damaged section of pipe.

Repairs were completed in two days.

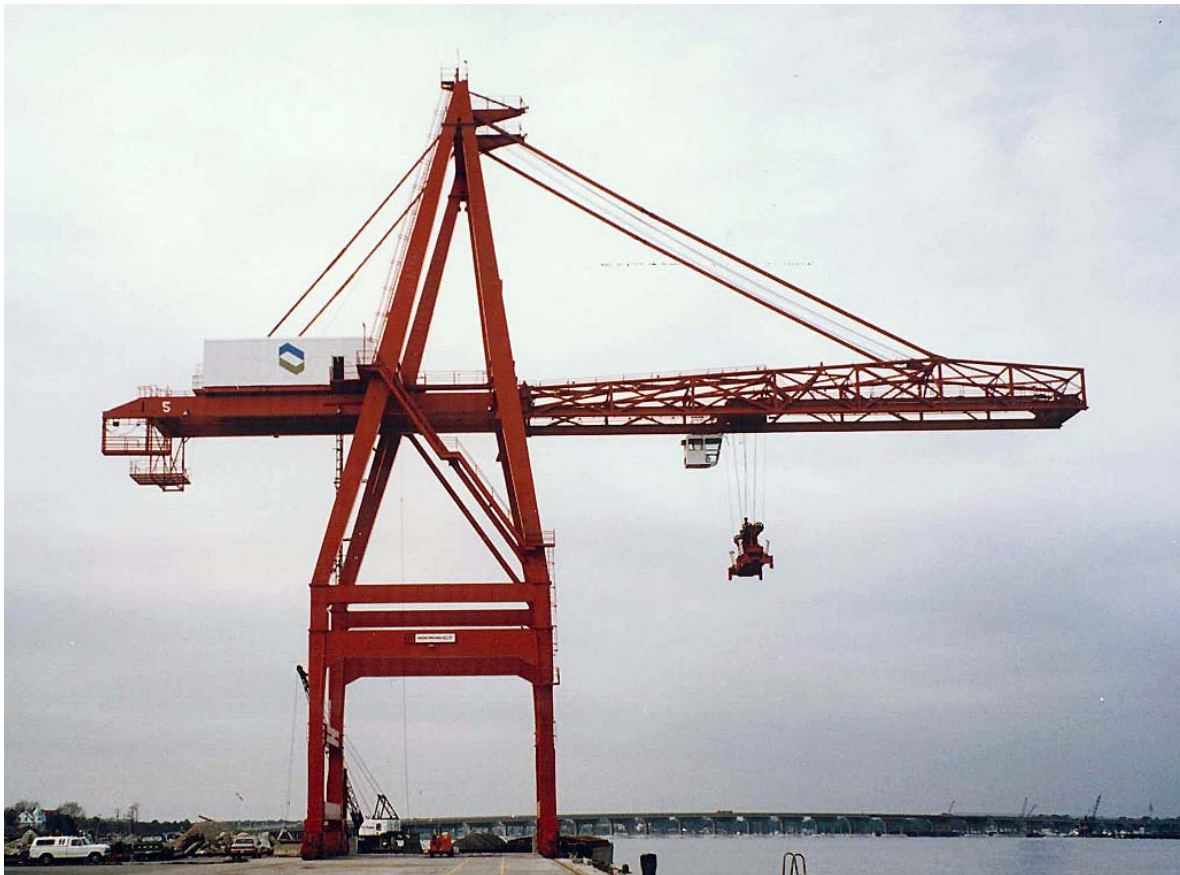
Virginia International Terminals  
Norfolk, Virginia  
1992

Over the years, the frame of this Virginia International Terminals Paceco truss boom crane had been modified several times. As a result, the frame was twisted and the boom misaligned. The resulting six inch (150 mm) lateral misalignment at the boom tip severely affected the crane operation.

The repair concept was to twist the frame in plan until the boom was properly aligned

Liftech designed a special push-pull jacking concept for the diagonals to untwist the frame. The two lower diagonals were released at the portal connection, and opposite compression and tension forces were applied. Computer analysis was used to determine the required jacking forces for the boom realignment.

The boom was aligned in less than a day after the jacking system was set up.

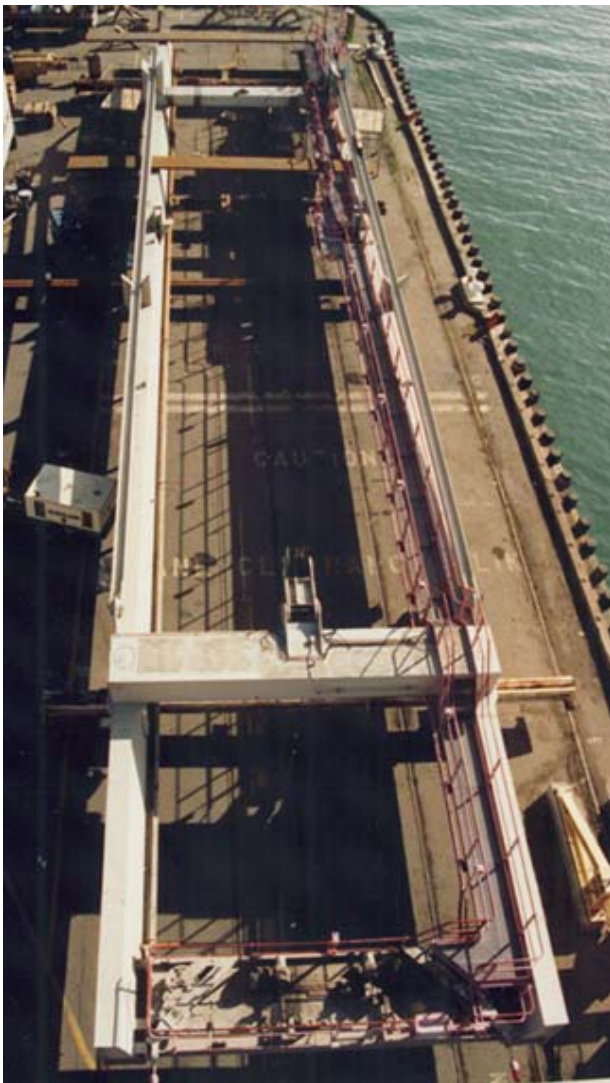
Rigging International  
Port of San Francisco  
1991

The Paceco crane boom was struck by a container vessel, and the boom tip was forced out of alignment by eight inches (200 mm). The boom was lowered to the ground, and repairs were made by heat straightening.

The heating pattern was determined using analysis to simulate the boom damage during impact. Required restraining forces were determined and applied to the structure during heat straightening. This method did not rely on any external supports. The boom was aligned to within 5/16 inch (8 mm) tolerance.

The boom was repaired in six days.

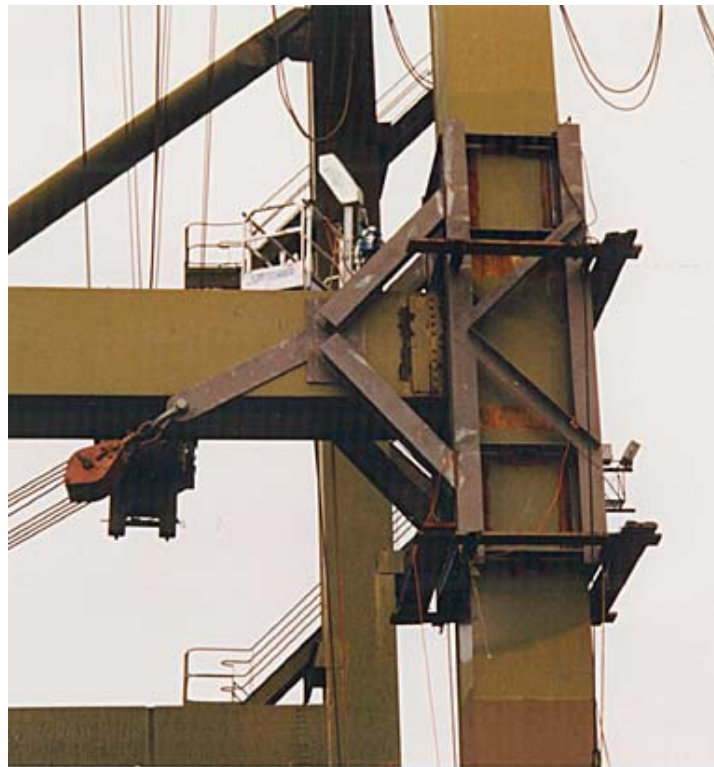
Paceco Corporation  
Port of Honduras, Puerto Cortez, Honduras  
1990

This Paceco truss boom crane was pushed off the rails when a container vessel struck a waterside leg during berthing. The gantry frame at the legs and at the portal tie beams was extensively damaged. Sections of the leg and portal were removed and replaced.

Liftech designed a self-supporting concept for the repair. A frame was built and attached to each side of the damaged sections to support the leg and portal tie, while the damaged sections were replaced.

Liftech has since used this support concept on other projects. The concept is particularly useful where a wharf is inadequate to carry the equipment loads. The strongback support frame eliminates the need for heavy lifting equipment to support the crane during repairs.

Repairs were completed in 15 days after the setup.

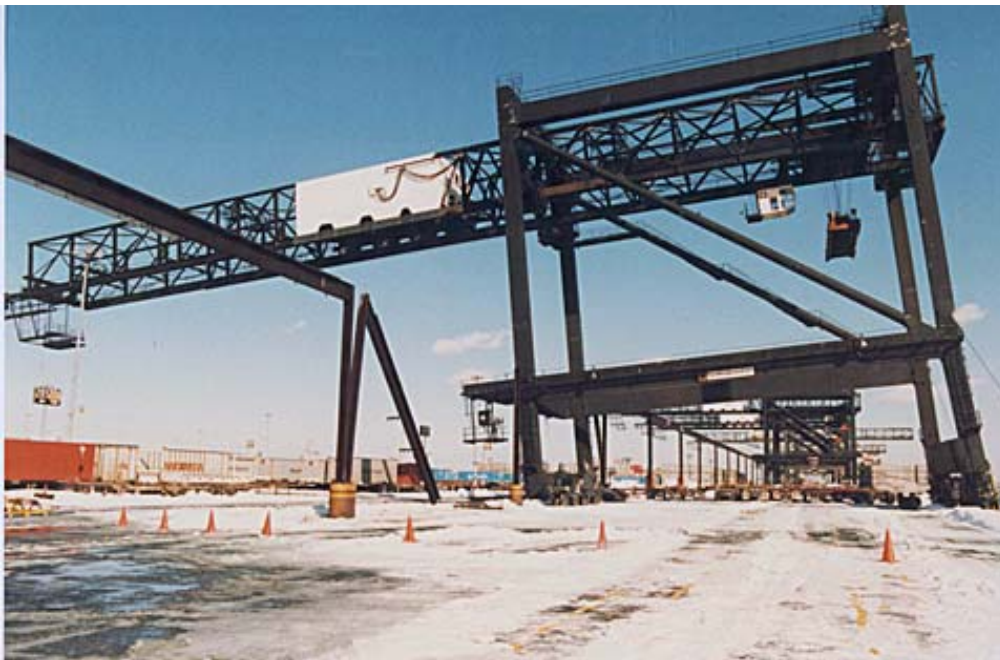
Sea-Land Services, Inc., Sea-Land Terminal  
Port of New York and New Jersey  
Elizabeth, New Jersey  
1987

While berthing, a Sea-Land container vessel struck one of the waterside legs of a Paceco low profile crane, pushing it back eight feet and causing extensive damage. The impact tore the landside and waterside gantry equalizer systems from the sill beams, the frame tilted backward, and the waterside legs buckled at the portal tie and sill beams. The frame list caused the boom to roll back into its bumper stops, deforming the lower chord.

The boom and frame were temporarily secured against collapse. The boom was lowered to the ground, and the boom and frame structures were

transported to the backlands behind the loading wharf for repairs. Portions of the waterside leg, sill beam, and portal tie were replaced. The landside legs and sill beam were salvaged and repaired by heat straightening. The boom lower chord was heat straightened to its original condition. Trucks and equalizers were replaced. The 350-ton boom was lifted and positioned on the hangar system, and the crane was transported back onto the wharf.

Repairs were completed in 90 days.

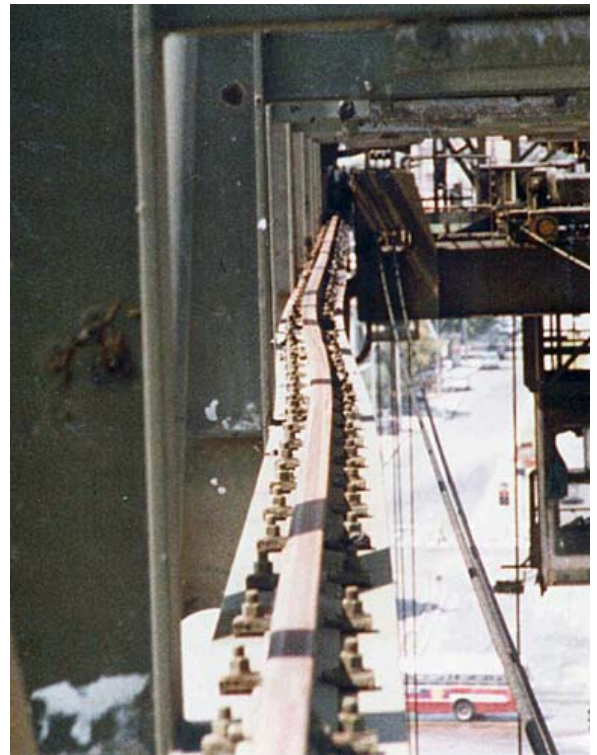
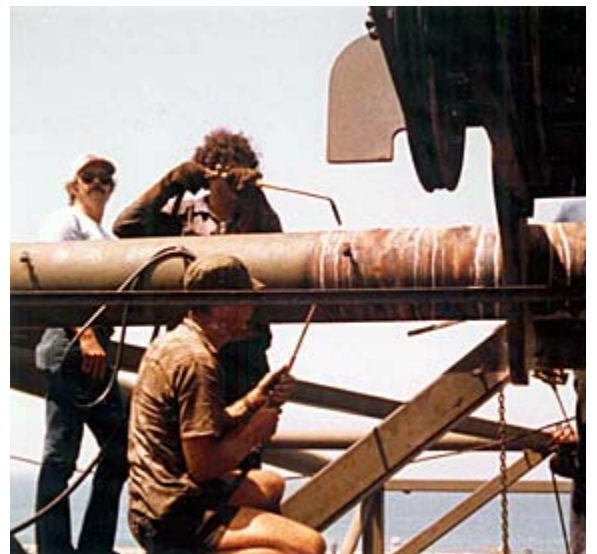
Israel Ports and Railways Authority  
Port of Haifa, Israel  
1983

While raising the Paceco crane truss boom, the boom hoist rope improperly wrapped around the drum. As the boom was lowered, the loose rope unraveled, and the boom dropped several feet onto one set of rails damaging the boom. The boom tip was deformed laterally 14 inches (350 mm) out of alignment. The trolley rail girder deformed into an S-shape. The support cross bracing at the boom hoist bracket buckled.

The boom was repaired in place by heat straightening. The deformation of the truss boom due to the accident was calculated. A finite element analysis was used to calculate the restraining forces needed to facilitate the straightening. The lower chord and rail girder were heat straightened. The boom was aligned to within 1/8 inch (3 mm) tolerance, and the damaged upper chord bracing members were replaced.

Repairs were completed in three days after the setup.
