Liftech engineers have been providing structural engineering services to the container crane industry for over 45 years and have experience in many crane failures.

Several catastrophic failures have occurred this year and several others nearly occurred reminding the industry of the risks.

## Accidents Related To:

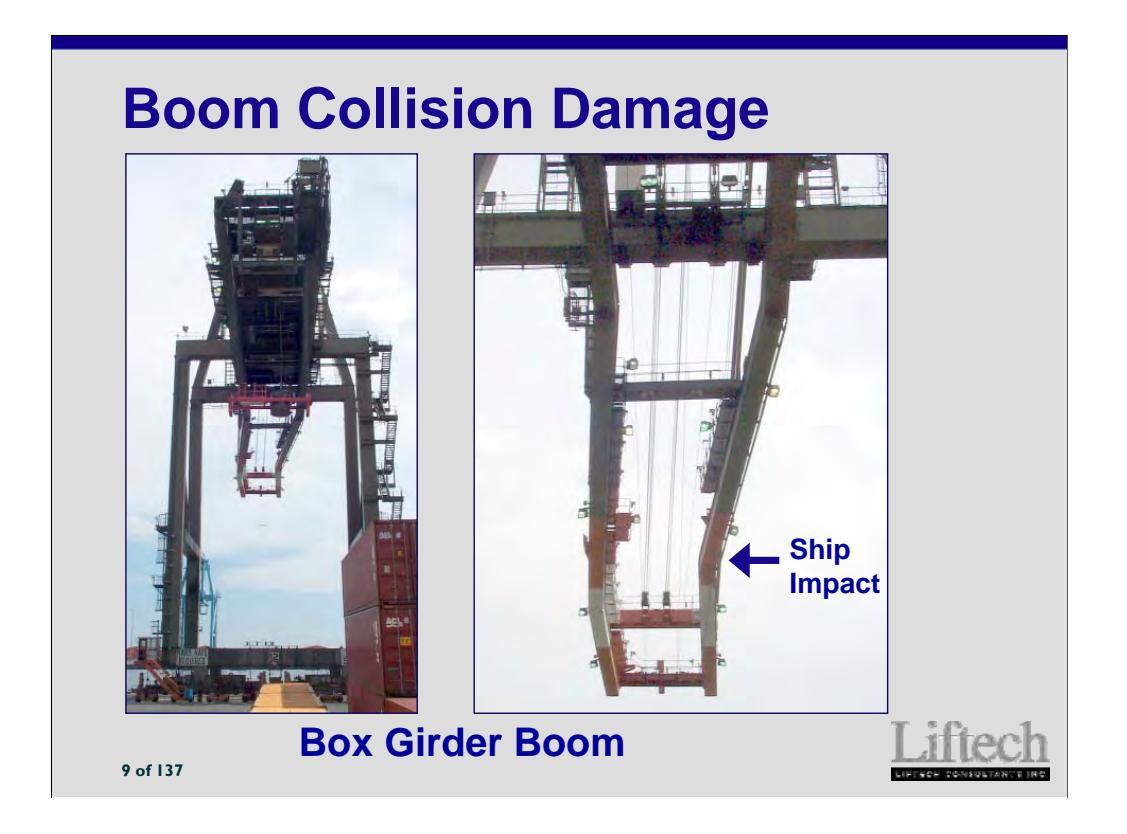
This collision occurred in New Jersey when a vessel berthed out of control. This type of collision causes severe damage.

The ship impacted the right girder pushing the boom laterally. Despite the severity of the damage, the crane frame was undamaged and the crane did not derail.

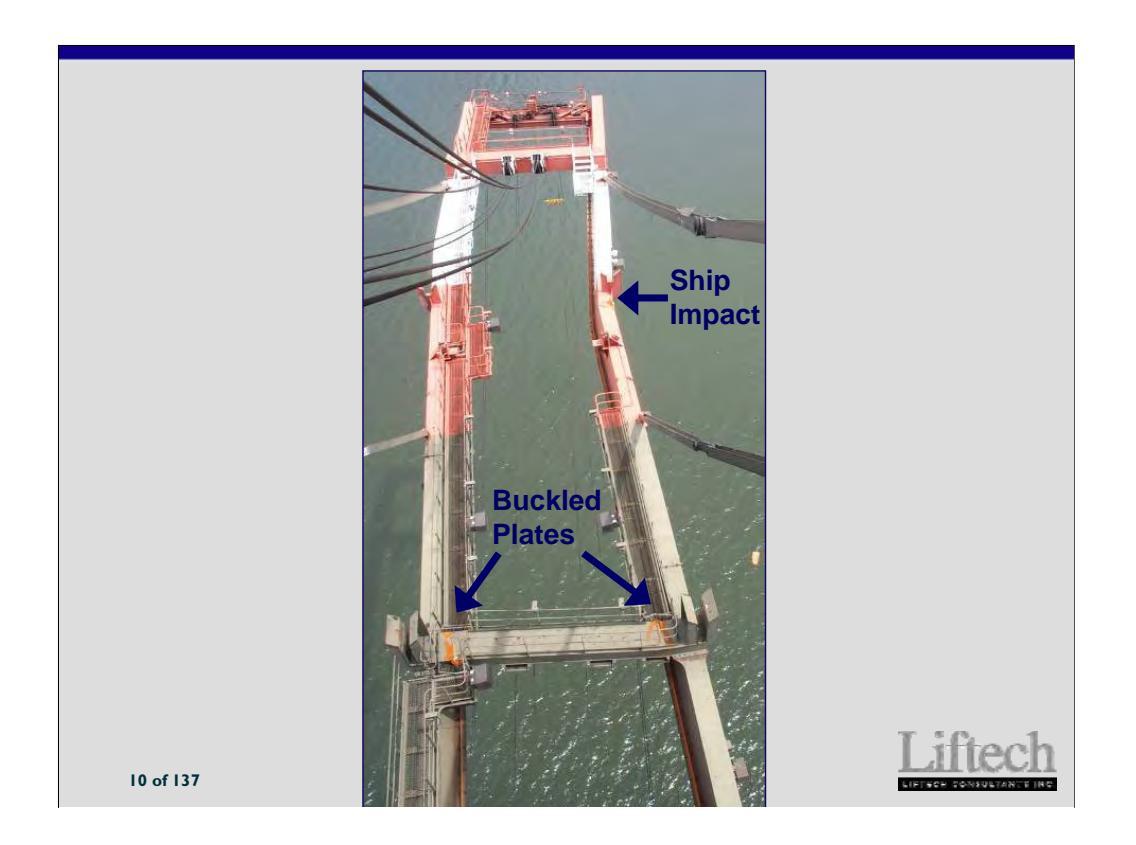
The right girder is bent plastically at the impact location. The landside cross beam buckled plastically on either end.

In this instance, the forestay connection plates on the boom and at the apex had permanent lateral deformations.

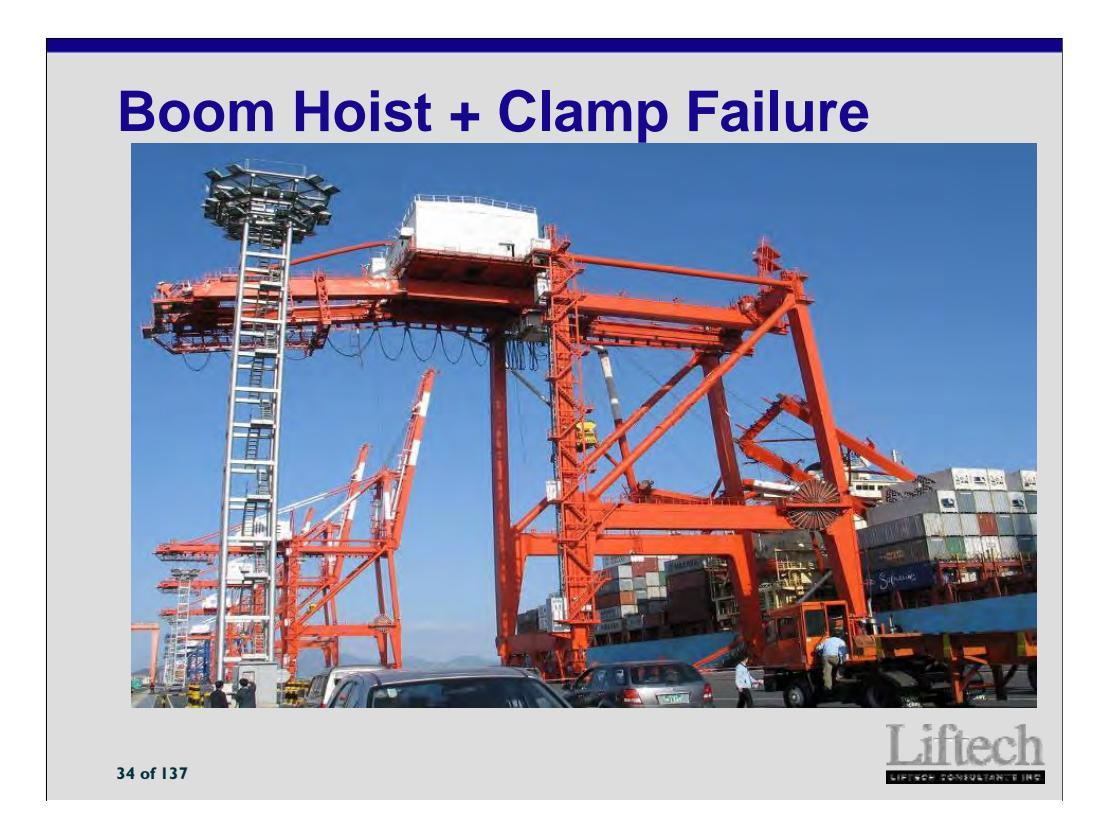
This is the same crane after the failure. The boom and A-frame members separated from the frame.

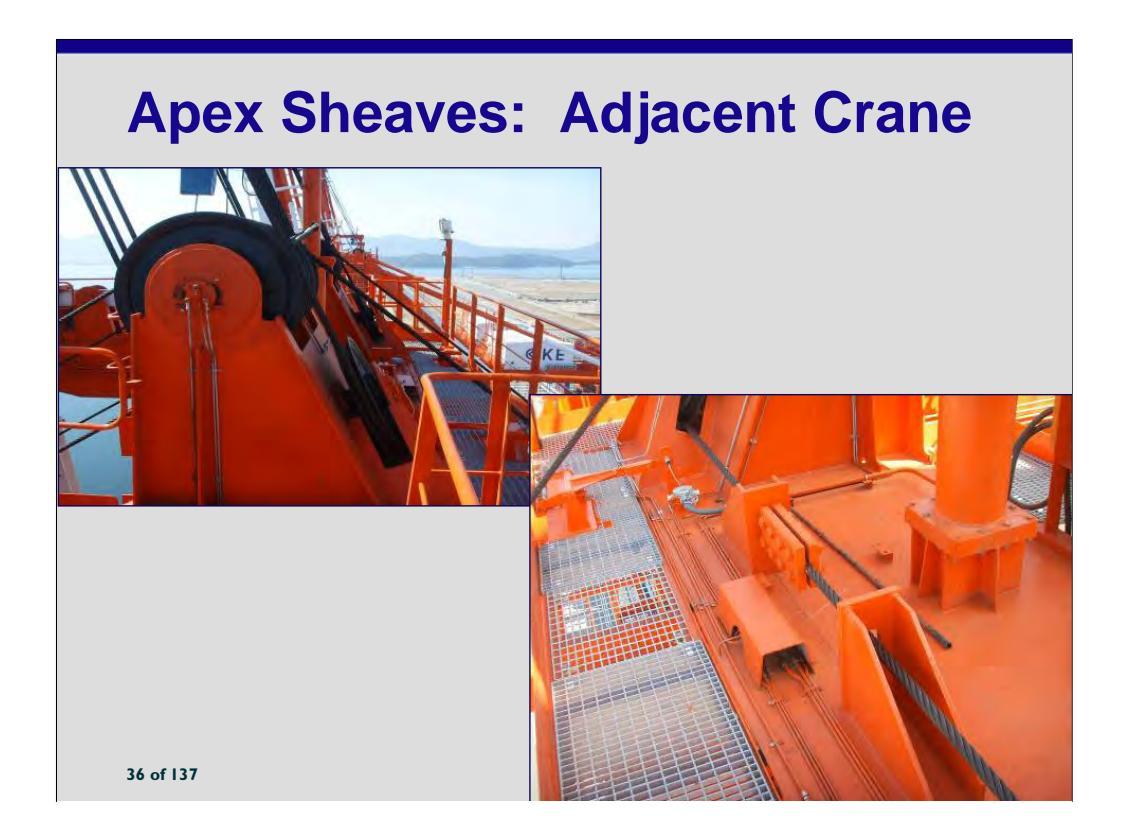
This photo shows reeving at the apex of the adjacent crane including the stop clamp and stops.

On the failed crane, the rope on the side of the reeving failed. The exact cause of the rope failure is unknown. The rope may have jumped the sheave for some reason. The stop clamp did not hold the rope after the rope broke. The clamp was likely not installed properly.

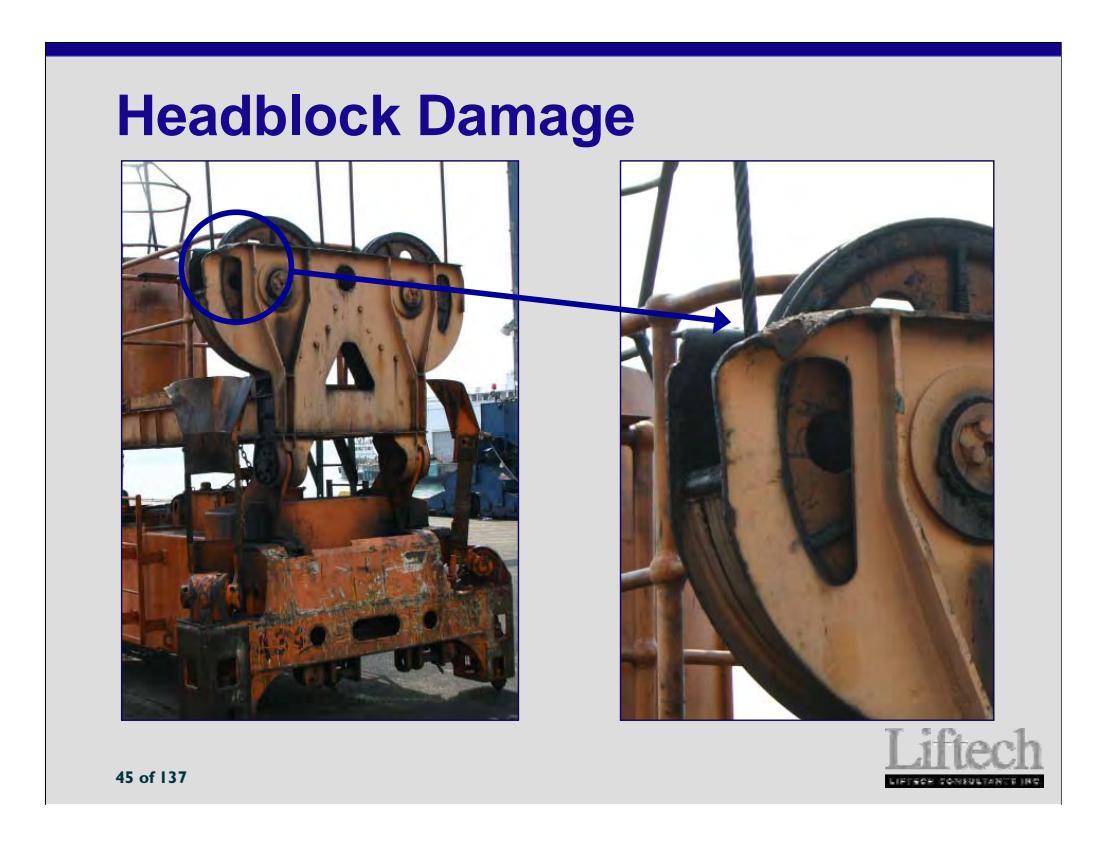
This slide shows damage to the headblock during a snag event.

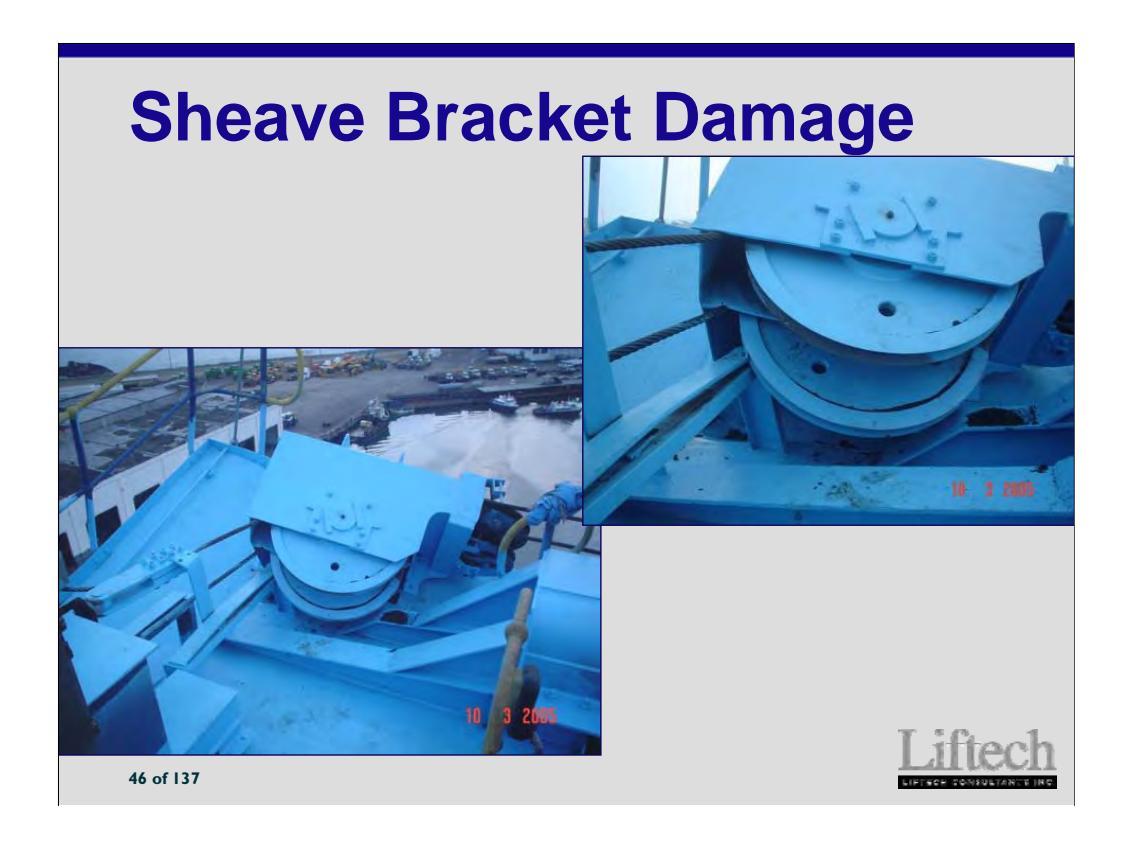
Damage to the end tie is shown here. The sheave brackets did not pull from the boom structure, but pulled the boom structure up.

The damage was caused by the severe loading and significant corrosion of the end tie structure.

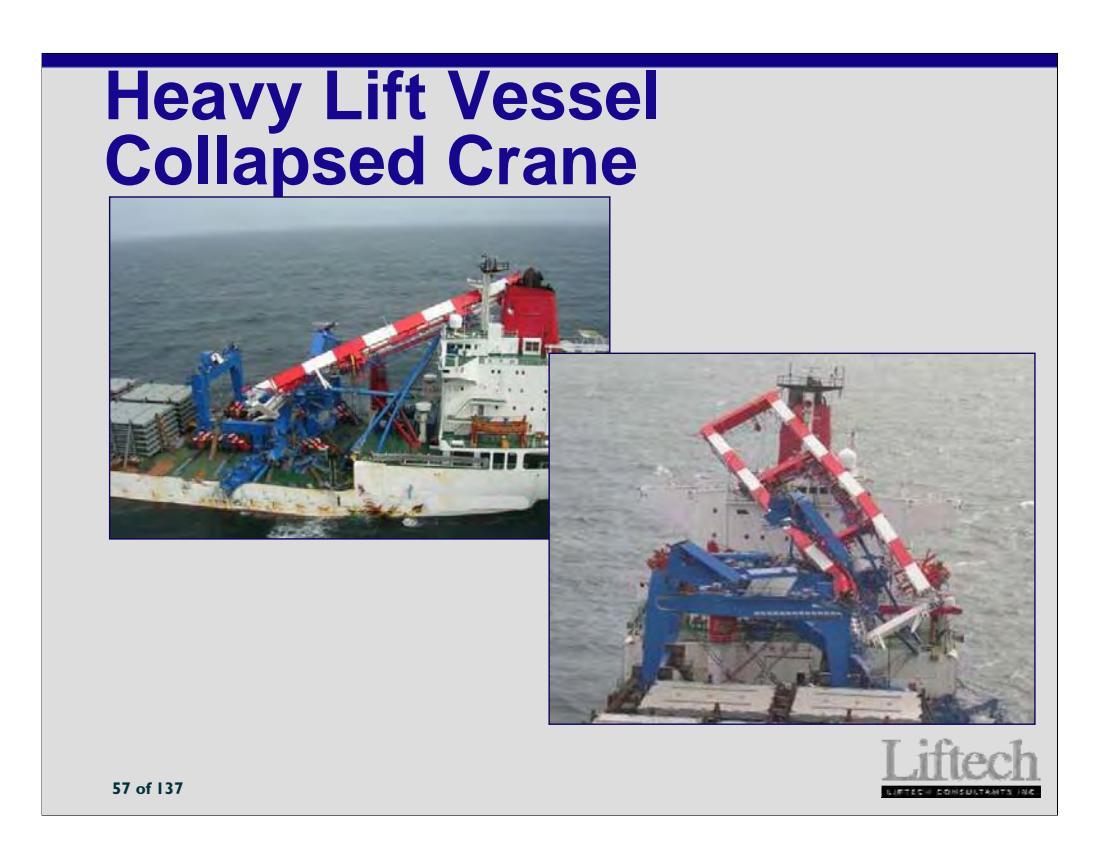
Damage to cranes transported by vessels also happens.

In this accident, the bracing connecting the crane to the vessel held; however, the bracing within the crane structure itself did not. It is important to perform an appropriate finite element analysis to correctly estimate the design forces within the crane structure and added bracing.

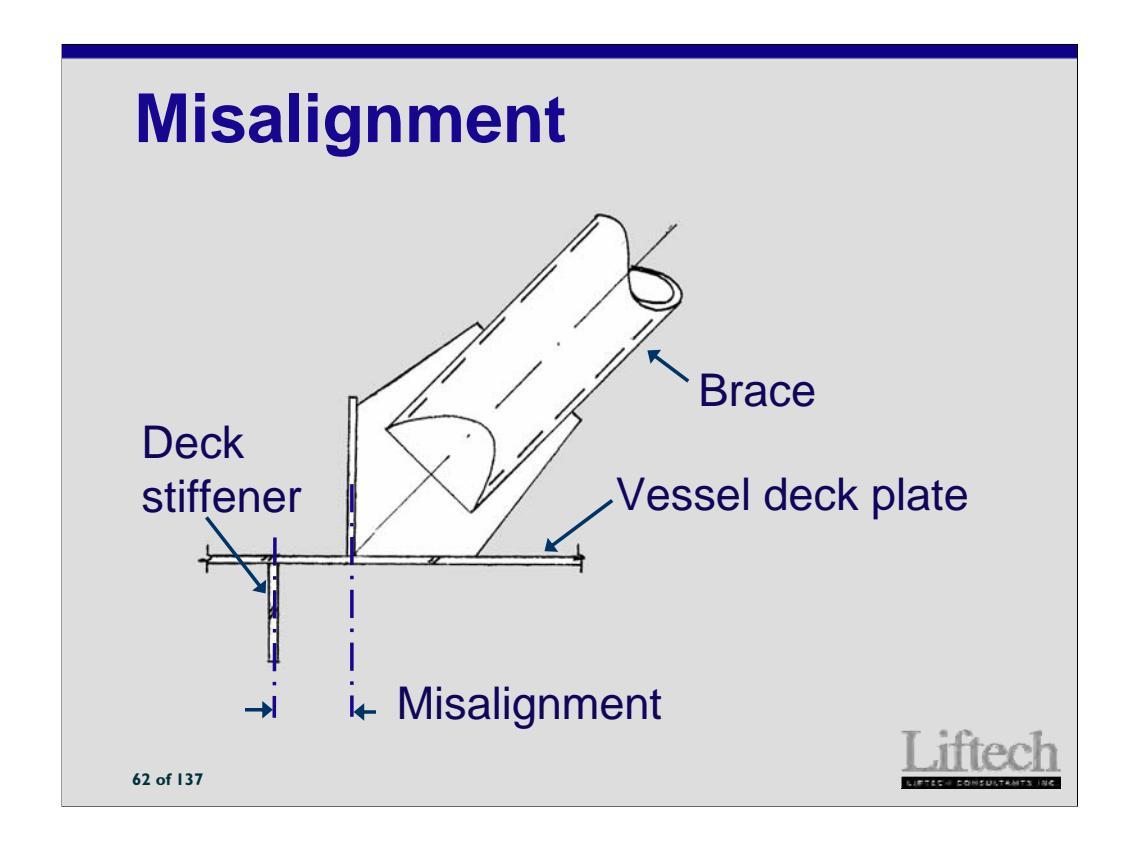
The most common mistake is improper alignment of the braces with the vessel structure.

Misalignment will result in significant bending stresses in both the bracing and vessel structure.

Typical alignment repair is to extend connection plates to transfer the bracing forces into the deck stiffeners below.

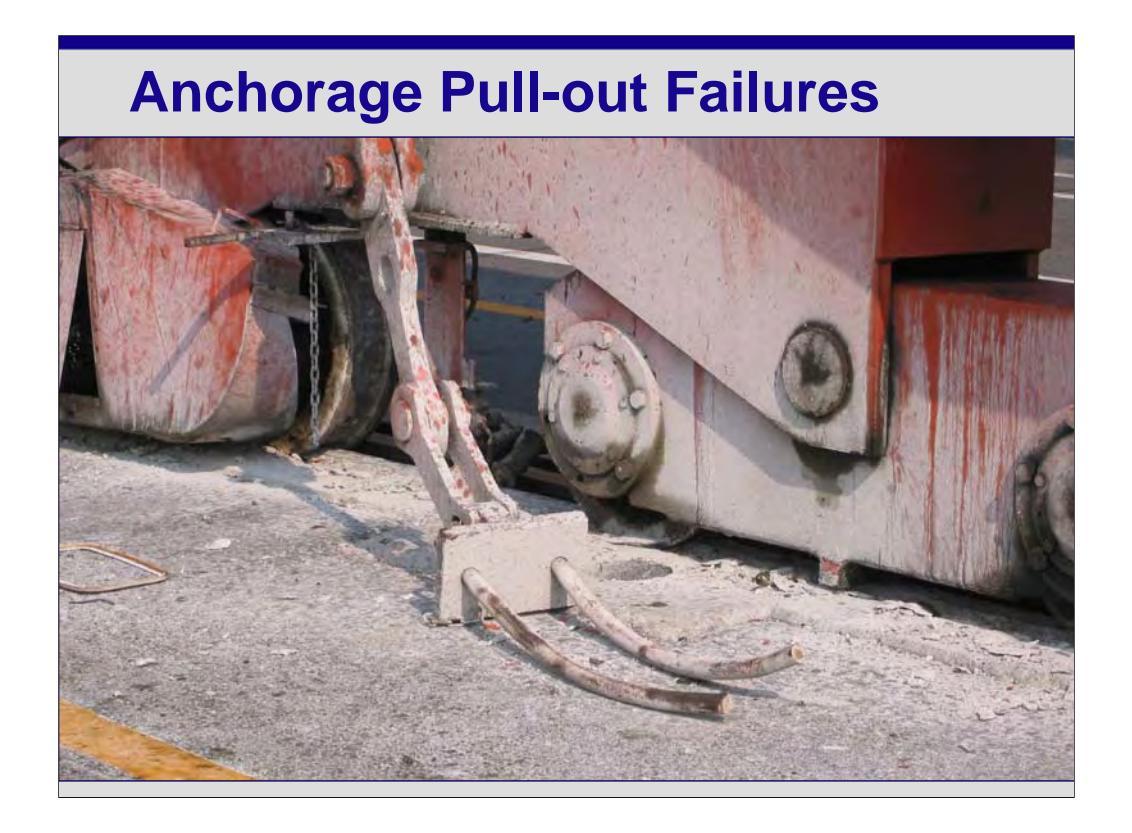
There were multiple types of failures during Typhoon Maemi. Tie-down anchorage was one failure type. Smooth anchors pulled out of the wharf.

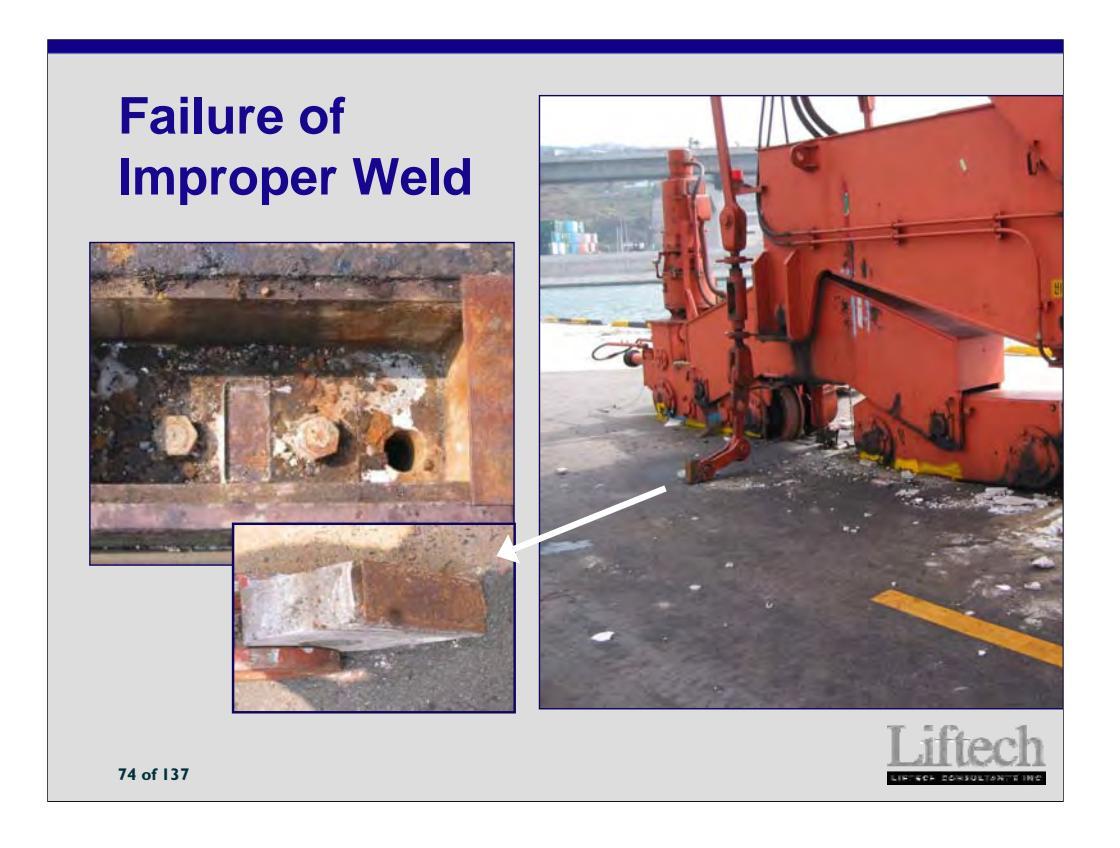
Improperly made and undersized welds failed at tie-down brackets.

Tie-down wharf bracket failure was due to improper fabrication--4 mm (3/16 inch) fillet weld between **base plate** and **60 mm** (2.5 inch) lug.

The design called for a complete joint penetration weld that would have developed the strength of the ear plate. This weld would have been many times stronger than the provided weld.

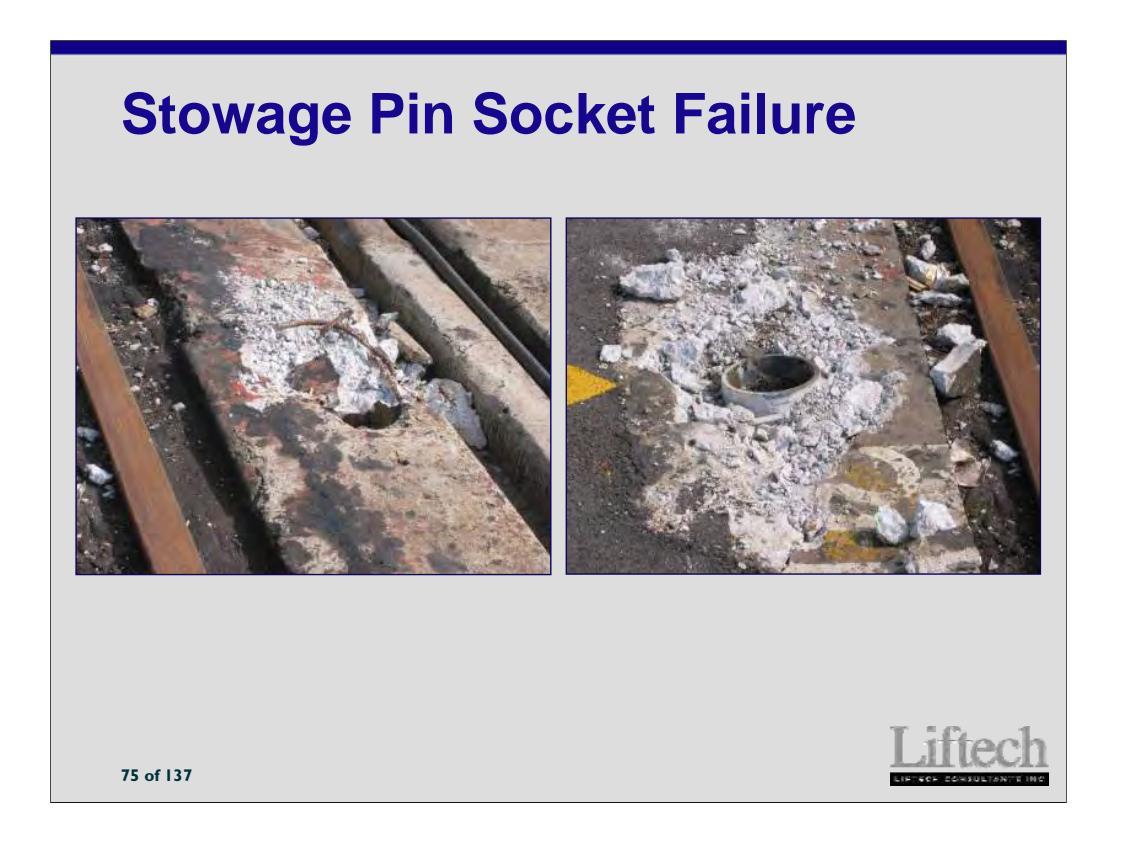
Local concrete bearing failures occurred at stowage sockets. The design did not consider the large bearing stresses that will occur. This was exacerbated due to crane uplift and localized bearing of the stow pin on the upper end of the cast in place tube.

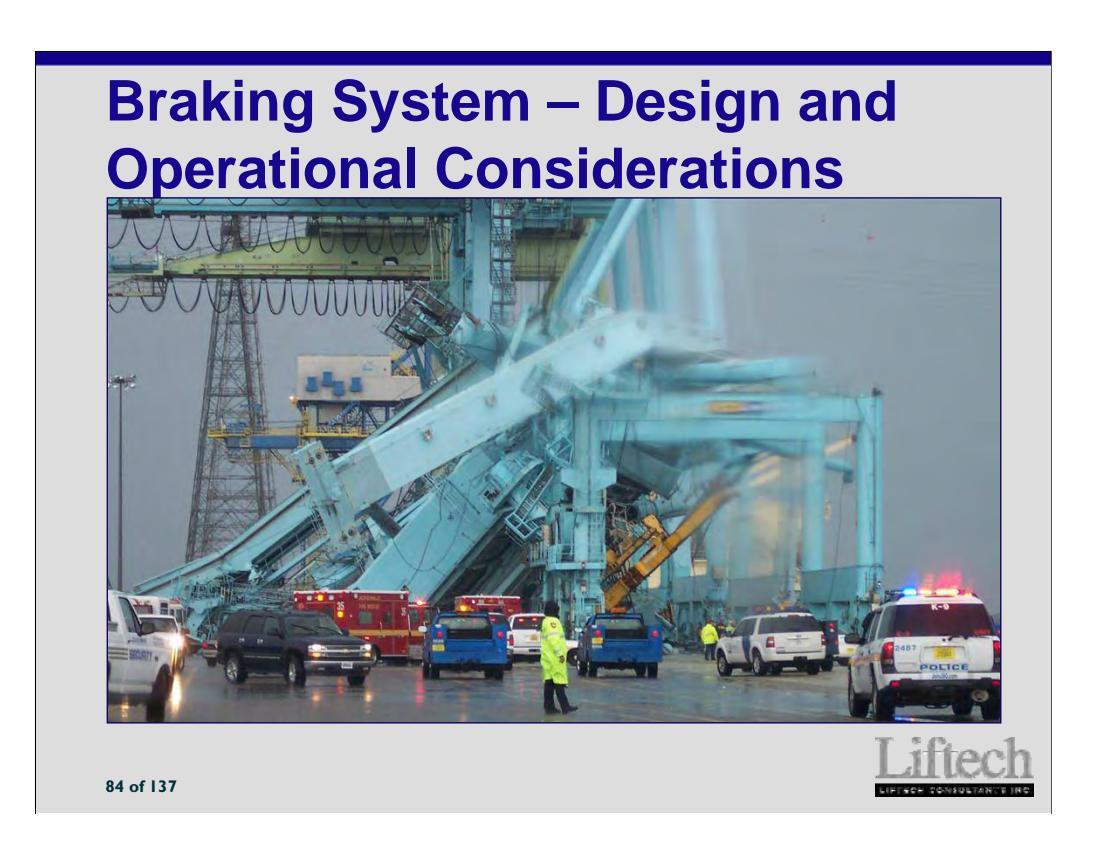
We understand that the braking system was not at full capacity because the rail brakes on one side of the crane were disabled due to a rail clearance problem.

This is a photo of the collapsed cranes.

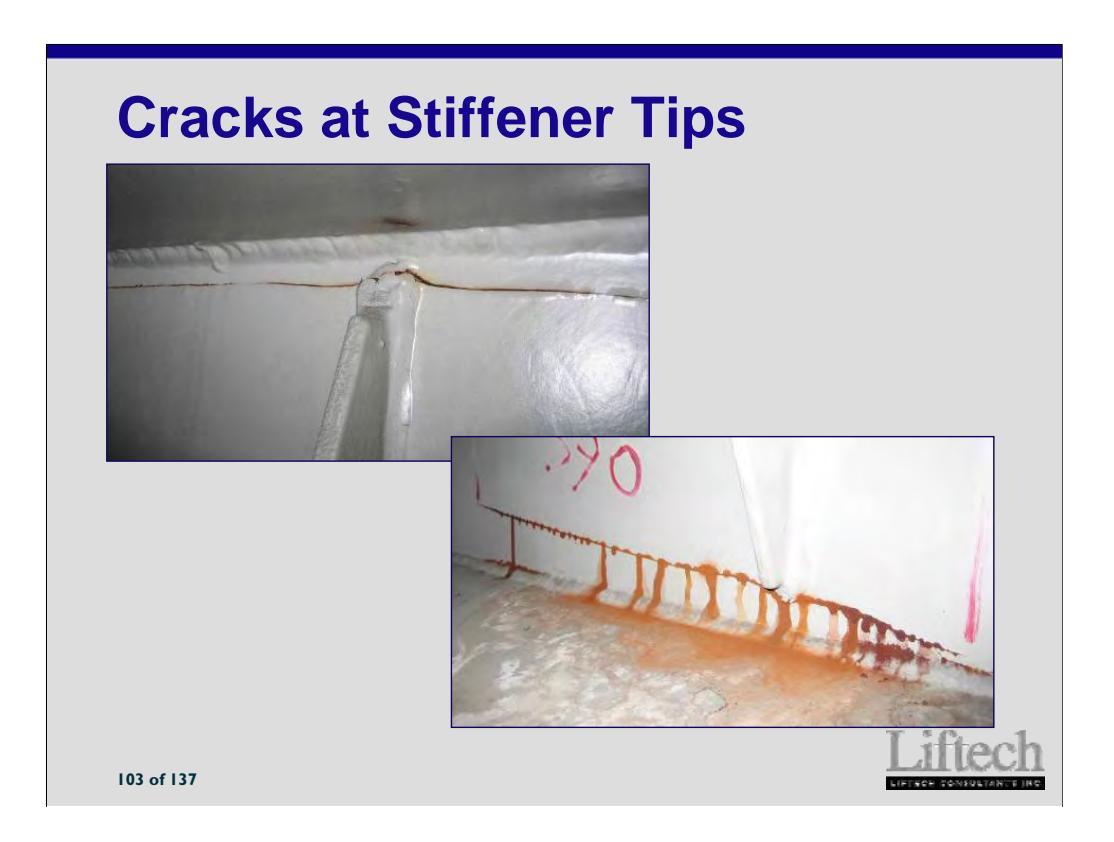
These pictures show more cracking at stiffener ends.

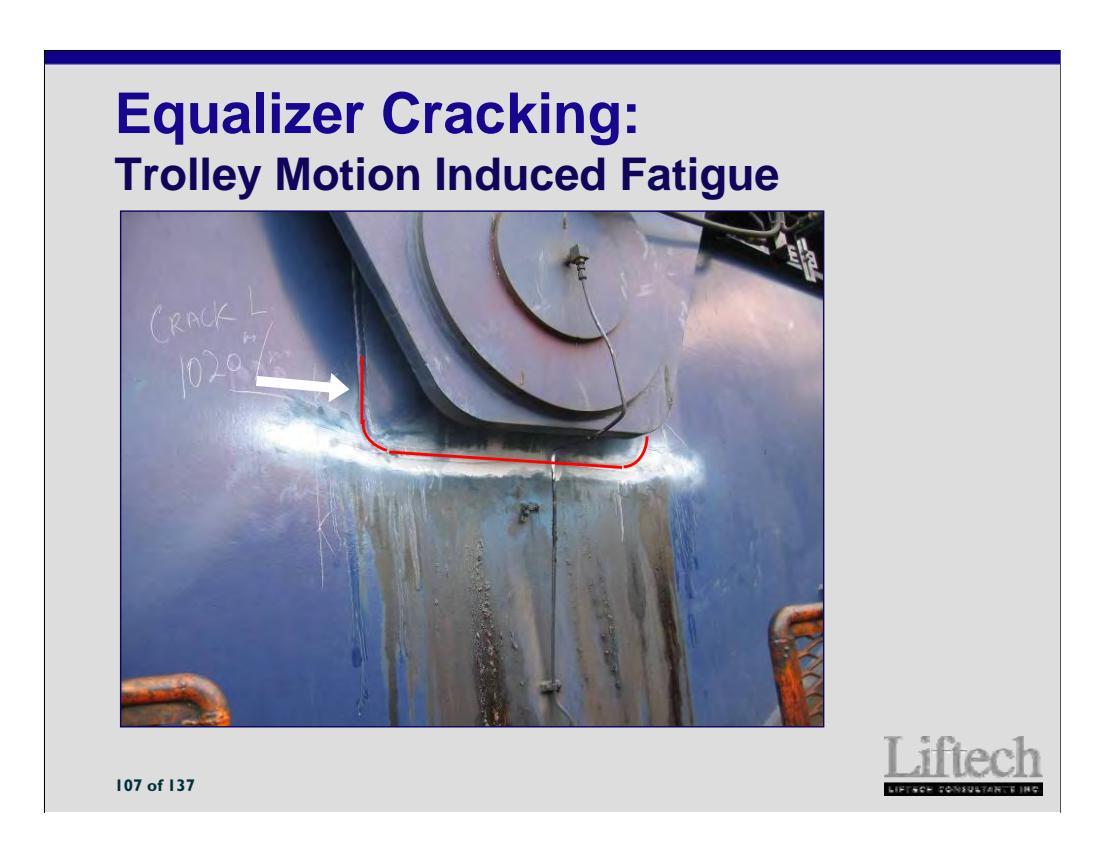
Cracking has occurred at the thickened pin plate in the equalizer beam.

In this photo, a red line has been added at the crack.

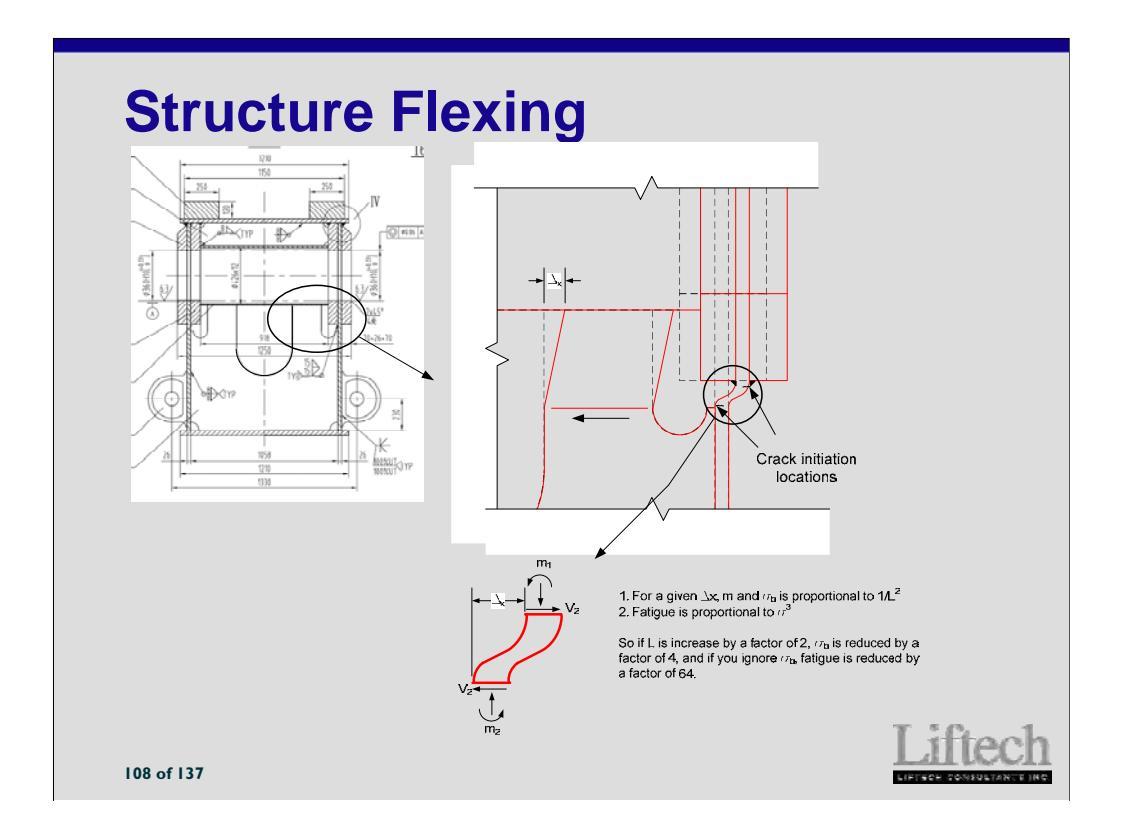
Cracking is the result of localized bending in the web due to the small clear distance between the diaphragm and boss.

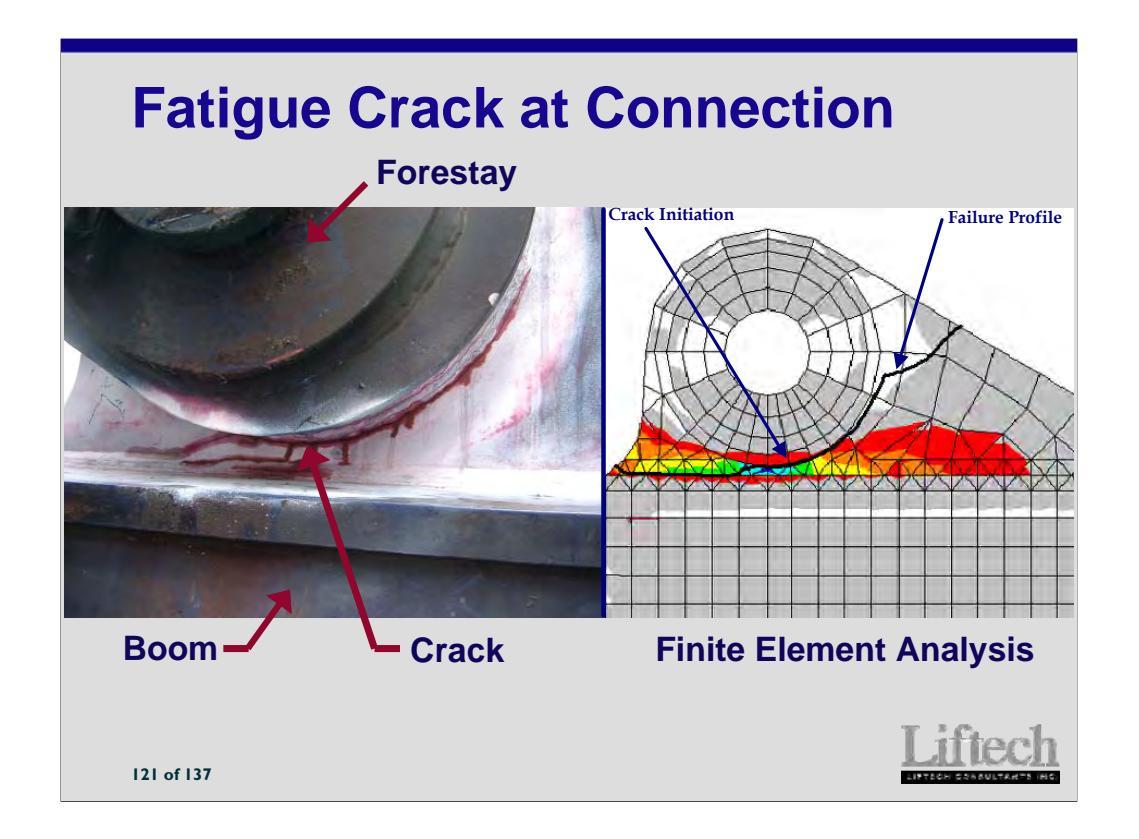
On another project, a forestay connection failed but the remaining stays held the boom. Cracks similar to that shown were discovered at all other connections.

The cracks initiated at the stress concentration at the toe of the boss weld and propagated across the plate in both directions

The photo on the left is a cracking detail that has not yet failed.

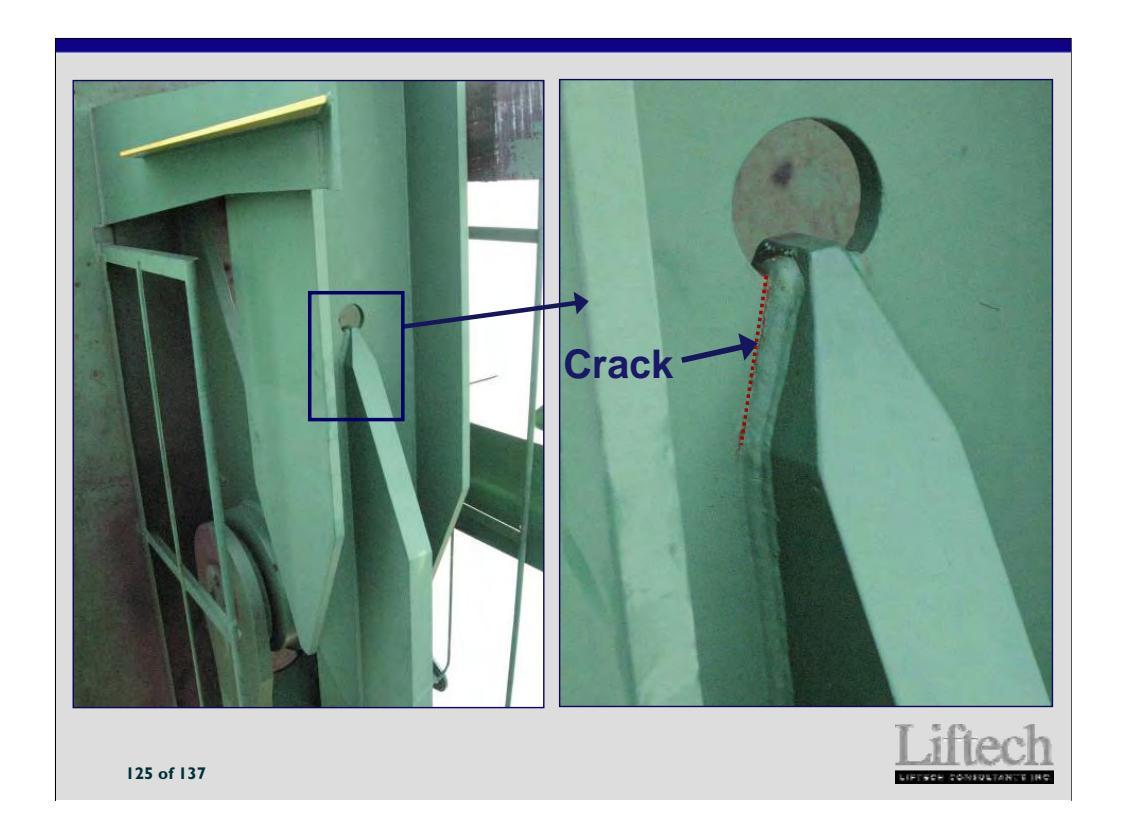
Cracks initiated at the plate termination due to large stress concentration. This is exacerbated by the dead load torsion on the plate when the stay is not fully tensioned, e.g., during boom raising.

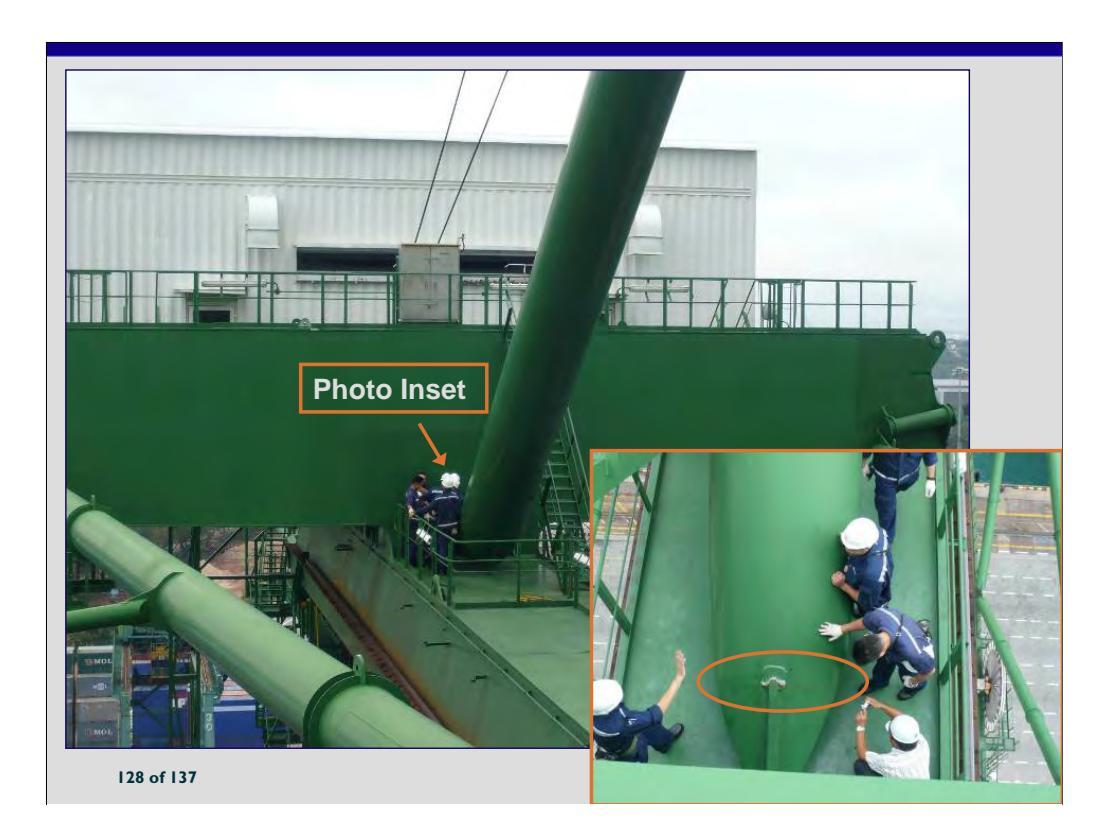
Very large cracks have developed at relief holes of the let-in connection plate. A catastrophic failure nearly occurred but did not because materials were much tougher than required.

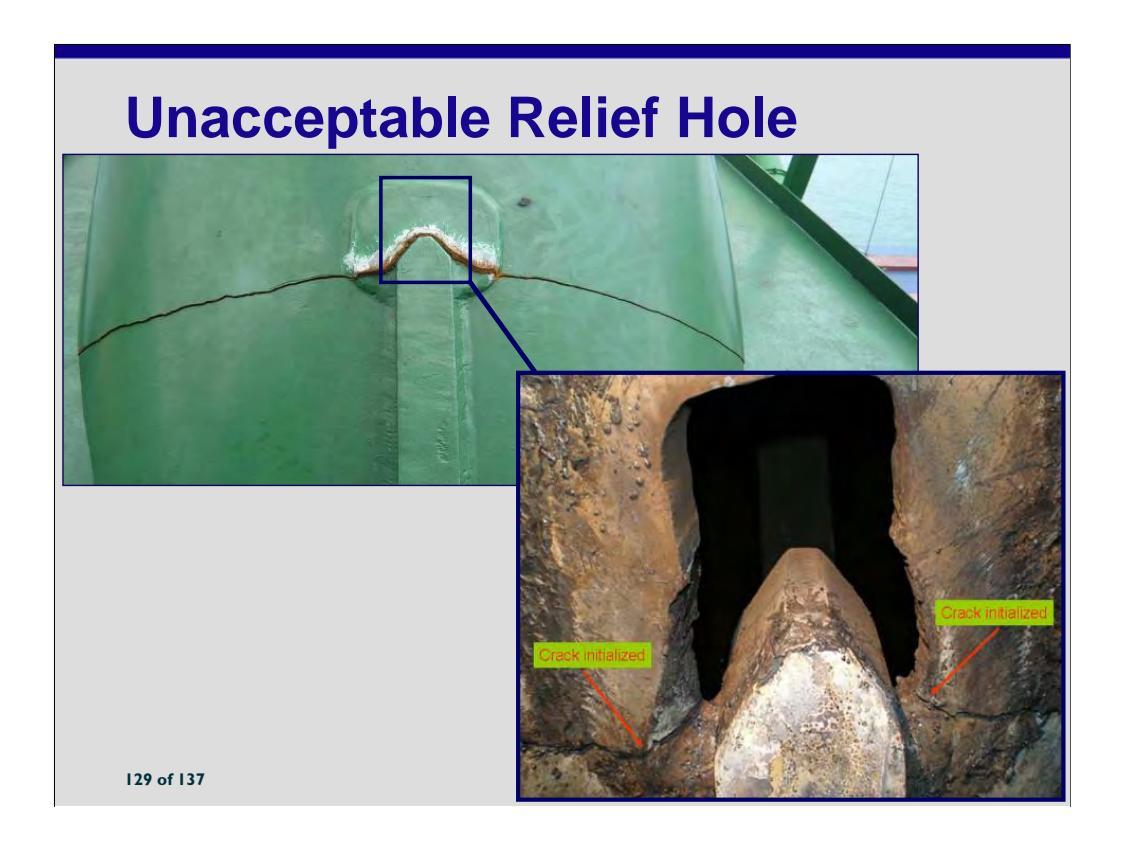
Removal of the cover plate revealed a relief hole with very poor geometry, edge roughness, and transition where it connected to the plate.

This member was very close to failing under its next significant loading.

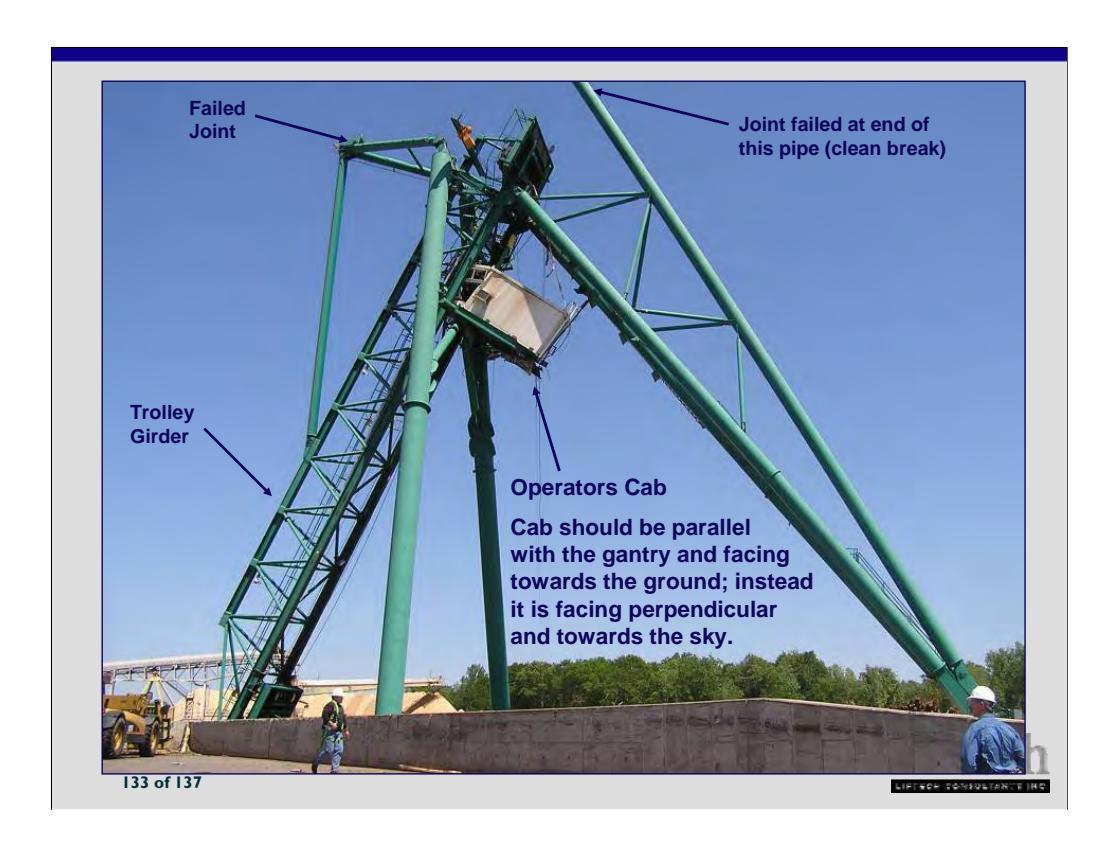
This photo shows how the failed connection caused the boom to fail.

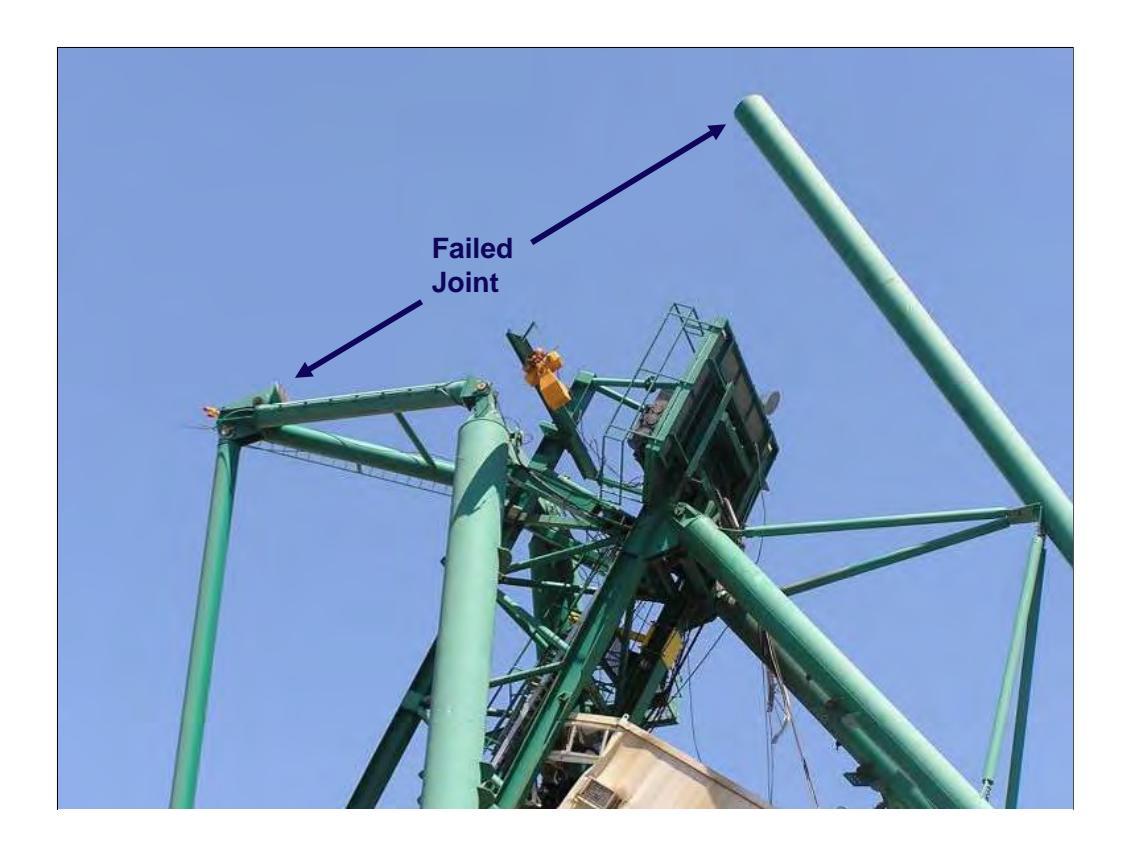
This photo shows a close up of the connection.

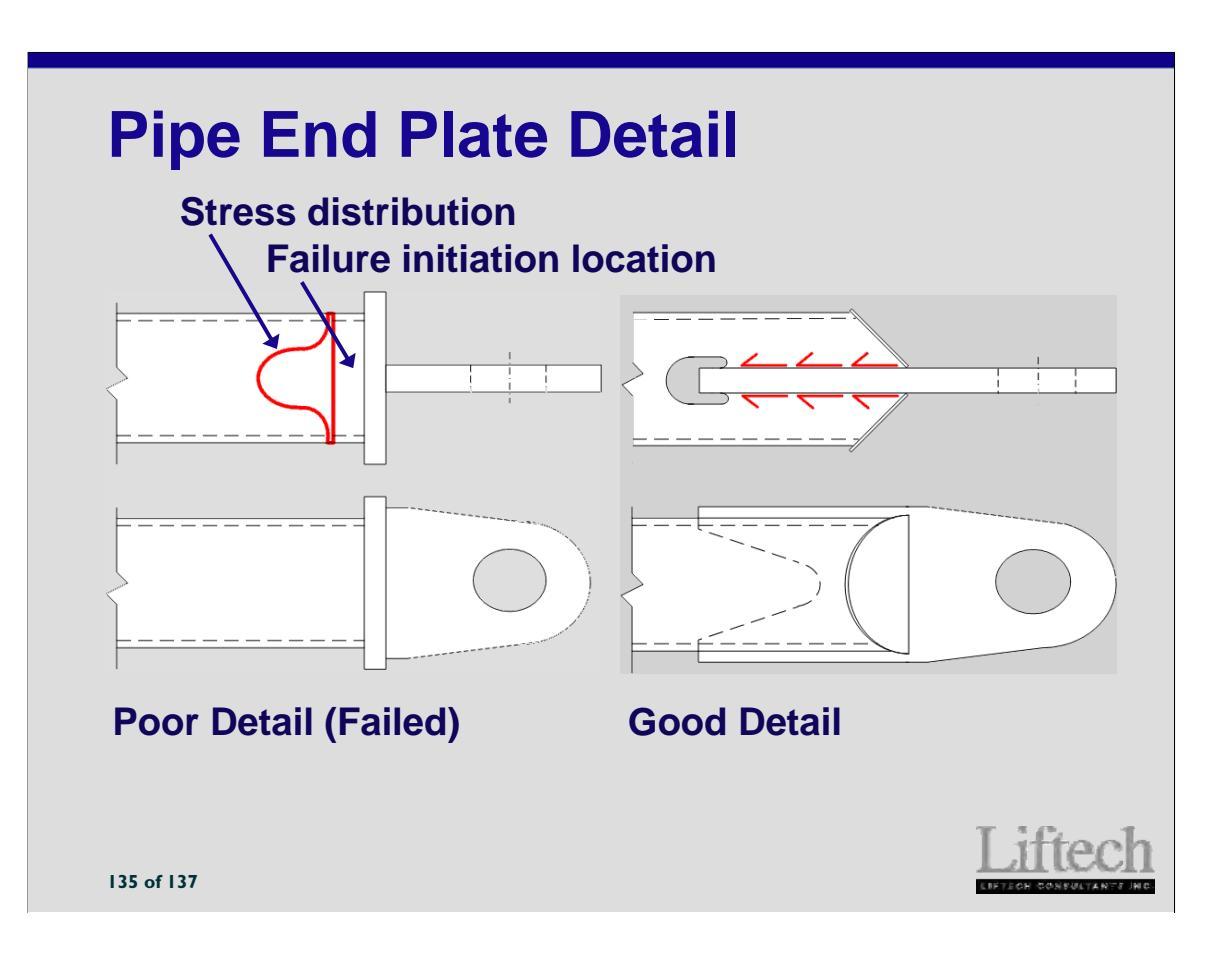
The detail used resulted in very large stress concentrations at the connection PL. This resulted in fatigue failure and subsequent fracture.
