# The Design of Earthquake Damage Repairs to Wharves Before the Earthquake Occurs

Gerald M. Serventi\*, Michael A. Jordan\*\*, George Fotinos\*\*\*, and Erik G. Soderberg\*\*\*\*

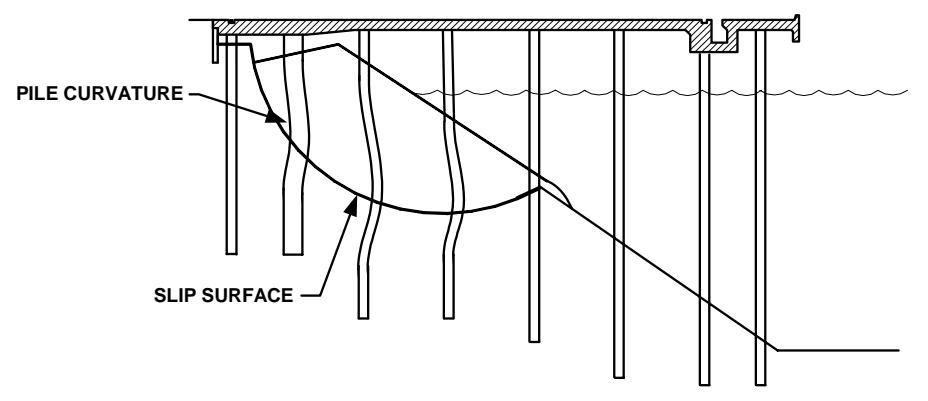
**Figure 1. Below Grade Soil Deformations**

Piles can be damaged at their wharf connection due to the movement of the wharf deck and below grade if the embankment moves and the soil displaces across a plane. See Figure 1. Batter piles may fail in tension by breaking or pulling from the wharf. Damage to vertical piles typically consists of cracking and spalling of the unconfined concrete cover.

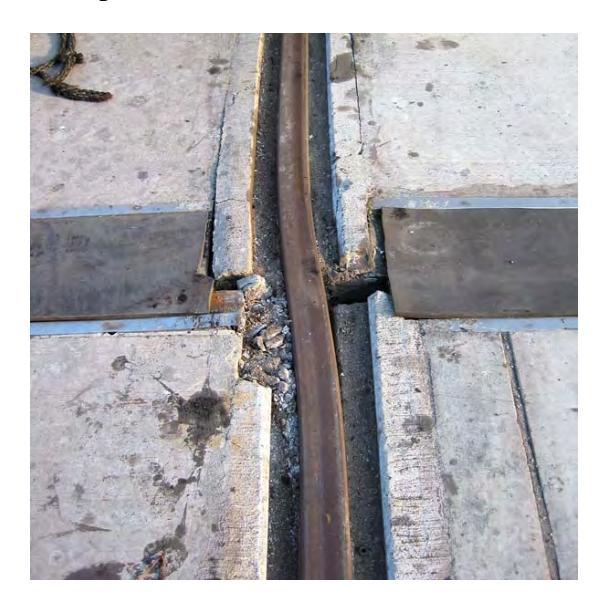
Figure 2. Crane Rail Damage at Expansion Joint

Relative displacement between wharf sections at the expansion joints may damage the shear key, the crane rail, the expansion joint cover, and the power trench or cable trench. See Figure 2. The designer should consider the use of a ductile shear key element and flaring the crane rail and expansion joint trenches to facilitate realignment of the rail and power or cable trench.

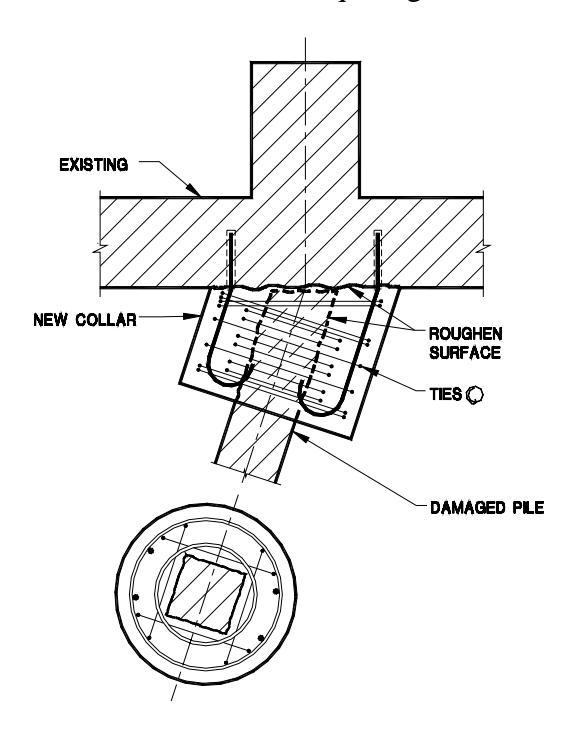
Figure 3. Batter Pile Repair Detail

The old Matson wharf at the Port of Oakland had many batter piles that failed in tension near their connections to the wharf deck. The detail shown in Figure 3 was used to reconnect the broken piles to the wharf deck. The detail relies on shear friction between the roughened outside surface of the pile and the new confined concrete collar. This detail was successful, requiring little time to construct.

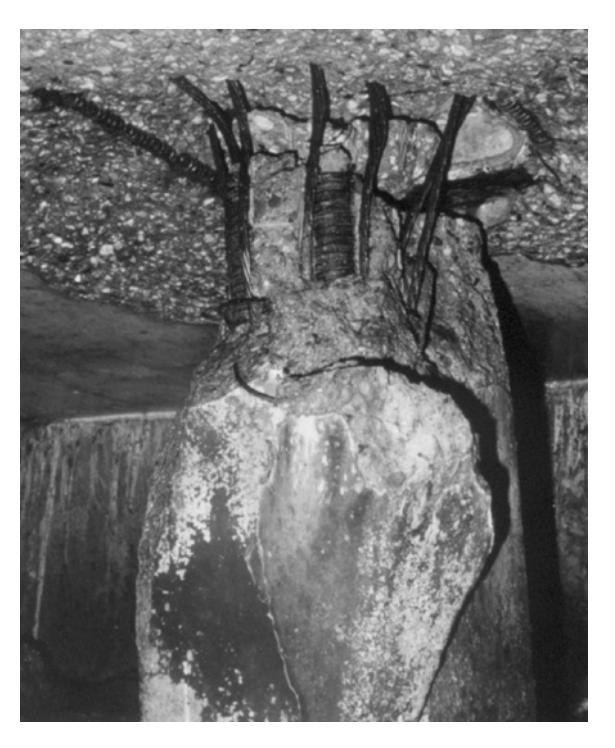
**Figure 4. Typical Damage to Piles**

Significant damage to Berths 35 - 37 resulted from the Loma Prieta earthquake. This terminal being constructed along the perimeter of a reclaimed peninsula of land experienced liquefaction of the fine granular soils used to construct the perimeter dike. As a result of this liquefaction, hundreds of piles imbedded in the dike were damaged beyond repair. It was necessary to shut down the terminal for several months to make repairs. Figure 4 shows the type of damage experienced at the terminal.

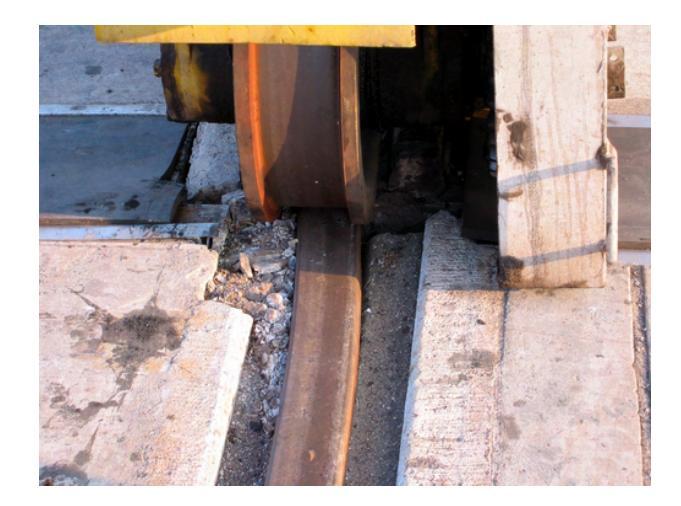
Figure 11. Crane Stranded at Displaced Expansion Joint

Even offset of a few inches can interrupt the crane rail so the cranes are isolated between expansion joints. Or worse yet, a crane can be stranded over a joint, such as occurred in the January 22, 2003 earthquake in Manzanillo, Mexico. See Figure 11.
