Liftech engineers have been providing structural engineering services to the container crane industry for over 45 years and have experience with many crane failures.

Catastrophic failures occur rarely, but they do occur, reminding the industry of the ever present risks.

This presentation will review a variety of accidents and ways of preventing them.

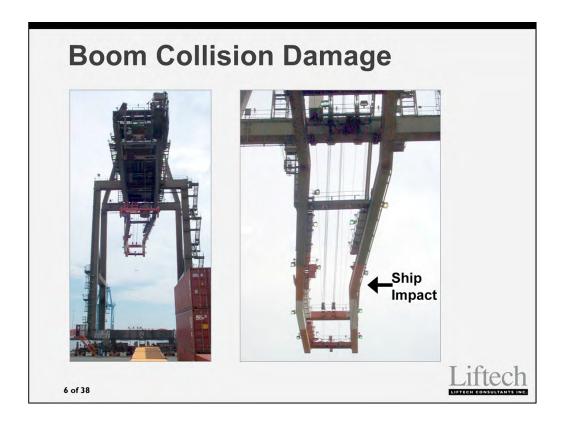
The most common vessel collision is between the ship and crane boom.

This collision occurred in New Jersey when a vessel berthed out of control.

The ship impacted the right girder pushing the boom laterally. Despite the severity of the damage, the crane frame was undamaged and the crane did not derail. Repairs were completed within a month by lowering the boom to the wharf and repairing damaged sections using a variety of methods including replacement, stiffening, and heat straightening. Repairs were completed in a month at a construction cost of around \$600,000 in 2001.

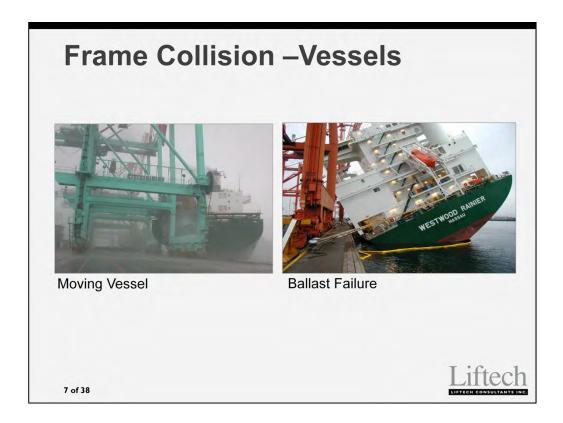
Frame collisions are less frequent. Many collisions occur due to vessels berthing in bad weather.

Sometimes the damage is repairable; sometimes it is catastrophic.

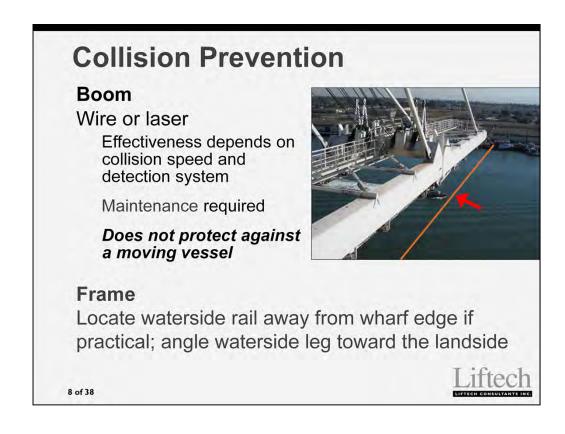
Boom collisions are common.

To mitigate boom collisions, we suggest using a tripwire or a laser system.

Be aware that these systems will not guarantee that collisions will not occur. For example, when vessels move into booms, the system cannot stop the vessel and a collision will still occur. Also, the tripwire may not protect a fastmoving crane from collision.

The tripwires require regular maintenance to be effective.

It is difficult to prevent and mitigate vessel collisions to the frame. One way is to set the waterside gantry rails back from the face of the wharf to provide additional clearance.

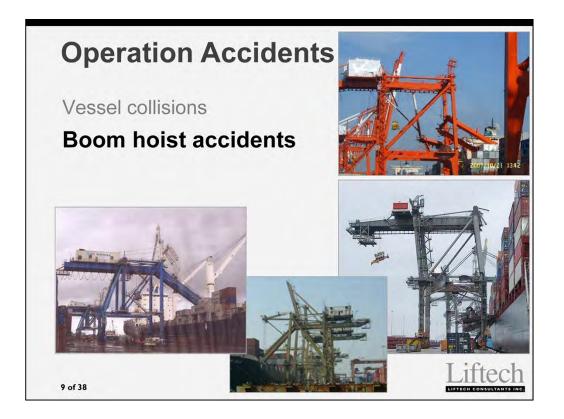
Four boom hoist accidents occurred in 2008.

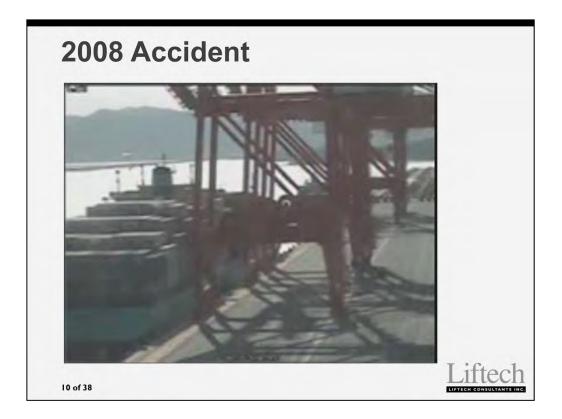
This 2008 failure occurred during raising with the boom nearly raised. The forestays could not catch the falling boom. The boom landed on the ship and pulled the upper A-frame members from the crane.

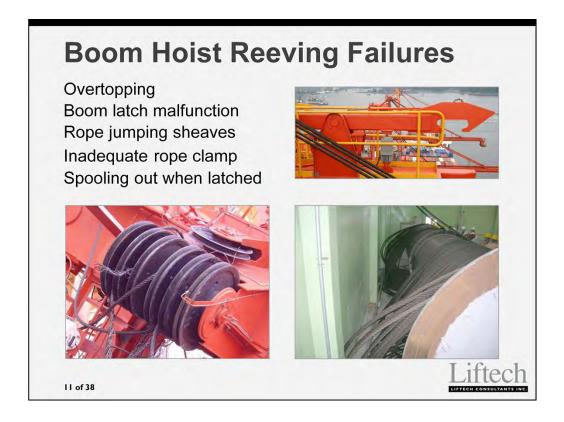
Boom hoist system failures have occurred for a variety of reasons, including:

overtopping – trying to raise the boom beyond the apex latch malfunctions ropes jumping sheaves damage to the rope rope spooling off the drum while the boom is latched inadequate rope attachments

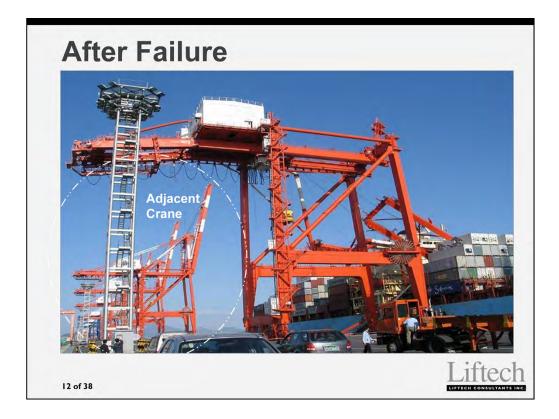
This is the same crane after the failure. The boom and A-frame members separated from the frame.

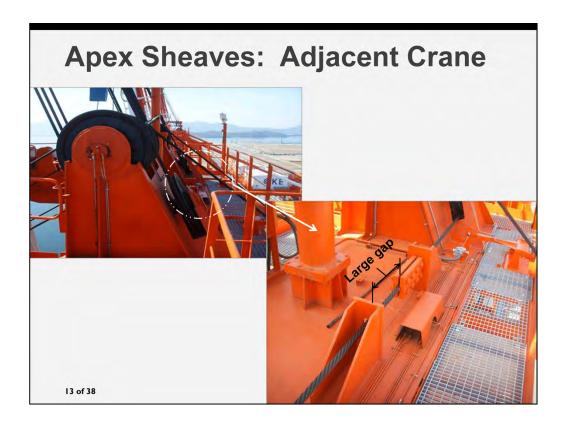
This photo shows reeving at the apex of the adjacent crane including the stop clamp and stops.

On the failed crane, the rope on the side of the reeving failed. The exact cause of the rope failure is unknown.

The stop clamp did not hold the rope after the rope broke. The clamp may not have been installed properly—notice the large gap.

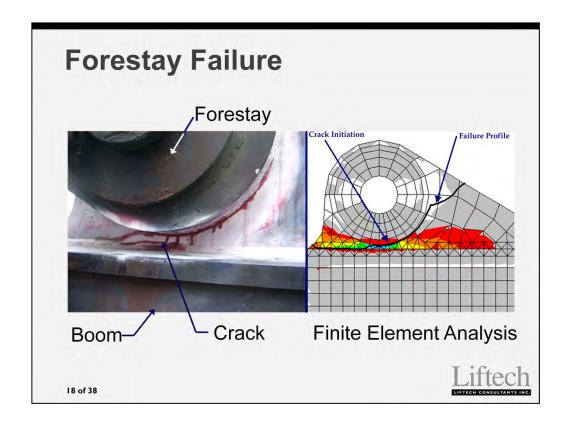
On this project, a forestay connection failed but the remaining stays held the boom. The forestay failed, but luckily the boom did not fall.

The cracks initiated at the stress concentration at the toe of the boss weld and propagated across the plate in both directions.

The photo on the left is a cracking detail that has not yet failed. The FEA plot on the right shows the stress in the uncracked plate with the failure profile of the failed plate superimposed.

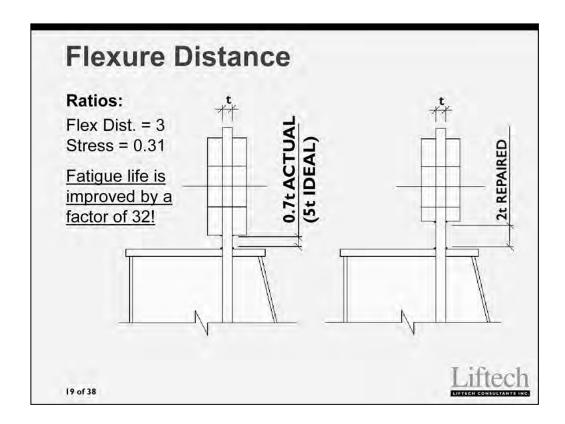
The stresses in the previous slide are due to a weak axis flexing when the boom sways to the side and from the forestay bending.

If the flexure distance between the boss and the boom upper flange welds is small, the stress is considerably higher than if the flexure distance is large.

We recommend 5 t flexure distance for fracture critical members (FCMs). By increasing the flexure distance in the problem detail from 0.7 t to 2 t, the stresses were reduced and the fatigue life was greatly improved. Fortunately, a small change in flexing distance has a major impact on the fatigue damage.

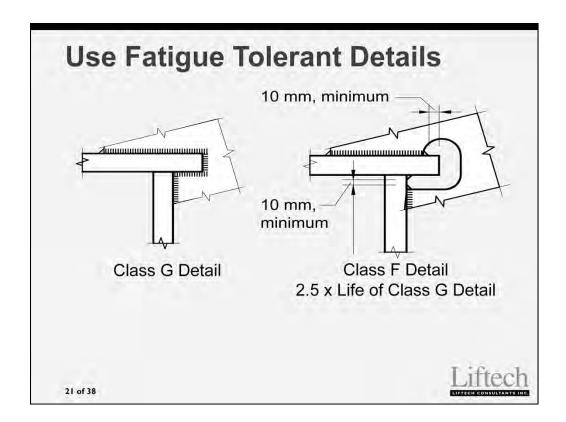
Another topic worth discussing is detailing. Fatigue tolerant details can greatly improve the fatigue life of a crane. Using fatigue tolerant details requires little or no additional effort.

As shown in this image, the fatigue tolerant alternative is easier to build and has 2.5 times the fatigue life of the alternative detail shown.

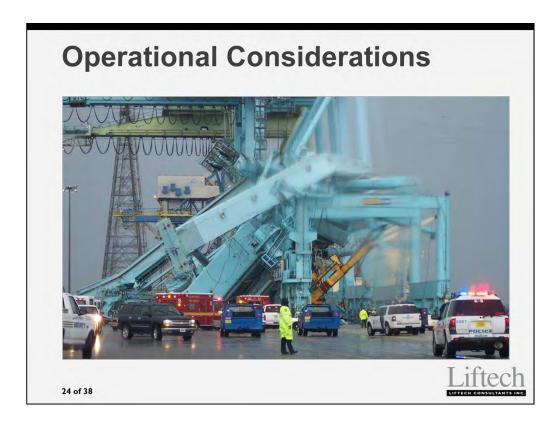
This is a photo of collapsed cranes.

Failures similar to this due to runaway cranes occur more frequently than expected.

It is often difficult to pinpoint why braking systems fail. Some design and operational considerations are presented.

The following discussion represents typical minimum specified braking system capabilities and operating parameters.

The motor stops the crane during operations (dynamic).

The motor brakes hold the crane statically. When control power is lost, motors will not work, but the motor brakes set.

The wheel (or rail) brakes are also static. Also, if set during an E-stop, if dynamic, some damage will occur. We recommend wheel brakes instead of rail brakes (less damage and more vertical reaction at wheels).

Anemometers should be at the highest point of the fixed structure.

Audible alarms are set at wind speeds decided depending on location, etc., 16-18 m/s (35-40 mph), 20-25 m/s (45-55 mph).

Motor brakes engage at operating warning alarm.

At high wind alarm, usually a bypass is needed to attempt to move a crane.

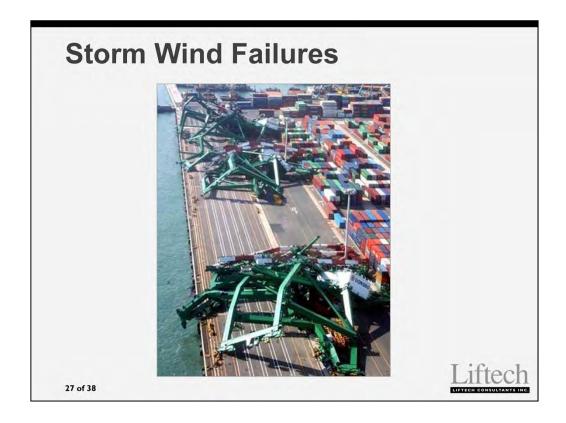
Hurricanes cause damage. The risks are real.

This photograph shows six collapsed cranes due to Typhoon Maemi in Pusan, South Korea.

The tie-downs failed. After failing, progressive failures ensued as cranes collided with each other.

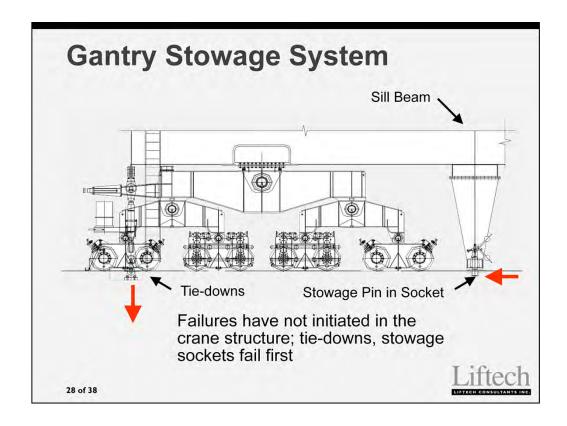
Stowage pins resist lateral loading. Tie-downs resist the uplift due to the overturning moment.

Ballast is an acceptable alternative to tie-downs. If a crane corner will lift, stowage pins should be long enough to accommodate the lift.

Failures never initiate in the crane structure. Failures have always initiated in the stowage hardware connecting the crane to the wharf.

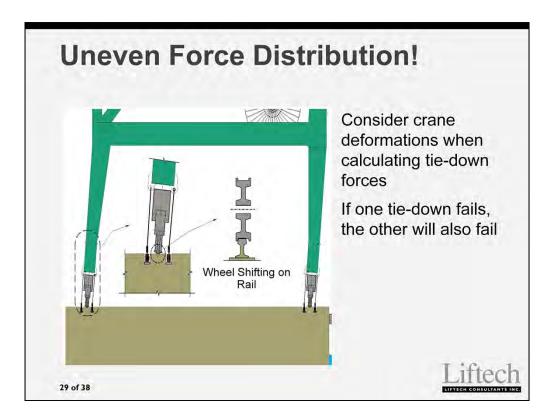
Cranes are flexible and hurricane forces cause cranes to deflect and move.

When there are multiple tie-downs at a corner, the forces in the tie-downs are **not evenly distributed**.

Crane structure deforms, translating and rotating.

Gantry wheels can shift.

Gap in stowage pin socket allows gantry wheels to roll (or slide) along the rail.

Links are not perfectly straight.

Wharf pins are not symmetric.

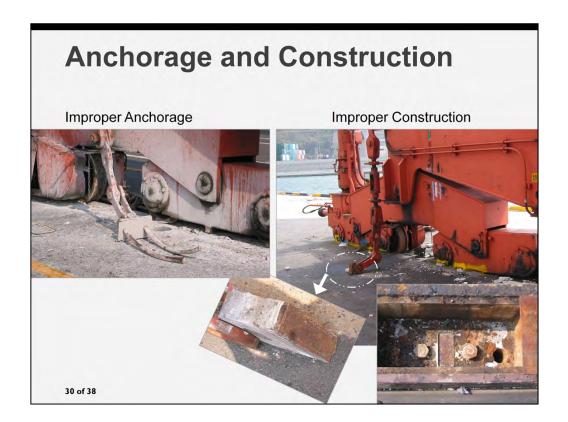
<u>Anchorage</u> Smooth anchors pulled out of the wharf. **Design** = headed **Fabricated** = no heads

Construction

60 mm plate; only a 4 mm fillet weld, with filler plates added in some places.

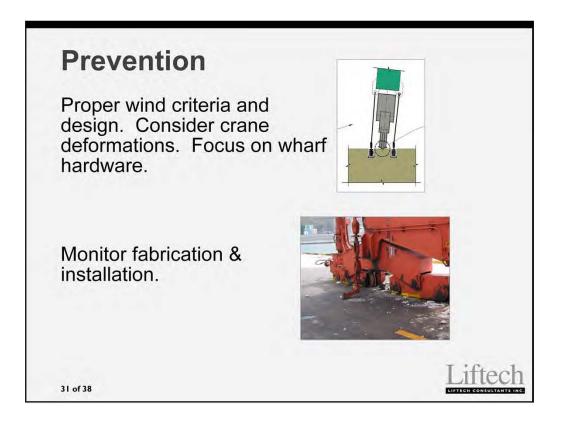
The reasons for failures can be equally attributed to incorrect calculations, poor design, and poor fabrication. Each of these should be addressed.
