Structural Maintenance of Dockside Container Cranes

Michael A. Jordan
Structural Engineer

Presented at the Facilities Engineering Seminar
American Association of Port Authorities
February 3-5, 1999 in Corpus Christi, Texas
Original Printing: 1999
Reprinted: May 2008

STRUCTURAL MAINTENANCE OF DOCKSIDE CONTAINER CRANES

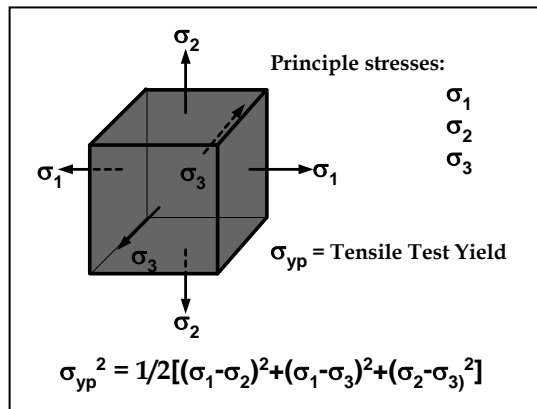
Fig. 2: Triaxial Stresses

When steel is subjected to two principal stresses, σ_1 and σ_2 , the maximum stress may be slightly higher than the tensile yield stress. When subjected to three principal stresses, σ_1 , σ_2 , and σ_3 , the maximum principal stress may be much higher than the tensile yield stress.

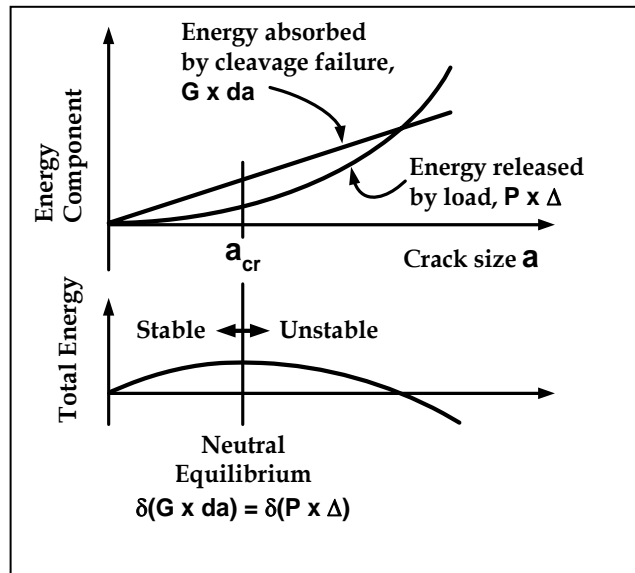
Fig. 8: Brittle Fracture Energy Balance

At first the energy absorbed by breaking the atomic bonds is less than the energy released by the deflecting load. The system is stable. Eventually energy absorbed by breaking atoms per unit area of crack growth equals the energy released by the deflecting load. The crack is in neutral equilibrium. Finally, the crack reaches critical size, and the energy released by the load exceeds the energy absorbed by the breaking atoms. The system is unstable. The unstable crack grows at thousands of feet per second. The member fails suddenly and without warning.

The stability balance for a crack is analogous to pushing a wheel over a hill. On the uphill side, work is required to raise the wheel. At the top of the hill on level ground, the wheel is in neutral equilibrium. But on the downhill side, energy is released, and the system is unstable. The same is true for the crack.

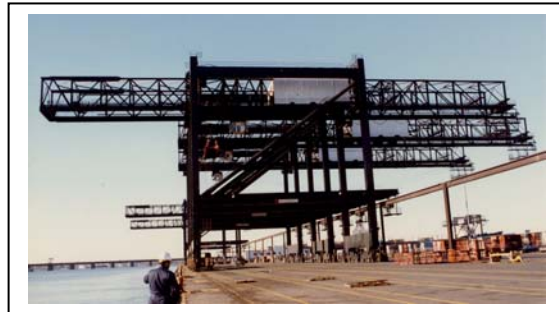
Elizabeth Low Profile Crane

In 1975, after a catastrophic fatigue failure caused a low profile boom to collapse and crash onto a ship, the remaining low profile cranes were carefully inspected. The inspection detected a small fatigue crack at the wrap around weld similar to the detail that failed in Oakland.

Repairs were made. A hole was drilled a short distance beyond the crack and reinforcing plates were bolted to the blade and gusset plate.

The hole acted a crack stopper. Once the crack reached the hole, the stress intensity would be less the fracture toughness and the crack would stop. After about 15 years, the crack did progress to the hole. Since the reinforcing bars covered the sides of the blade, only the end was visible. Now that the crack had reached the hole, it opened enough so the crack was visible at the edge of the blade. This was to be expected and had been predicted. But the operator was concerned that perhaps the crack did not go to the hole and may be progressing across the blade. So the bolted plates were removed for inspection. The hole had progressed to the hole and stopped just as fracture mechanics led us to expect. There are many unknowns about crack growth. But there is one certainty: the crack always grows perpendicular to the principal stress.
