THE 1995 KOBE EARTHQUAKE

Michael A. Jordan, SE
Chief Executive Officer
Liftech Consultants Inc.

The Event

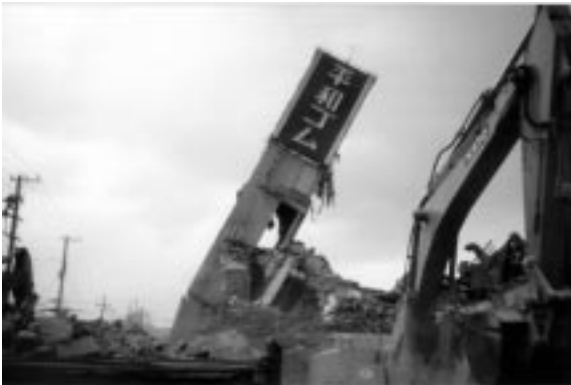
Many died at home. One and two story Japanese homes are designed for vertical loads. Delicate post-and-beam construction supports tile roofs. The walls are laced bamboo with mud covering or wood slats with stucco. The bamboo construction is called Shinkabe, the stucco Okabe. No attempt is made to tie the structural components together: no nails, no braces, no reinforcing, and no resistance to even moderate lateral forces. Very charming and very dangerous.

WEAK STRUCTURES FAILED

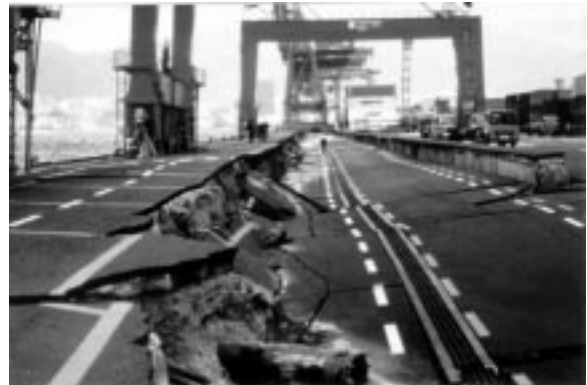
THE DISABLED TERMINAL

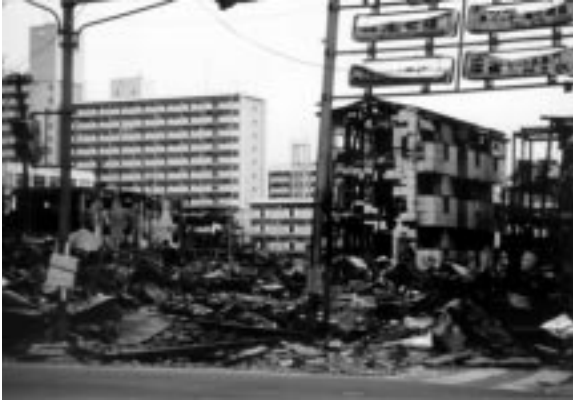
Five hundred of the 5300 died in one block. First the quake wrecked the buildings, then fires, which could not be stopped because there was no water, killed the occupants.

FIVE HUNDRED DIED ON THIS BLOCK

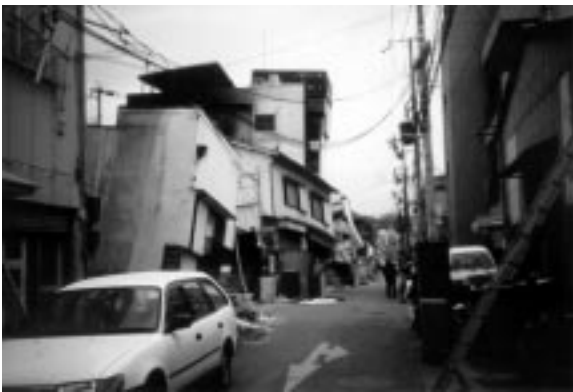
COLLAPSED HOME

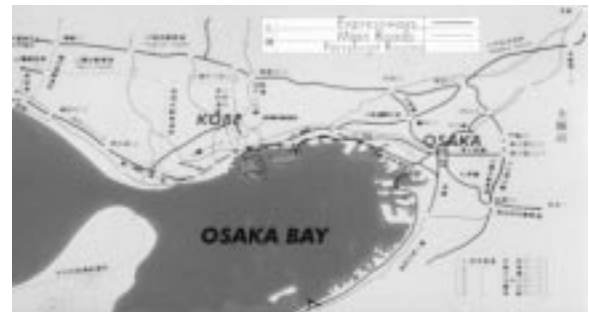
PORT, ROKKO, AND MAYA PIER ISLANDS

The three main islands at the Port of Kobe, Port, Rokko, and Maya Pier, are in Osaka Bay and are man made. Concrete caisson quay walls enclose hydraulically placed granular fill.

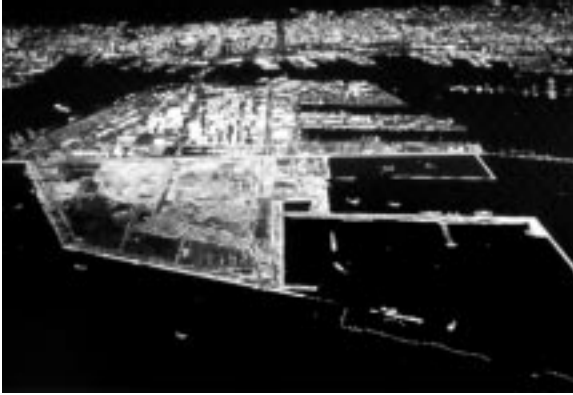
PORT ISLAND

damaged wharves at Port and Rokko Islands are shown in the section.

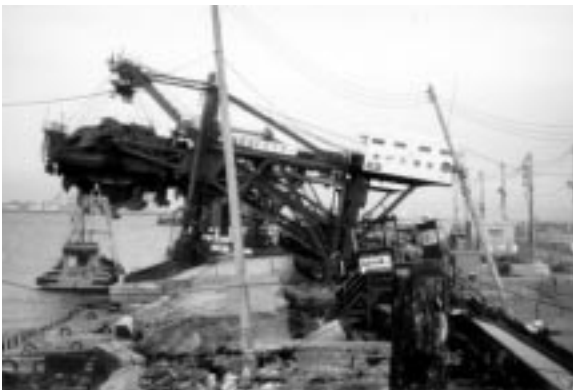
This paper concentrates on the container terminals, but the port at Kobe is more than a container port. The reclaimer shown is on a portion of Rokko Island that was being expanded. This wharf was under construction when the quake struck. Notice the damage is due to the wharf failure and not the failure of the crane structure. The soil under the crane rails liquefied.

DAMAGED RECLAIMER

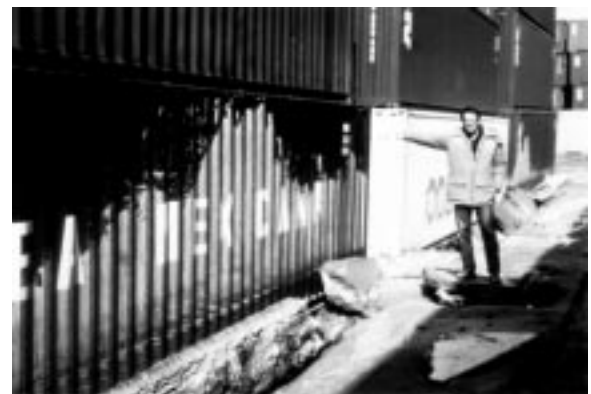
Notice the photo of the container next to the fractured pavement. Notice the stains on container's side. These marks are the signature of liquefaction. How did they occur?

LIQUEFACTION SIGNATURE

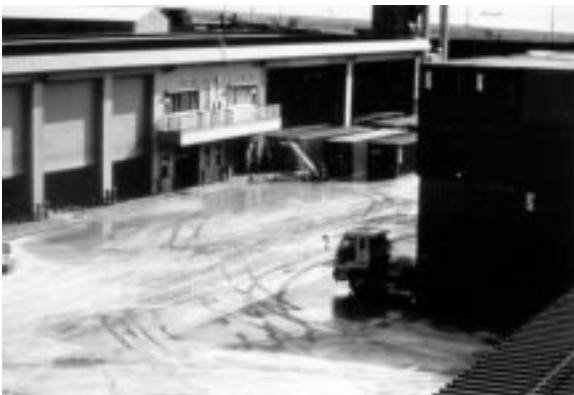
The mud that remains on the surface after liquefaction is the fines carried with the groundwater. Remember the settlement is mostly due to the loss of groundwater, not fines. The pavement settled meters, the mud is only centimeters thick.

SOIL FINES CARRIED TO THE SURFACE

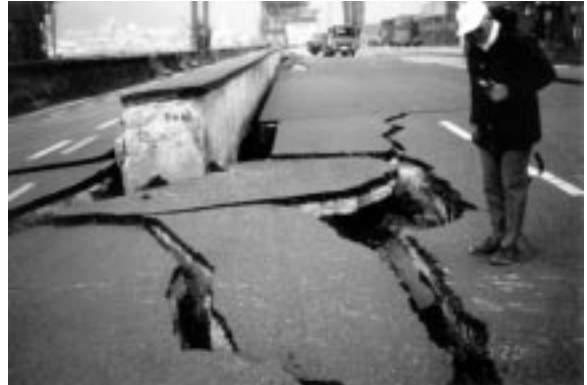
Pile supported structures did not settle and were not seriously damaged. The pile supported crane concrete girder at 50' gage that appears to have risen, in

fact, did not rise or settle. The adjacent pavement settled.

THE PAVEMENT SETTLED

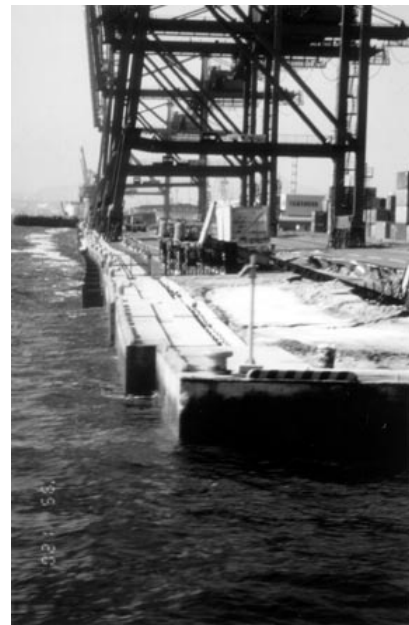
The caissons displaced toward the sea about one meter and settled about one meter. Each caisson moved independently. No attempt was made to key them together. Keys could have been provided at a very small cost.

The gantry rail gage increased one meter or more, causing serious damage to most of the cranes and causing one crane to collapse.

FAILED QUAY WALLS

- Tie the crane rail girders together.

- Design the caissons to resist the pressure from the liquefied soil and the earthquake lateral

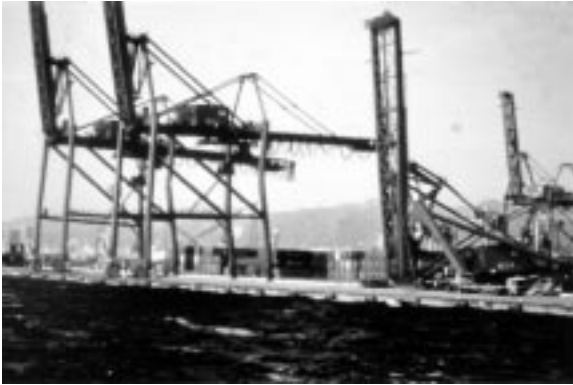
Liquefaction, not lateral earthquake accelerations, damaged most of the cranes and destroyed one crane. Notice the collapsed crane fell vertically; not sideways. As the rail gage spread several meters, the legs buckled.

CRANE DAMAGE

The other cranes were seriously damaged. Notice the leg fractures above the portal and in the portal tie. The legs and portal ties are made of thin stiffened plates. Even though some local buckling occurs, the global structure remained ductile.

The damage to the cranes is very similar to that sustained when a ship collides with a crane. It appears that the designer did not anticipate an accident.

For a few dollars, the portal tie beam could have been increased and ductile joints could have been provided. The resulting ductile moment frame would have come off the rails, and the frame would have not collapsed.

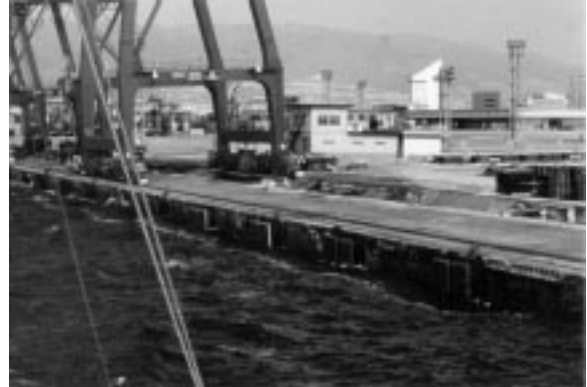
DUCTILE FRAMES PERFORMED WELL

Liftech has investigated the effects of earthquakes exceeding Richter magnitude 8, in Honduras and Guam, and of earthquakes exceeding magnitude 7, the Loma Prieta in Northern California and the Northridge in Southern California. Ductile frames can resist significant lateral displacement without failure.

So far, no container crane having a ductile moment frame has been seriously damaged in an earthquake. Many, however, have left their rails.

Ductile moment frames are an inexpensive way of increasing earthquake resistance of any structure. Crane specifications should require ductile moment frames.

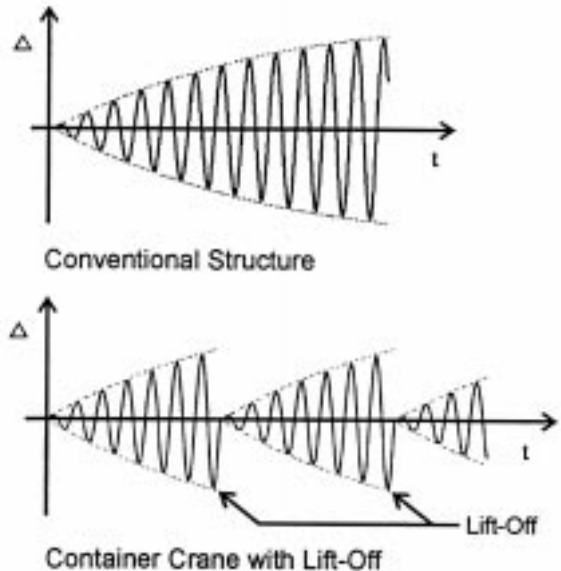
The crane naturally outwits the quake when the crane structure responds to the quake. Those vibration modes in resonance with the ground motion experience the maximum response. This response increases with time; maximum displacement is not instantaneous. If the quake is powerful enough, the forces build until one leg lifts.

This interrupts the response, the crane settles down, and the cycle begins again. When the shaking is done, the crane may be off the rails, but it's not seriously damaged.

Lift-off interrupts the build-up of seismic stresses, protecting the crane.

EARTHQUAKE RESPONSE OF A CONTAINER CRANE
