Crane Structural Maintenance

Liftech has learned a great deal about crane structural maintenance from five decades of assisting clients with fatigue and fracture issues. Michael Jordan and Simo Hoite, Liftech Consultants Inc., offer some observations and recommendations based on the company's vast experience.

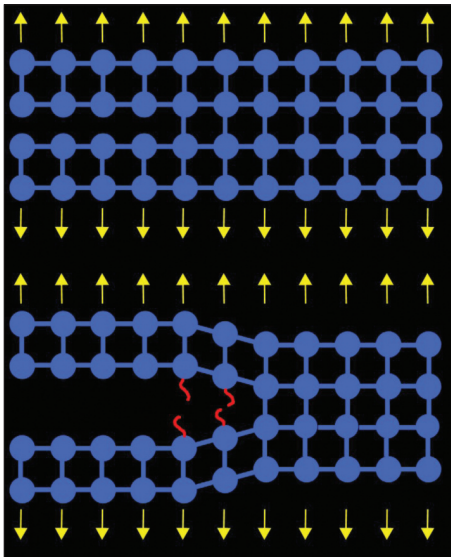
Figure 1: Atomic bond failure = crack growth

Unfortunately, there is always a chance of failure. The reliability is never 100%. Less than 100% may seem unacceptable to the layman but it is unavoidable. The failures are called "fatigue" failures, but the atomic structure of steel does not get tired. Instead, stress fluctuations cause some of the atomic bonds to fail (see Figure 1).

The separation causes a crack, however small, to grow from an initial discontinuity. This separation releases energy. The structure deforms a little with each cycle, and the crack grows incrementally until the atomic bonds in the steel can no longer absorb the energy generated by the deformation. The crack then shoots across the steel at the speed of sound - bang - sudden failure. This is steel fatigue failure.

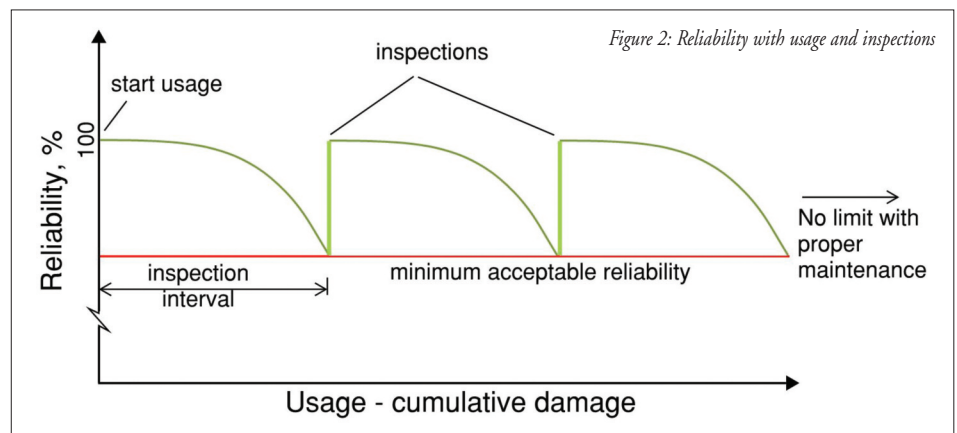
Figure 2: Reliability with usage and inspections

Reliable life is a better term than design life. Liftech defines reliable life as the number of applied cycles needed for the reliability to fall below an acceptable level (see Figure 2). The reliable life may be extended by periodic inspection and repair.

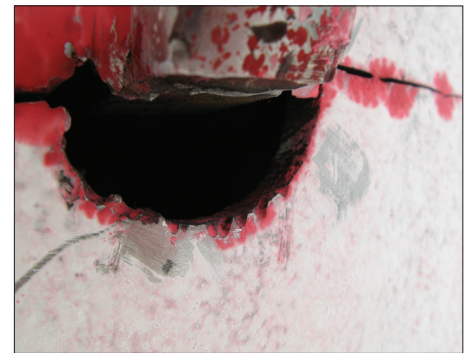
Figure 3: Roughly cut stress relief hole

Liftech has investigated many fatigue failures. The underlying causes in nearly every case of fatigue failure are one or more of the following: poor design, poor materials, poor workmanship (see Figure 3), incompetent or inadequate inspection during construction, and improper structural maintenance during service.

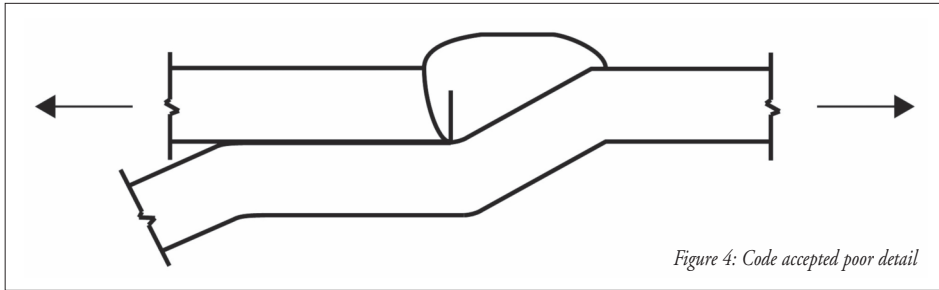
Figure 4: Code accepted poor detail

Complying with codes is often not enough to produce a reliable crane. Some poor details comply with the codes (see Figure 4). Liftech does not accept some details regardless of the code standards.

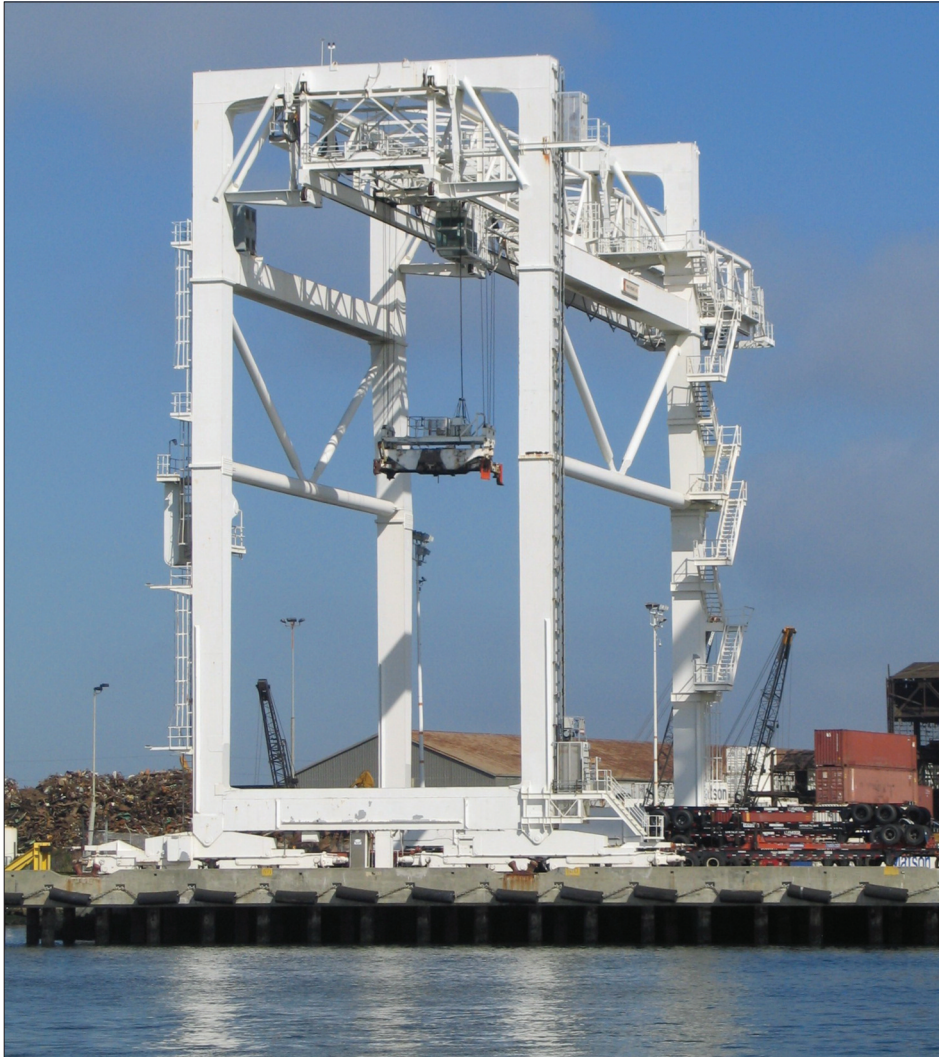
Figure 5: Low profile crane - late 1960s (subsequently raised)

One crane was built in the late 1960s. The other was built in the 1970s. See Figure 5 for an overall view of the 1960s crane. The image is from many years after the crack was discovered and repaired, and after the crane was subsequently modified to increase the lift height.

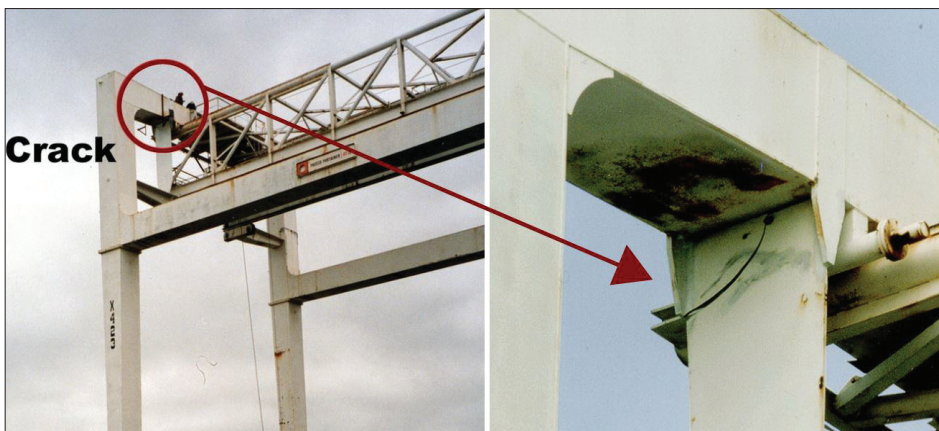
Figure 6: Fractured hanger plate

One hanger failed on a 1960s crane. An undiscovered fatigue crack in the boom hanger plate had been growing for over ten years. When the crack reached the critical size, the slow growing crack suddenly shot across the plate jeopardising the boom support (see Figure 6). The boom dropped a little and twisted but did not fall. Under the Liftech engineer's supervision, the boom was retracted while being supported by only one of the two waterside hangers.

The crack that caused the failure was not detected, even though an inspection of critical points was performed every few years. When the engineer looked at the failure surface a few hours after the accident, he got wet paint on his hand. He learned the hanger had been recently painted because it had been MT examined the day of the failure. The paint had been removed so the MT examination would detect cracks, if any. The critical cracks were not found, and the test area was repainted.

The inspector did not know to look at the edge of the plate, which was the most probable location where cracks would initiate. The inspector and the engineer observer, although conscientious, did not know what they were looking for or what the arrow pointing to the plate edge, in the inspection manual, meant. They only looked for cracks about three inches from the edge. The owner was paying for a worthless inspection.

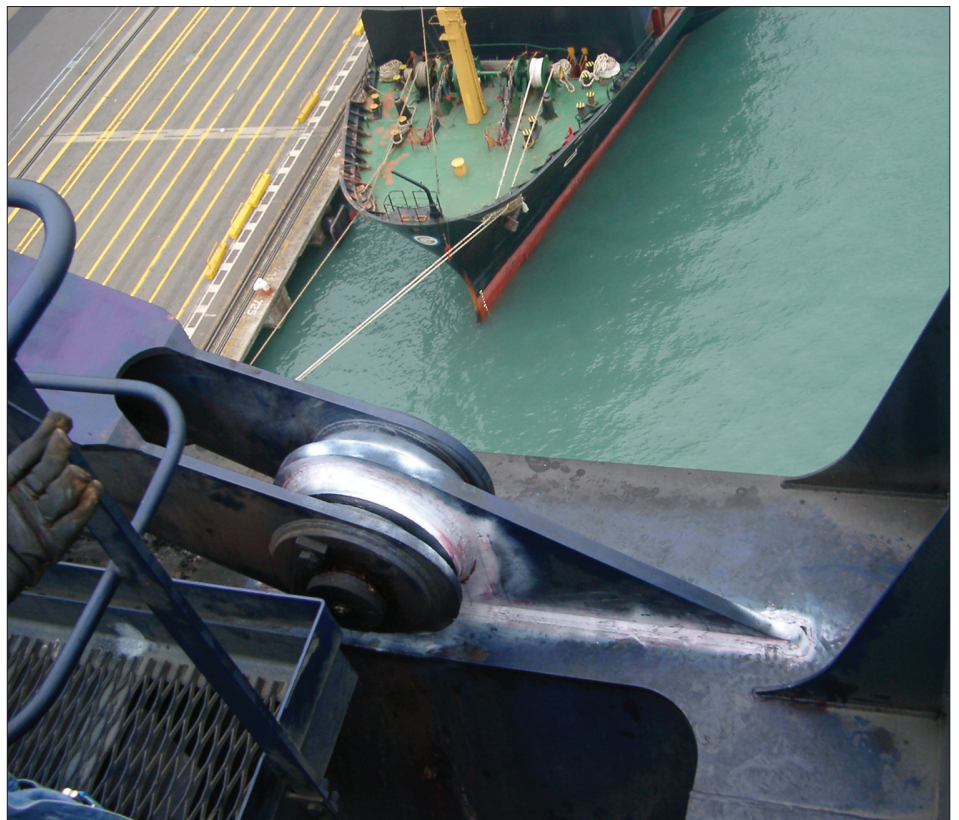
Figure 7a: Forestay boom connection plate failure

However, FEA can be used to determine the relative improvement between the original detail and a proposed improved detail. This method was used to design the improvements of a forestay-to-boom connection plate. The improvement was trimming the boss plates to allow the connection plate to flex, thereby reducing the stress as the boom girder rotates in torsion due to trolley loading (see Figures 7a - 7c).

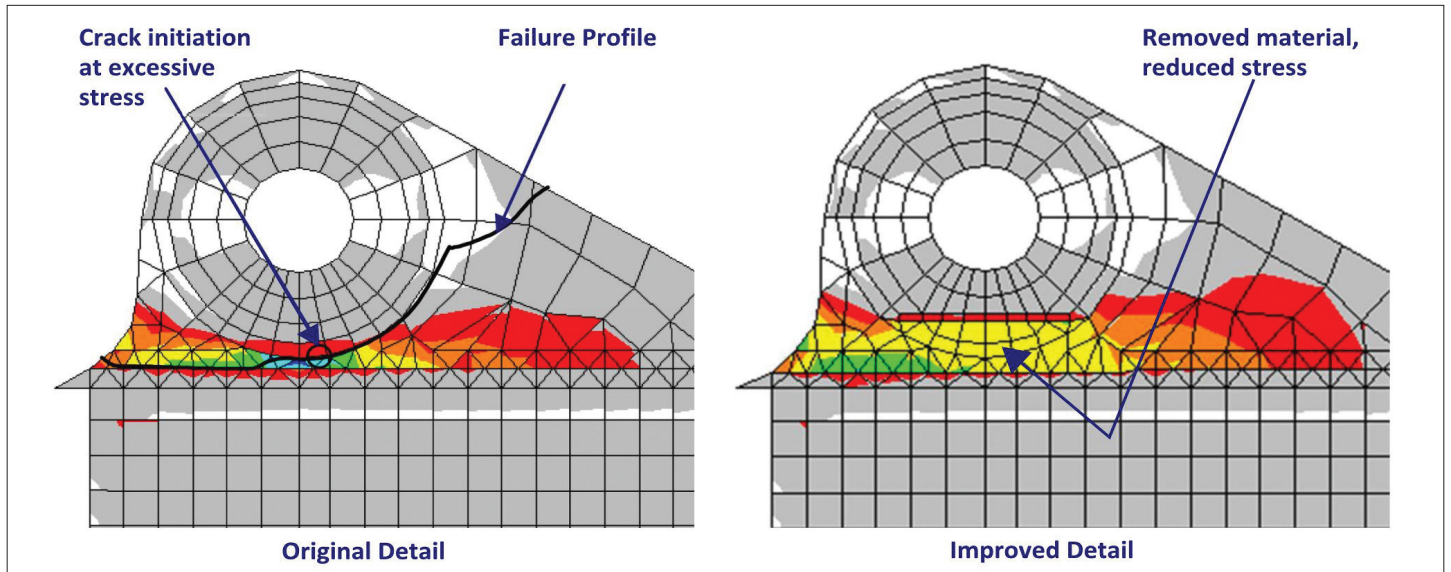
Figure 7b: FEA of original and improved details

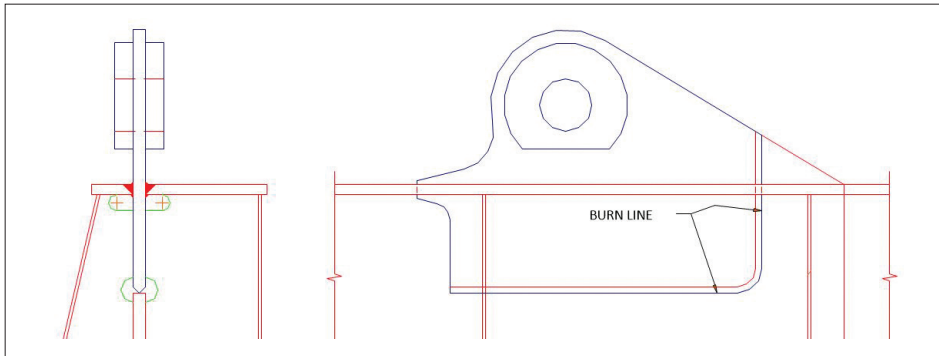
Figure 7c: Drawing showing improvement by removing material

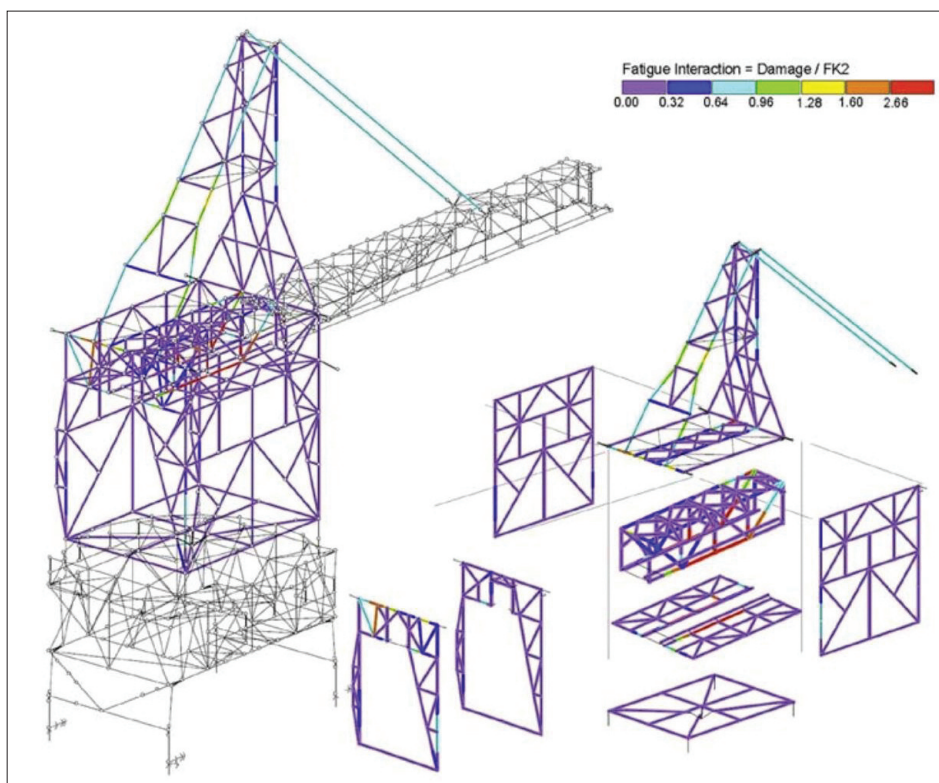
Figure 8: Calculated fatigue damage interactions – portions of a structure

the stress concentration factors when calculating the stress. It is worthwhile to calculate cumulative damage and determine where to focus structural inspections. Often only a relatively few members need frequent inspection, while the rest could be inspected less frequently. This can save significant inspection effort and costs (see Figure 8).
