# Practical Structural Examination of Container Handling Cranes in Ports and Terminals

A PEMA Information Paper

This Information Paper is intended to provide practical guidance about structural examination of ship-to-shore (STS), rail mounted gantry (RMG), and rubber tired gantry (RTG) cranes.

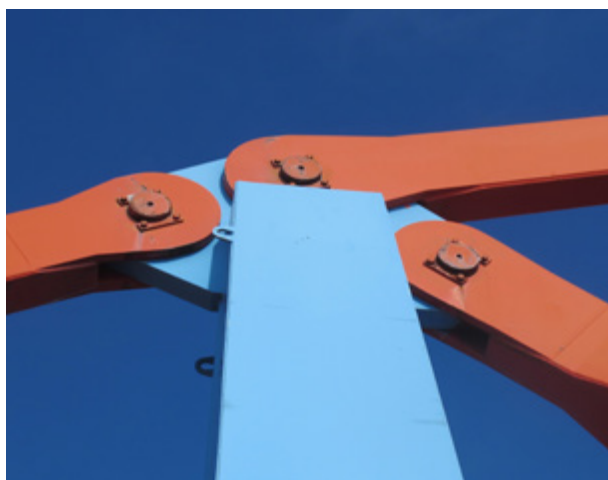
Picture 1.1: Critical elements at the landside crane apex that must be inspected periodically.

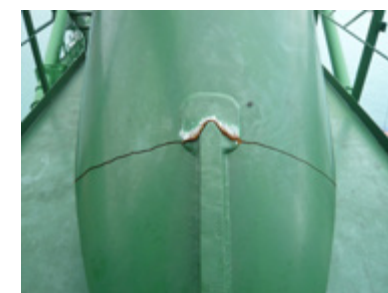
Picture 2.1: Crack in FCM at lower end of single upper diagonal pipe.

Picture 2.1 is an example of a crack that could have fractured the upper diagonal. Pictures 3.43 and 3.44 show other examples.

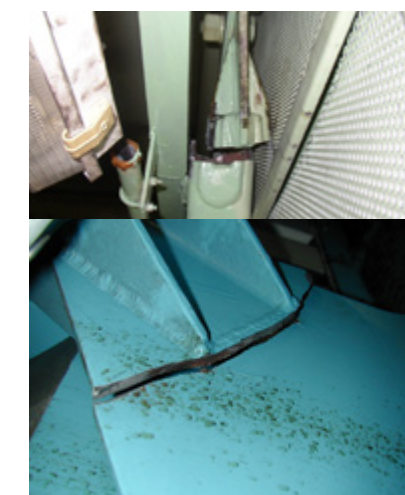
Pictures 2.2 and 2.3: Fatigue fractures of diagonal members on machinery trolleys.

Pictures 2.2 and 2.3 show examples of trolley diagonal fatigue failure.

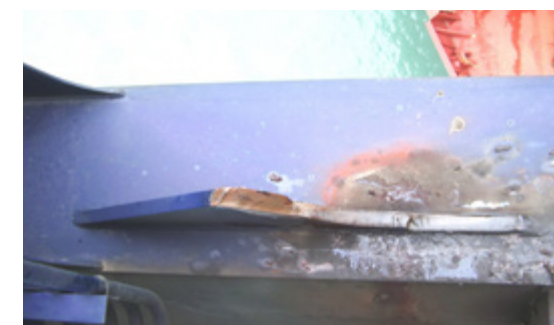
Picture 2.8: Looking down on a forestay connection plate that failed in fatigue.

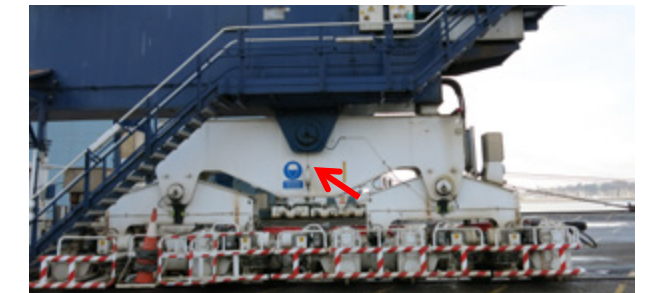
Picture 3.2: STS crane gantry system with 4 of 8 wheels driven per corner.

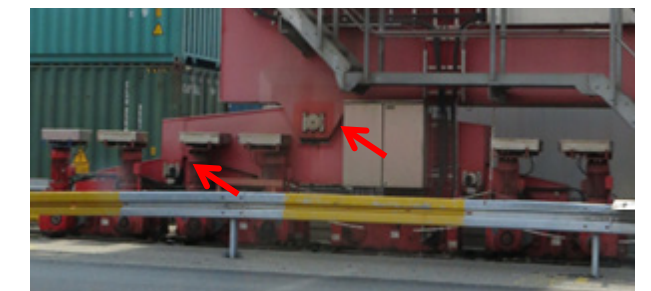
Picture 3.4: RTG crane with 1 wheel per corner.

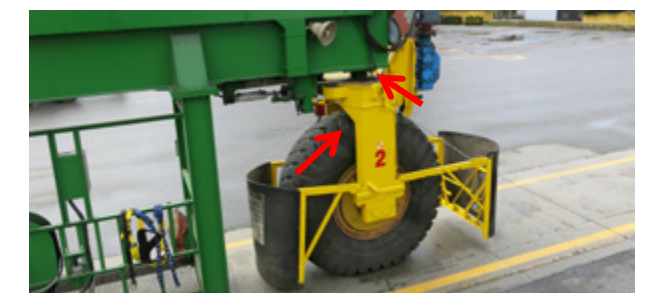
Picture 3.5: RMG crane driven at 5 of 6 wheels.

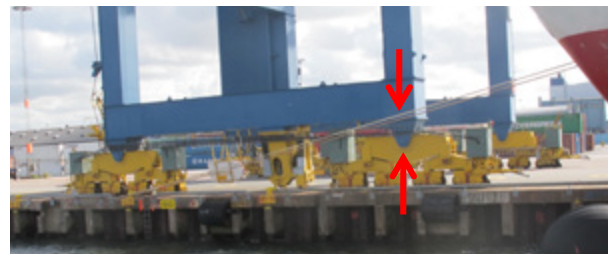
Picture 3.6: Sill beam with legs centered on equalizer pins.

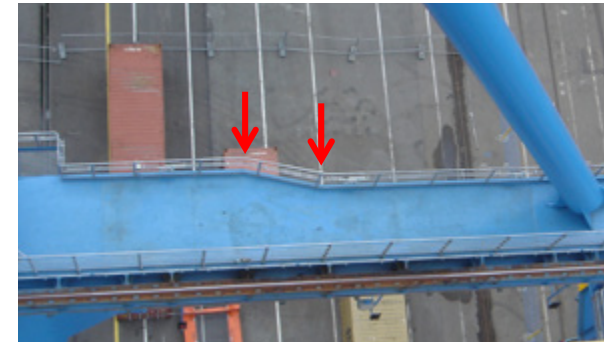
Picture 3.8: Portal beams with tapered end sections. The arrows indicate the transition points. The change in direction of the load in the web plates means there can be a significant cyclic tension load in the internal diaphragms.

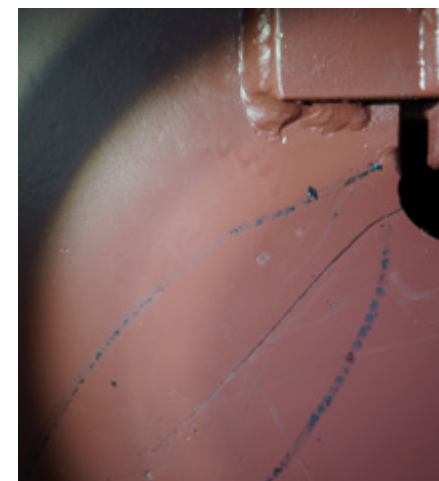
Picture 3.9: A crack in the inside diaphragm at a transition in the portal beam.

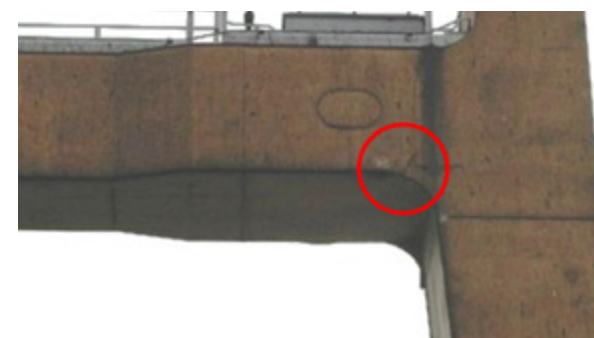
Picture 3.10: Another type of portal beam crack.

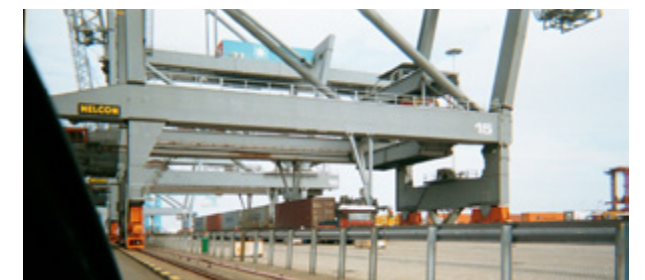
Picture 3.12: Sill beam, lower legs, and portal beam. Note landside lower legs are pinned at the portal. In this case, all horizontal loads are taken by the waterside legs, on the left.

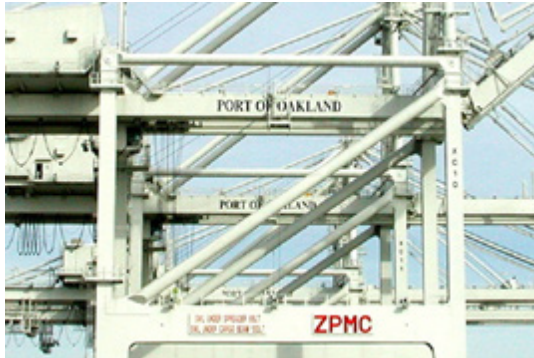
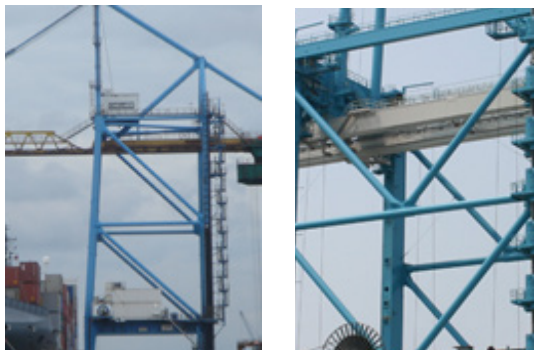
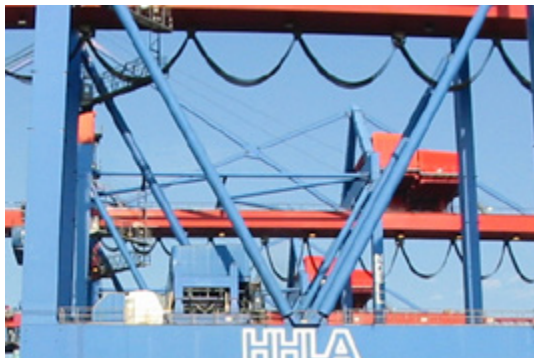
Pictures 3.13, 3.14, 3.15 and 3.16: Different arrangements of lower diagonals.

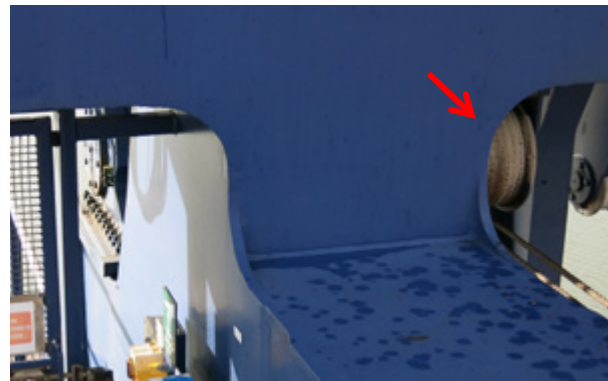
Picture 3.17: Welded TGSB to girder connection on twin girder crane with curved transition details to minimize stress concentration.

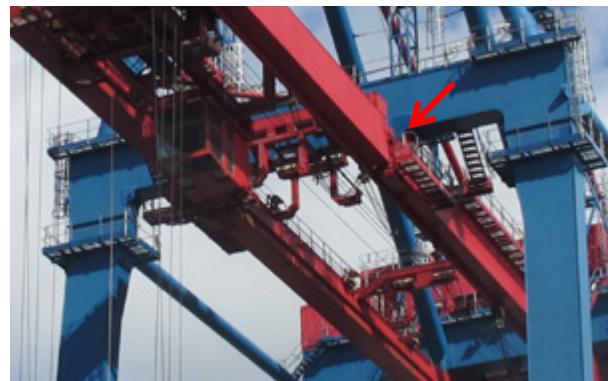
Picture 3.18: WS TGSB of twin girder crane. The arrow points to a detail similar to that shown in 3.17.

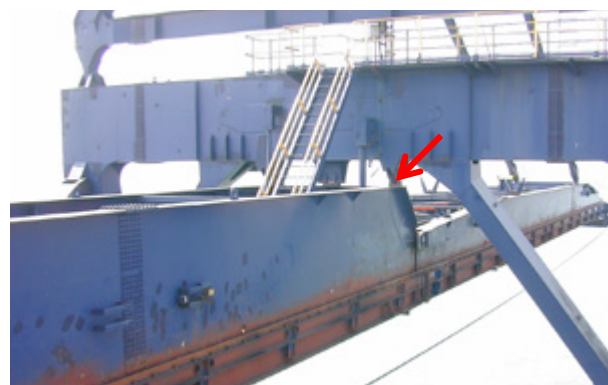
Picture 3.19: WS TGSB with pinned connection to plate girder boom.

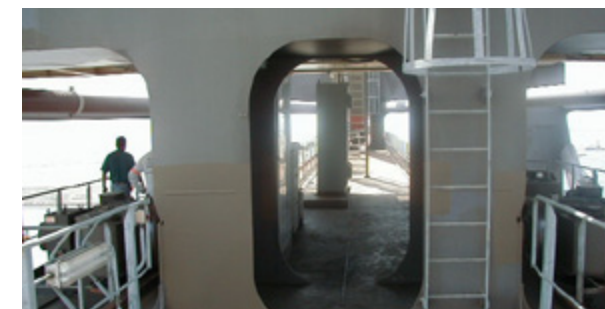
Picture 3.21: Welded LS TGSB connection to monogirder boom. Notice the large radii at the transition.

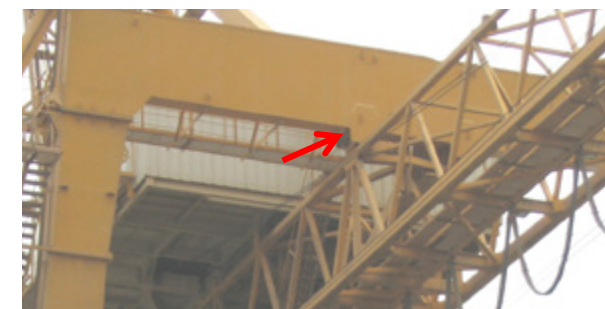
Picture 3.22: LS TGSB of a truss boom crane, in this case without radii at the points of transition.

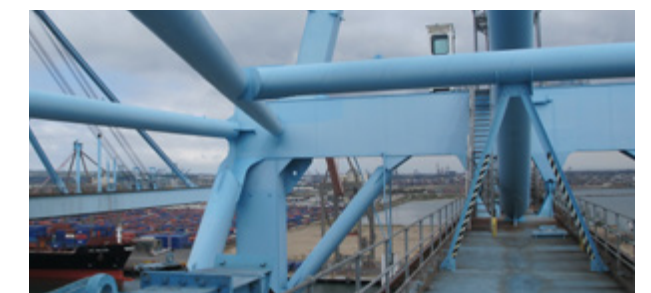
Bracing members in the plane of the trolley girder support beams provide rigidity against twisting when the crane is subjected to torsional loads about a vertical axis through the crane. These members are not fracture critical.

Pictures 3.23 and 3.24: Various bracing members in the plane of the TGSB.

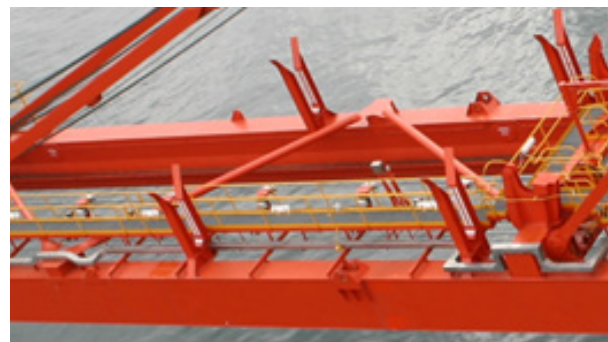
Picture 3.31: Twin girder boom with cross beams and diagonal bracing.

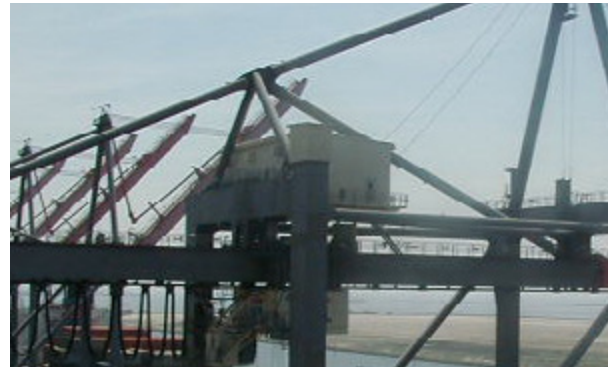
Picture 3.38: Different design but same arrangement as Picture 3.37.

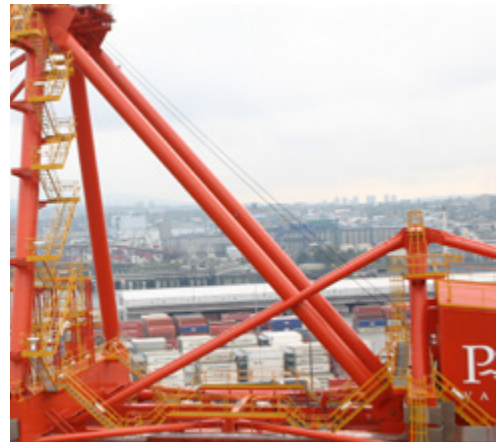
Picture 3.39: Upper diagonal connecting to forestay at the top trolley girder at bottom.

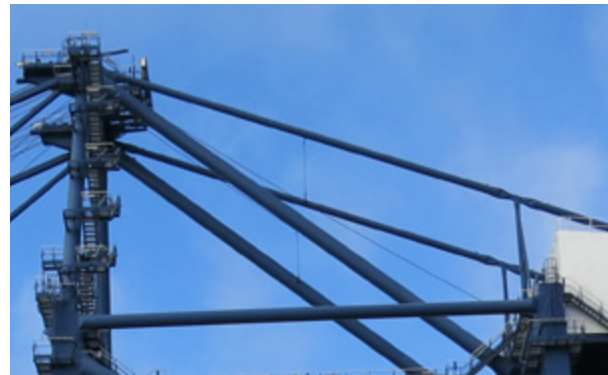
Picture 3.40: Typical arrangement for twin girder crane, backstays above the upper diagonals.

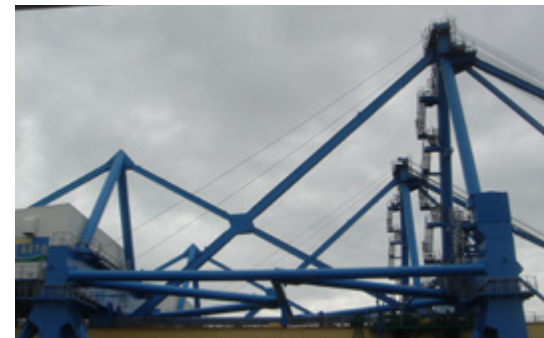
Picture 3.42: Crossing tension members, landside and waterside upper diagonals.

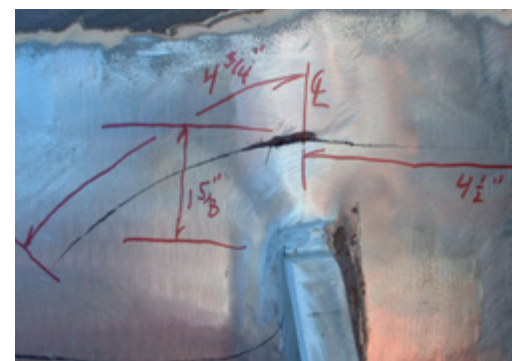
Picture 3.43: Dangerous cracks in an upper diagonal member. The member can fracture at any time.

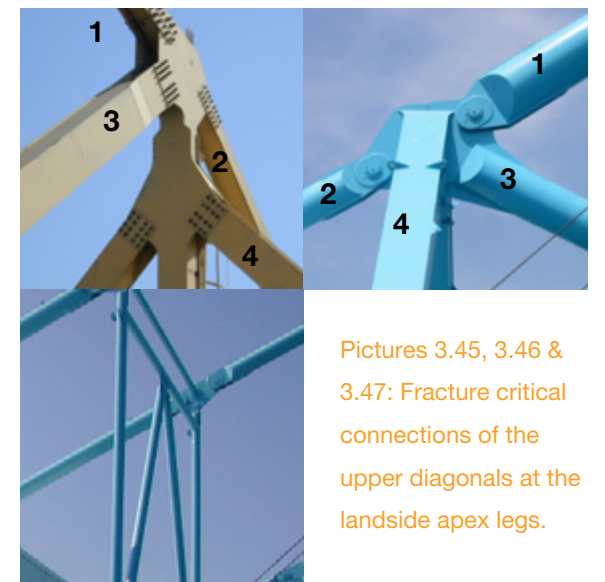
Pictures 3.45, 3.46 & 3.47: Fracture critical connections of the upper diagonals at the landside apex legs.

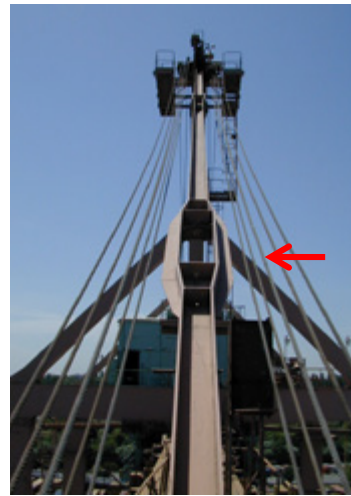
Picture 3.48: A geometrical discontinuity in the forestay. This area will have severe stress concentrations.

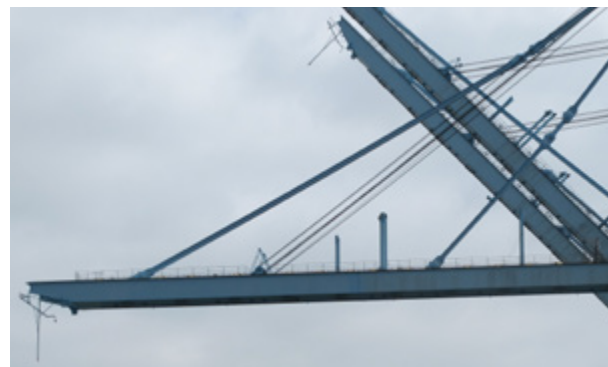
Picture 3.49: Forestays of three monogirder cranes. Sagging and straightening of the stays, due to loading and unloading the boom, results in stays bouncing up and down, which increases fatigue cycles of load.

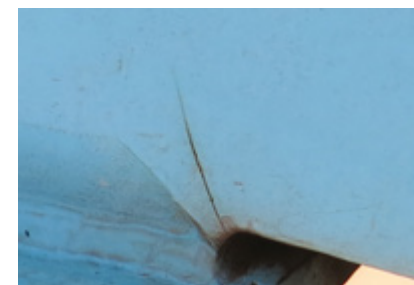
Picture 3.53: A crack at a forestay end connection plate.

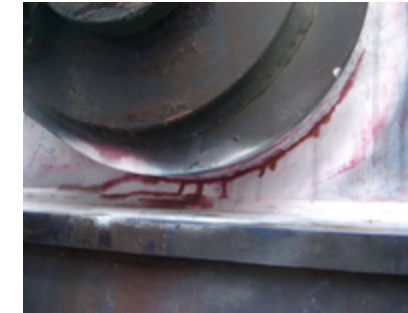
Picture 3.54: A crack at the boss weld on the boom forestay connection plate.

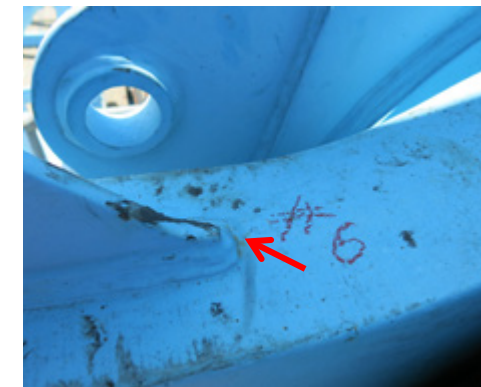
Picture 3.55: A crack indication at the end of a lifting lug on an intermediate forestay link plate.

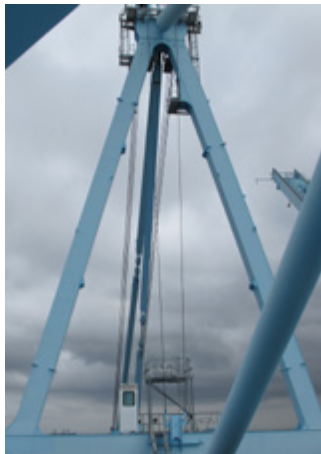
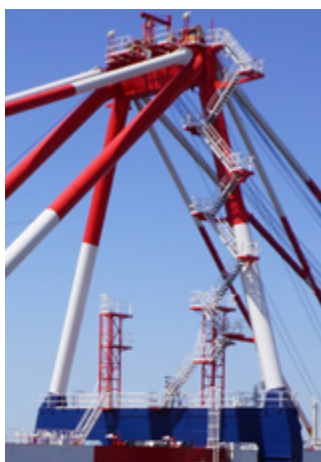
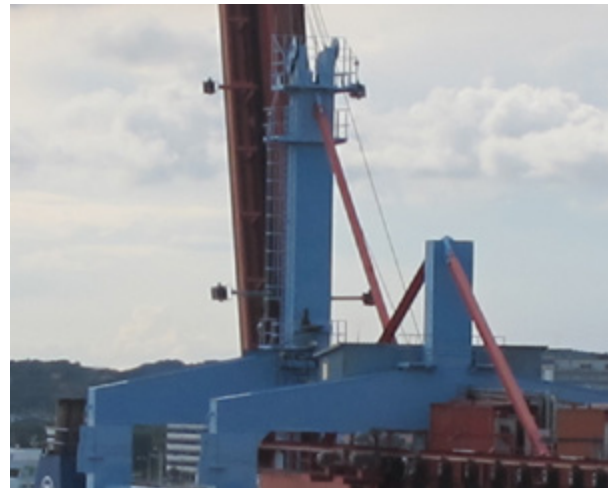
Pictures 3.56, 3.57 & 3.58: Crane with a single apex tower, viewed from the landside.

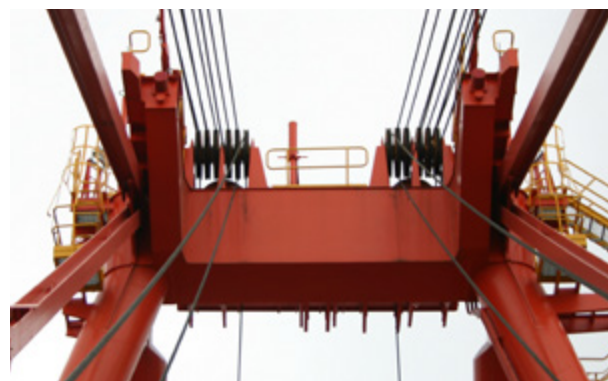
Picture 3.59: Apex beam seen from waterside with forestays on the outside and boom hoist in centre.

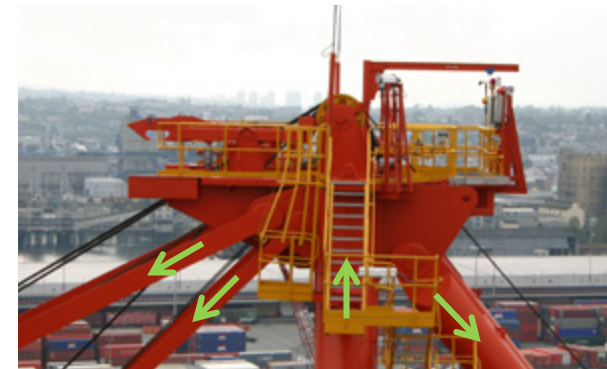
Picture 3.60: The same beam from the side with arrows showing typical forces at the apex.

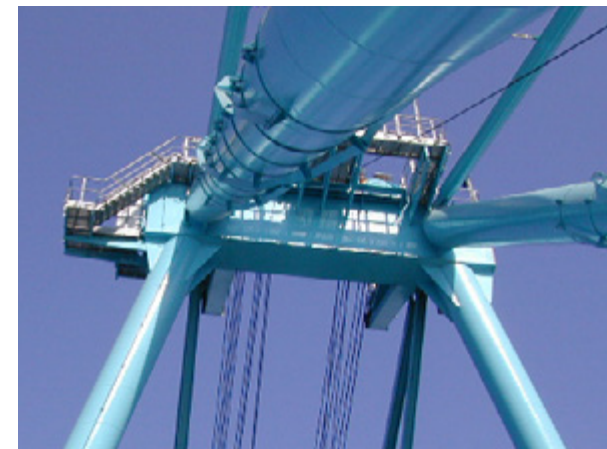
Picture 3.61: A similar view as in Picture 3.59, except from the landside.

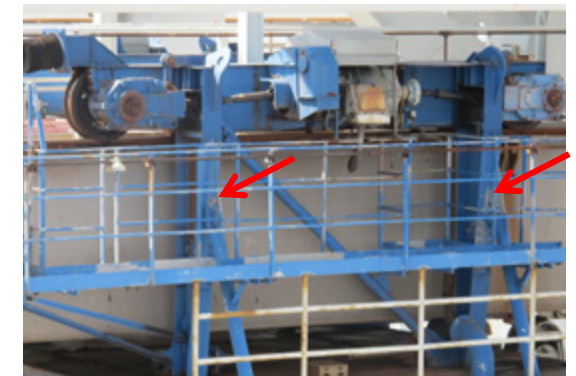
Picture 3.62: Main carrying members on trolley frame.

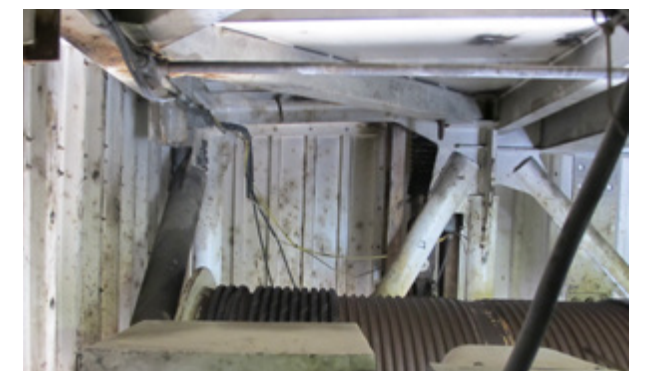
Picture 3.63: Trolley members inside machinery house.

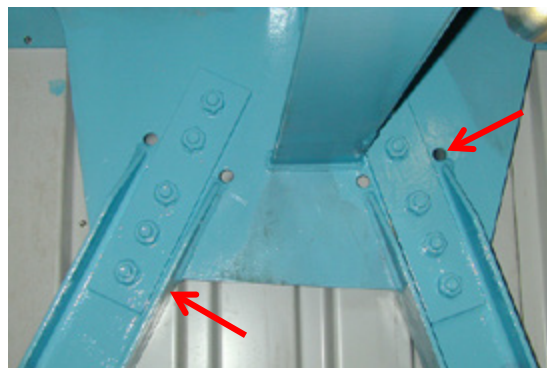
Picture 3.65: Trolley members with likely crack locations indicated.

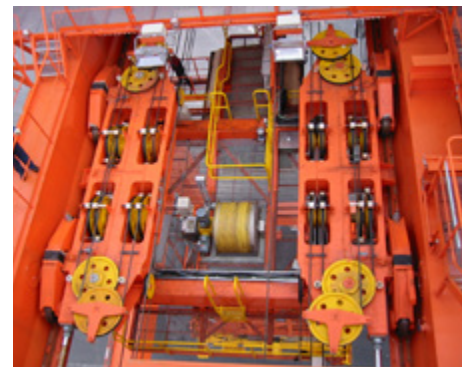
Picture 3.66: STS continuous rope support trolley.

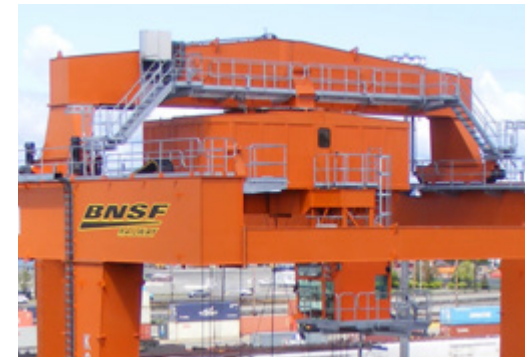
Picture 3.68: An underhung rotating RMG trolley.

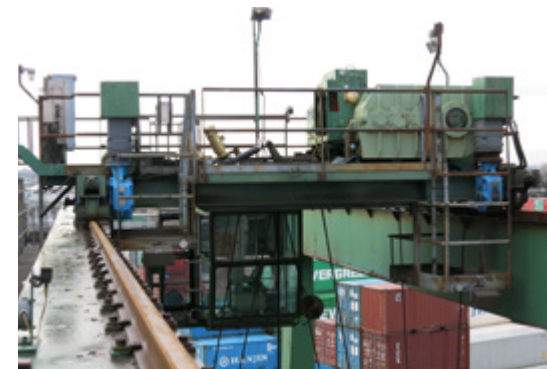
Picture 3.69: RTG trolley that is also suitable for ASCs.

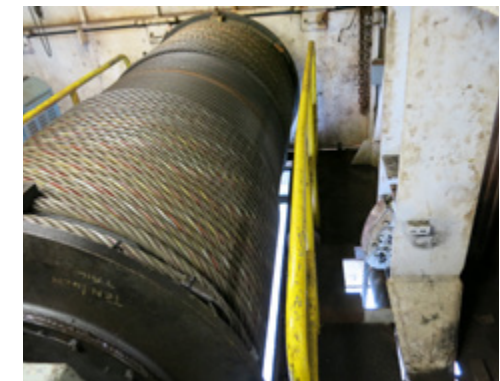
Picture 3.70: Machinery trolley hoist drum on left and rope direction change and dead end on right.

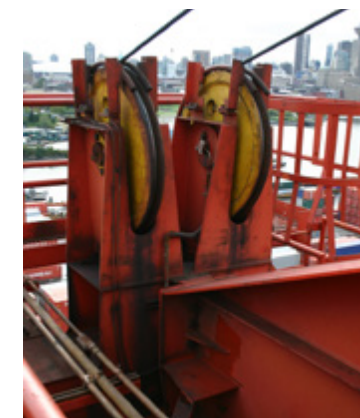
Picture 3.71: Main hoist sheaves at the backreach. These structures are fracture critical.

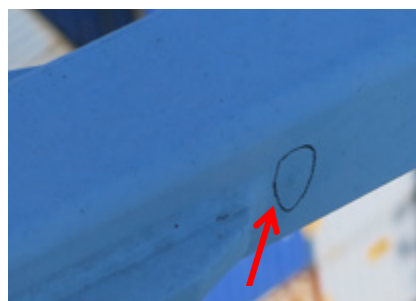
Picture 3.72: Washing and festoon platform hanger at end of girder. The arrow points to a crack indication at the end of the connection plate. The platform is lightly loaded, but bounces up and down during operation.
