Quay Crane Accidents Lessons and Mitigation

Port and Terminal Technology 2010

Arun Bhimani, SE
President
Liftech Consultants Inc.
www.liftech.net

October 2010

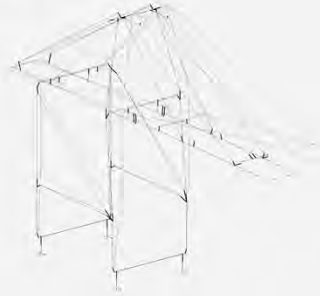
Repair Step 1: Investigation

Document Damage

- Measure and plot deformed geometry
- Analyze deformed geometry & strains
- Inspect suspect areas

The first step in repair is to document the damage carefully to understand what happened, identify potential damage to other areas, and inspect the damage.

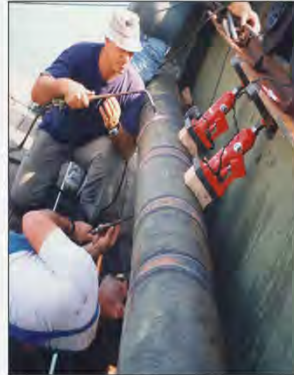
Repair Step 2: Restoration

It is worthwhile to analyze the structure to estimate the loading that caused the damage, and to understand the strains that occurred elsewhere in the structure. This understanding will aid in checking the extent of damage as well as in deciding on and developing repair procedures.

Develop Method and Analyze Options

- Repair members
 - Heat flatten
 - Stiffen

- Replace members

- Repair & Replace

Align Boom

Continually Evaluate Geometry

Repairs typically consist of heat flattening plates, heat straightening entire members, stiffening plates, and replacing sections of members. The repair method depends on the availability of construction cranes and the type of damage. In this example, the contractor preferred to lower the boom on the ground for repairs. The contractor selected to replace the buckled plates instead of heat flattening them. In regions where the construction cranes are not readily available, the repairs may be made in-situ. Heat flattening the plates may be the appropriate choice.

The geometry of the boom must be continually evaluated throughout the repair process to ensure proper alignment. Considering weld distortion is also important.

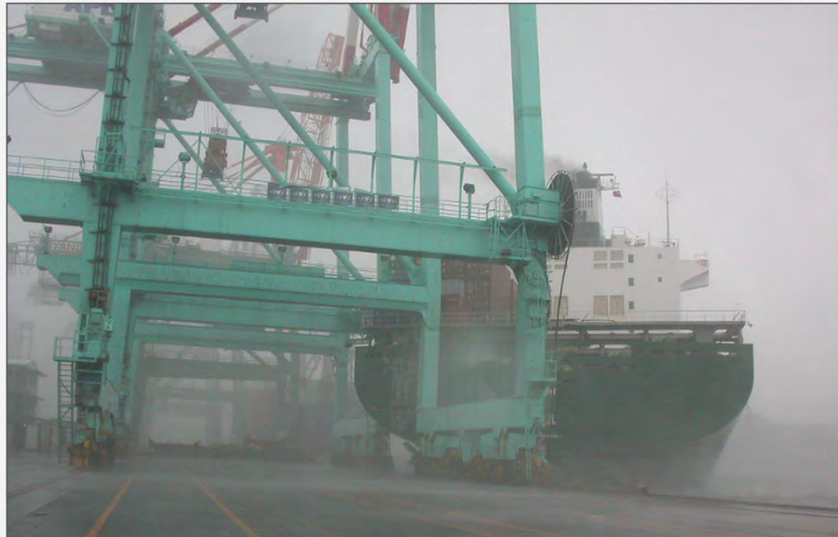
Vessel Collision With Frame

Frame collisions are less frequent, but often cause significant damage.

Many collisions occur due to vessels berthing in inclement weather.

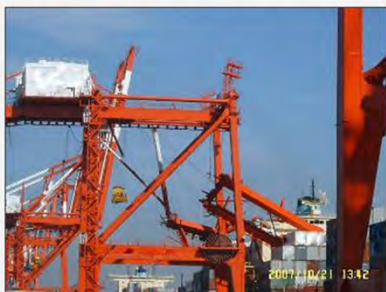
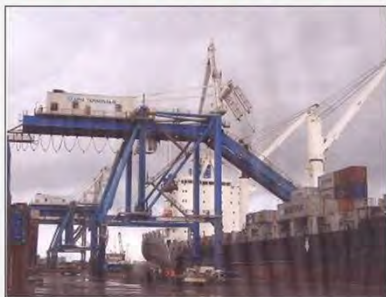
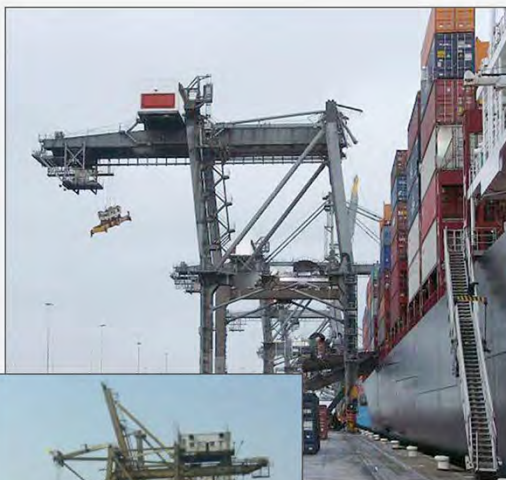
Boom Failures

Multiple boom hoist accidents recently occurred.

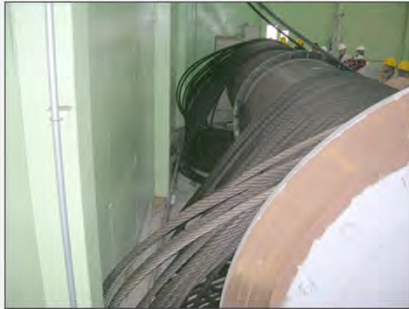
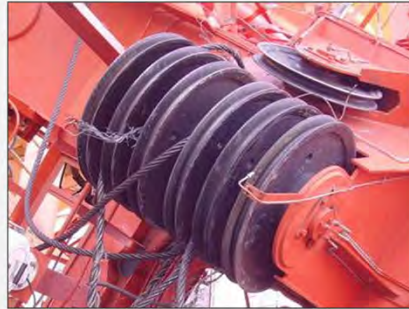
Boom Hoist Reeving Failures

Rope damage

Inadequate rope clamp

Boom hoist system failures have occurred for a variety of reasons. Some include latch malfunctions, ropes jumping sheaves, damage to the rope, and inadequate rope attachments.

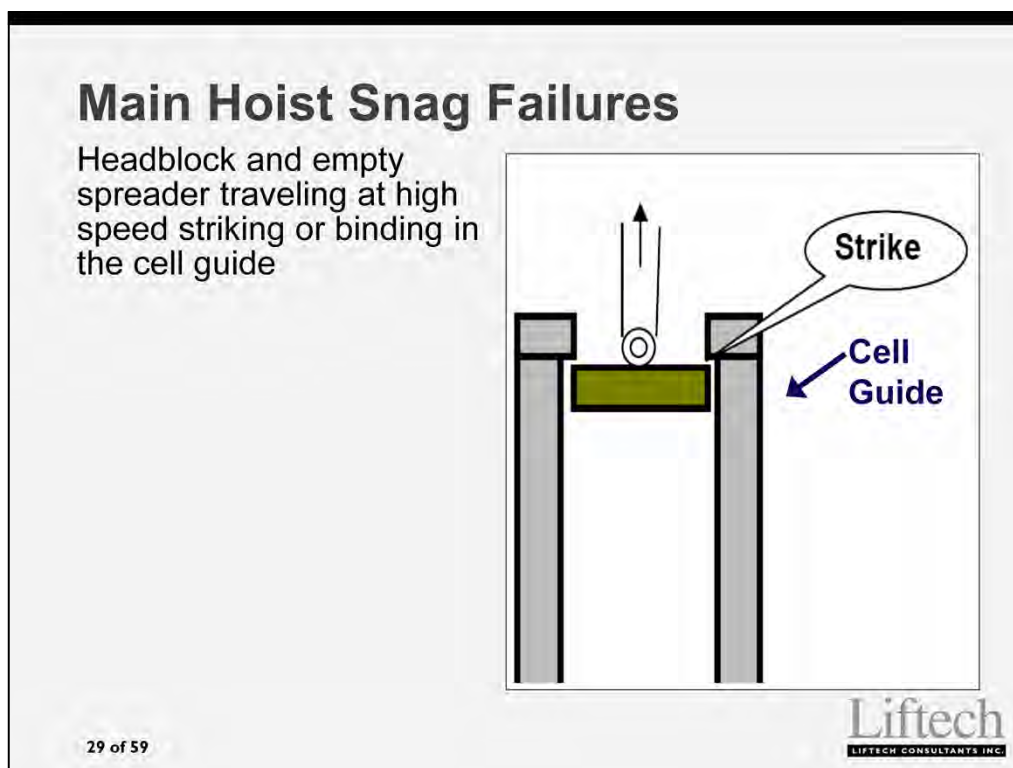
Snag accidents are common and can result in a severe loading.

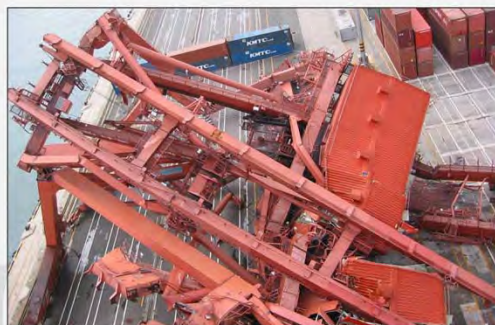
Typhoon Maemi, Pusan, South Korea

The image on the left is of damage caused by Typhoon Maemi.

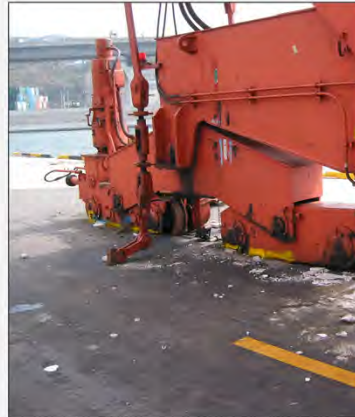
Stowage Hardware Failures

Stowage failures have not initiated in the crane structure

Tie-downs, stowage sockets, or brakes failed first

- Poor design

- Poor fabrication

Failures have never initiated in the crane structure.

Failures have always initiated in the wharf stowage hardware.

The reasons for these failures can be equally attributed to incorrect calculations, poor design, and poor fabrication.

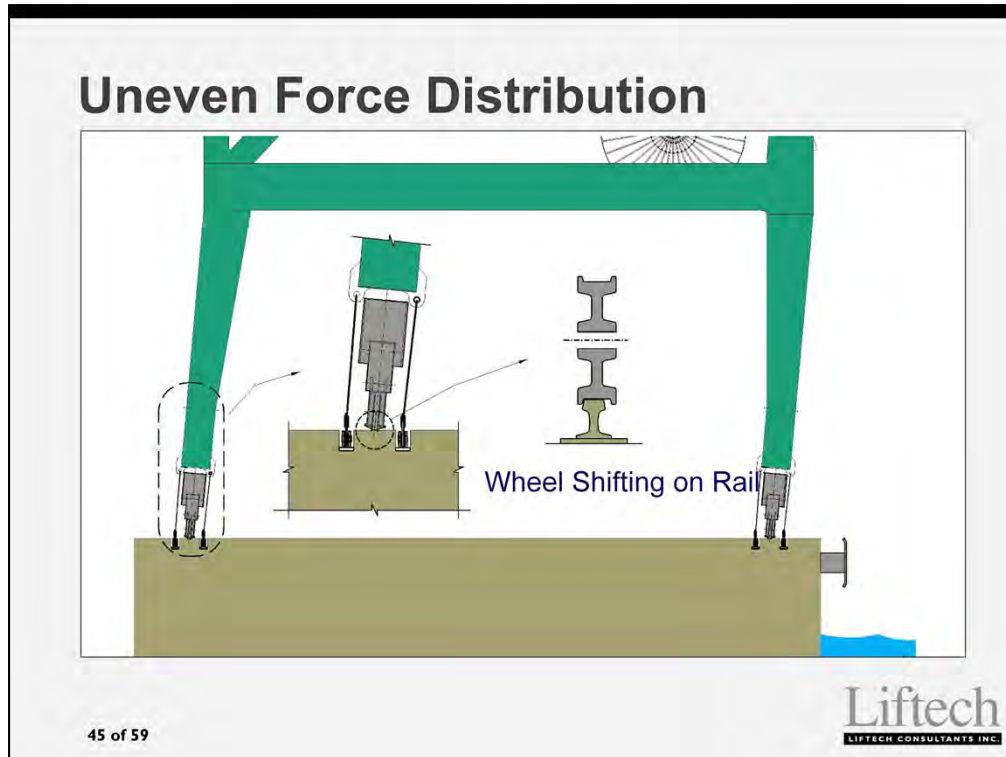
When calculating the design forces, the deflection of the crane must be considered, particularly when there are multiple tie-downs at a corner.

On some cranes we have studied we determined that one tie-down at a corner may experience 100% of its design load before the other corner tie-down experiences any loading.
