Liftech engineers have been providing structural engineering services to the container crane industry for over 45 years and have experience in many crane failures.

Several catastrophic failures have occurred this year and several others nearly occurred reminding the industry of the risks.

## Accidents Related To:

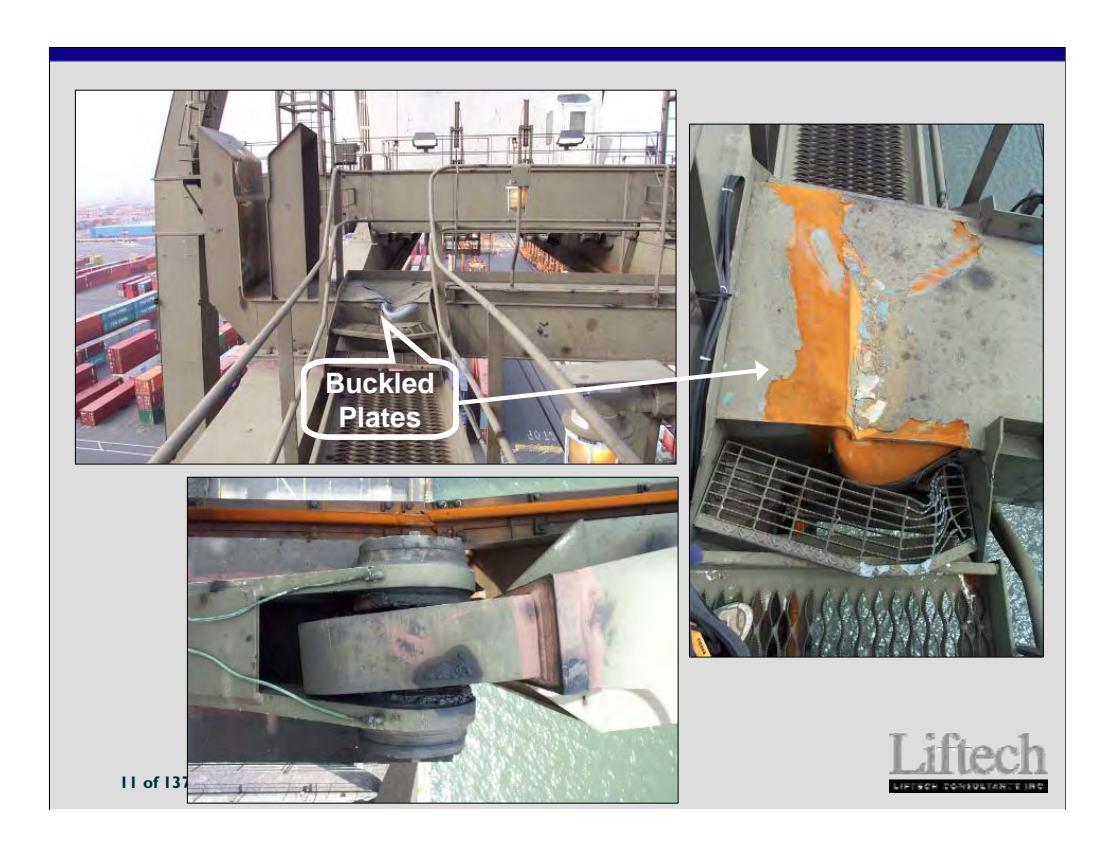
This slide shows a close up of the buckled portions of the landside cross tie, and the residual rotation at the upper boom hinge (lower left).

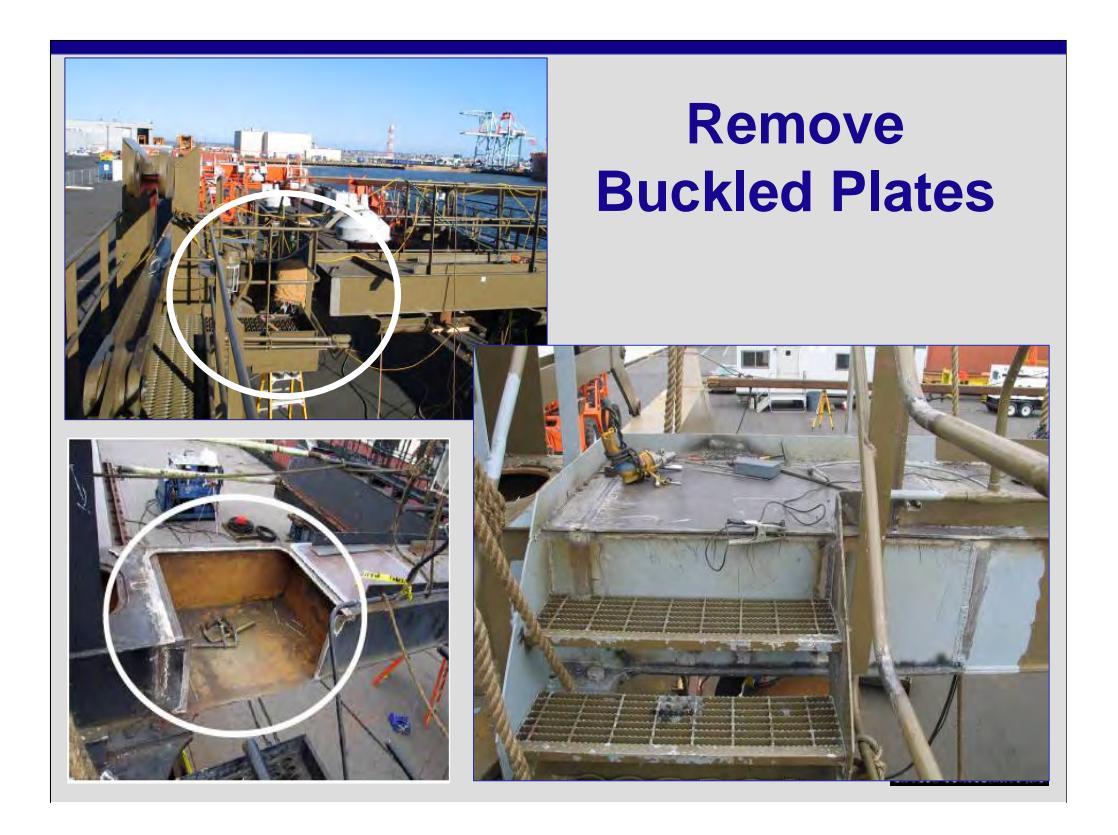
These are examples of replacing buckled plates at the landside boom tie.

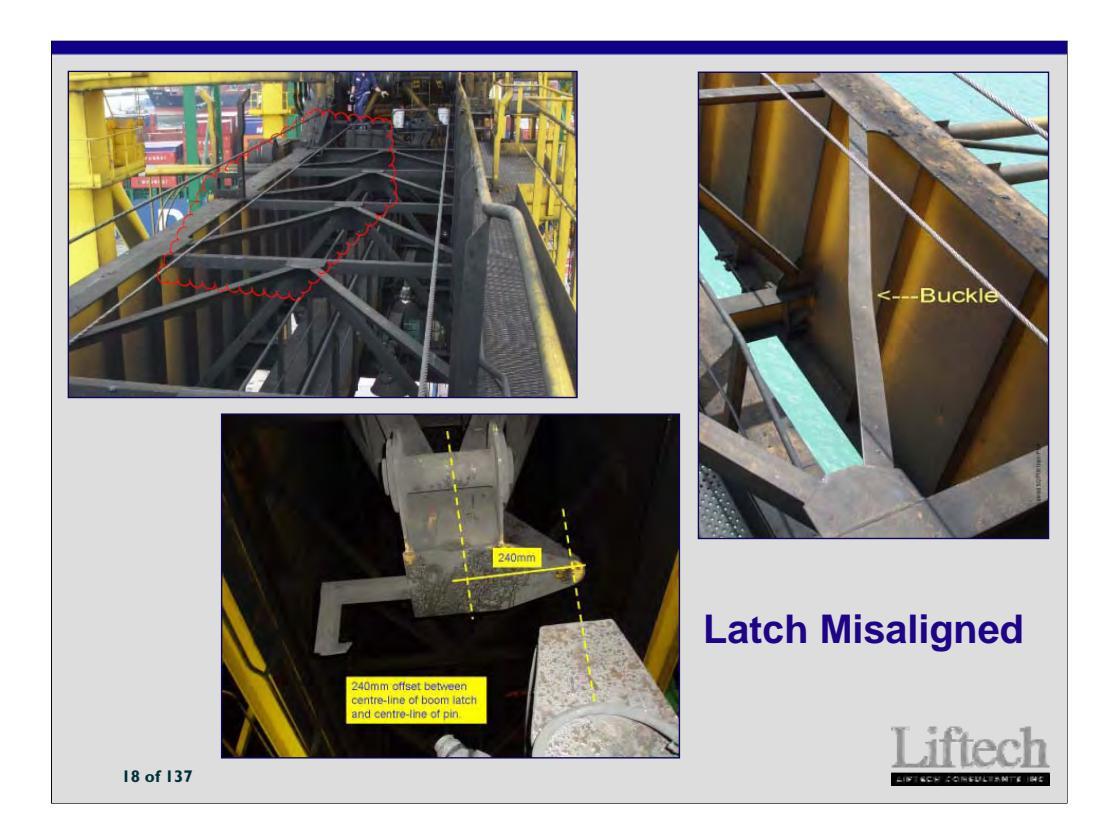
The compression members of the trusswork between the boom girders buckled in the first three bays from the boom hinge. The boom twisted causing a vertical differential between the two sides and the latch to go out of alignment.

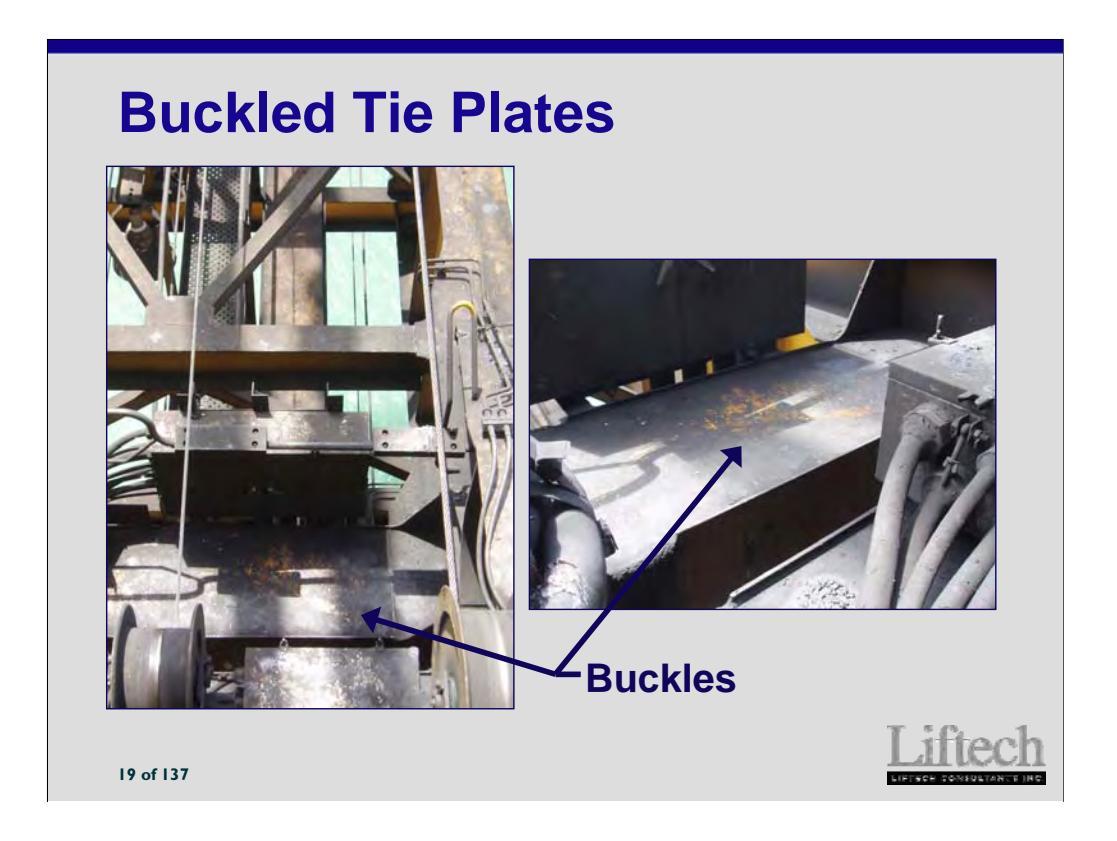
The tie plates at the boom hinge also buckled.

Repairs involved removing the buckled truss members, pulling the boom to correct lateral alignment, and installing new truss members.

It is important to check the strength and stability of the upper chord of the boom before removing the buckled diagonals. For this repair, the right girder is unbraced for three bays, and a significant aligning load is applied.

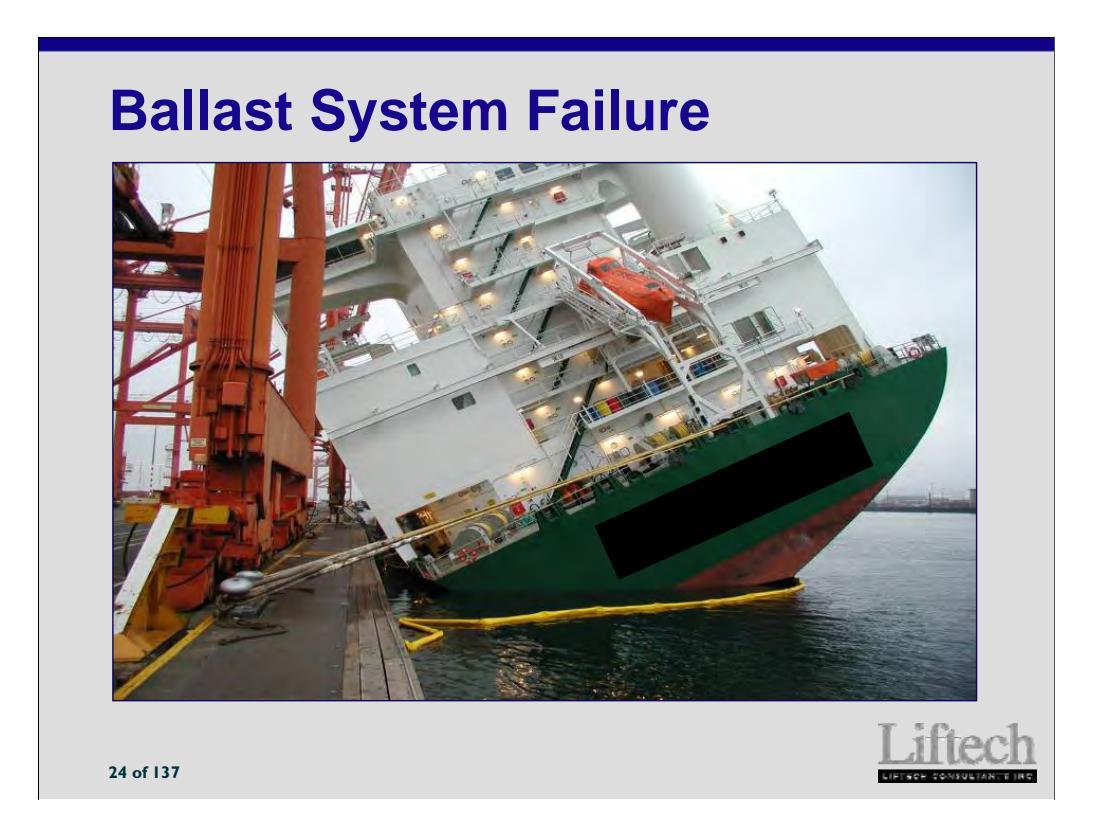
A ballasting system failure caused the vessel to list. Fortunately, the ship structure missed the adjacent cranes and caused only minor damage.

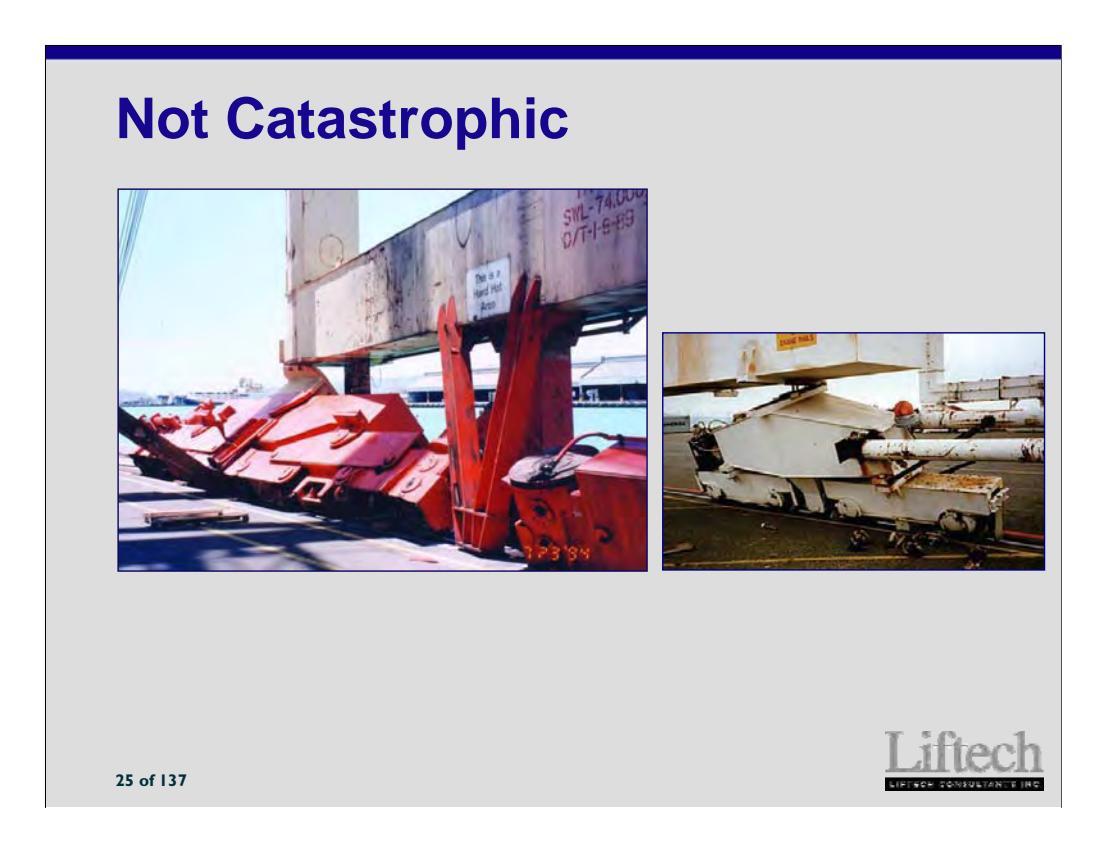
Many collisions are not catastrophic. In these instances, the gantrying system broke from the crane but the cranes did not collapse.

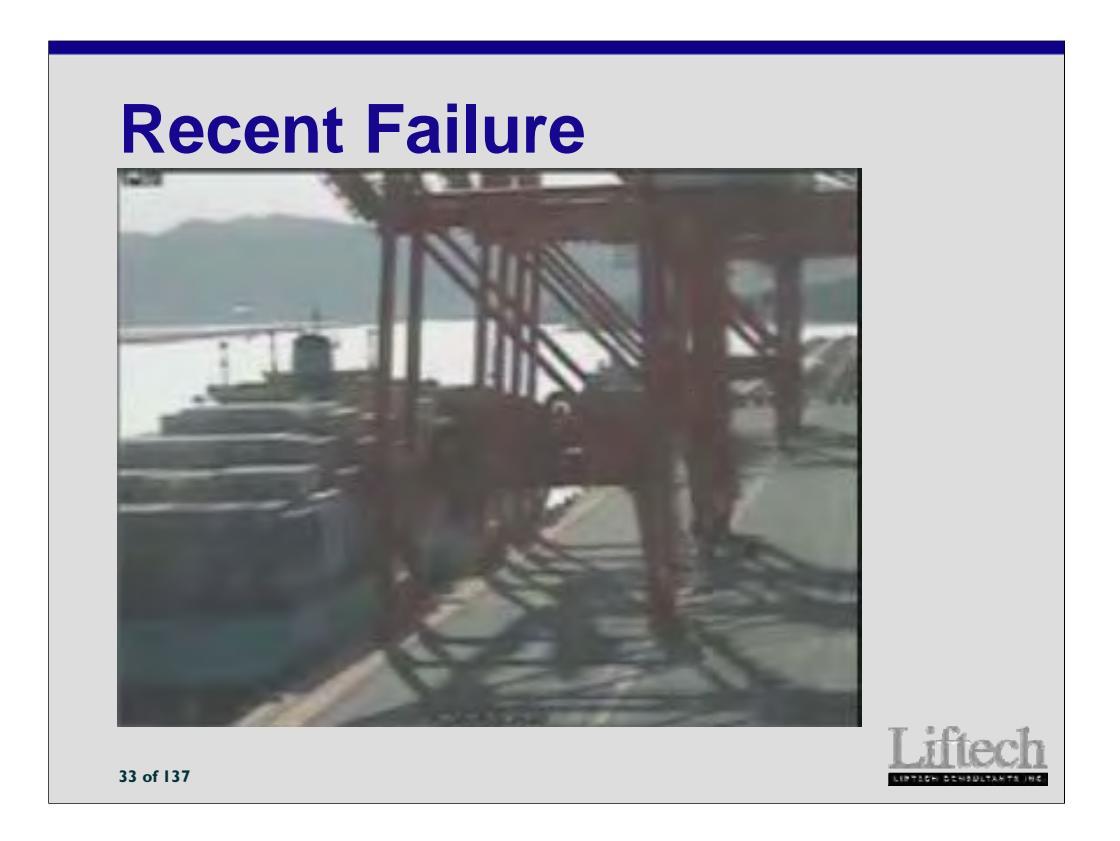
This recent failure occurred with the boom mostly raised. The forestays could not catch the falling boom. The boom landed on the ship and pulled the upper A-frame members.

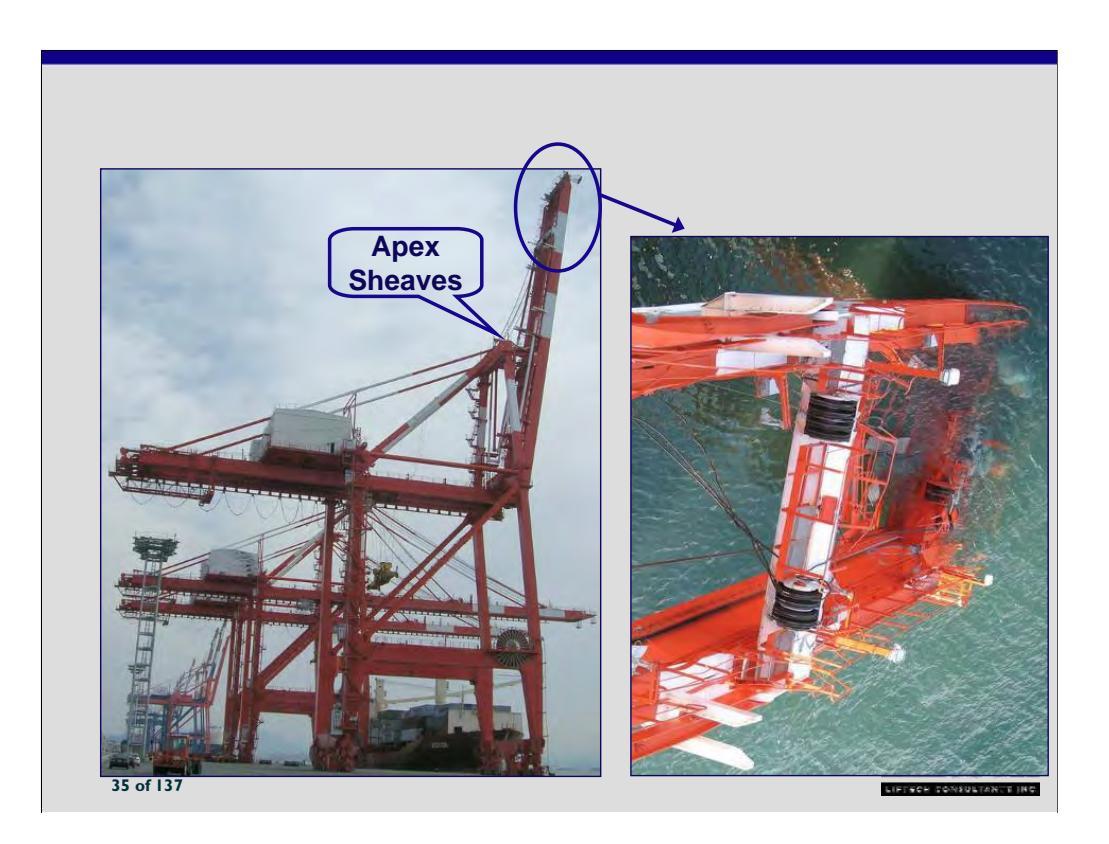
The photo on the left is of an adjacent crane. Notice the apex sheave.

The hoist sheaves on the boom are shown on the failed boom nearly in the water. There was no damage to the sheaves. The rope is damaged.

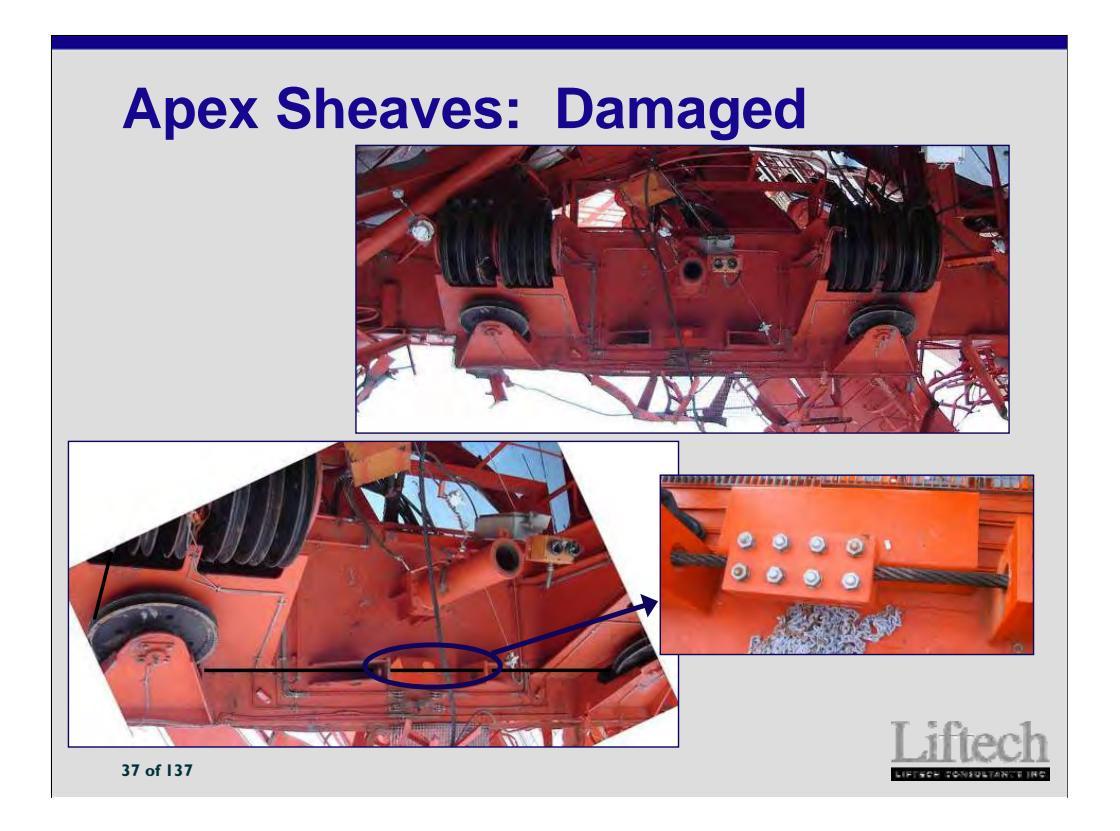
On the failed crane, the rope on the side of the reeving failed. The exact cause of the rope failure is unknown. The rope may have jumped the sheave for some reason. The stop clamp did not hold the rope after the rope broke. The clamp was likely not installed properly.

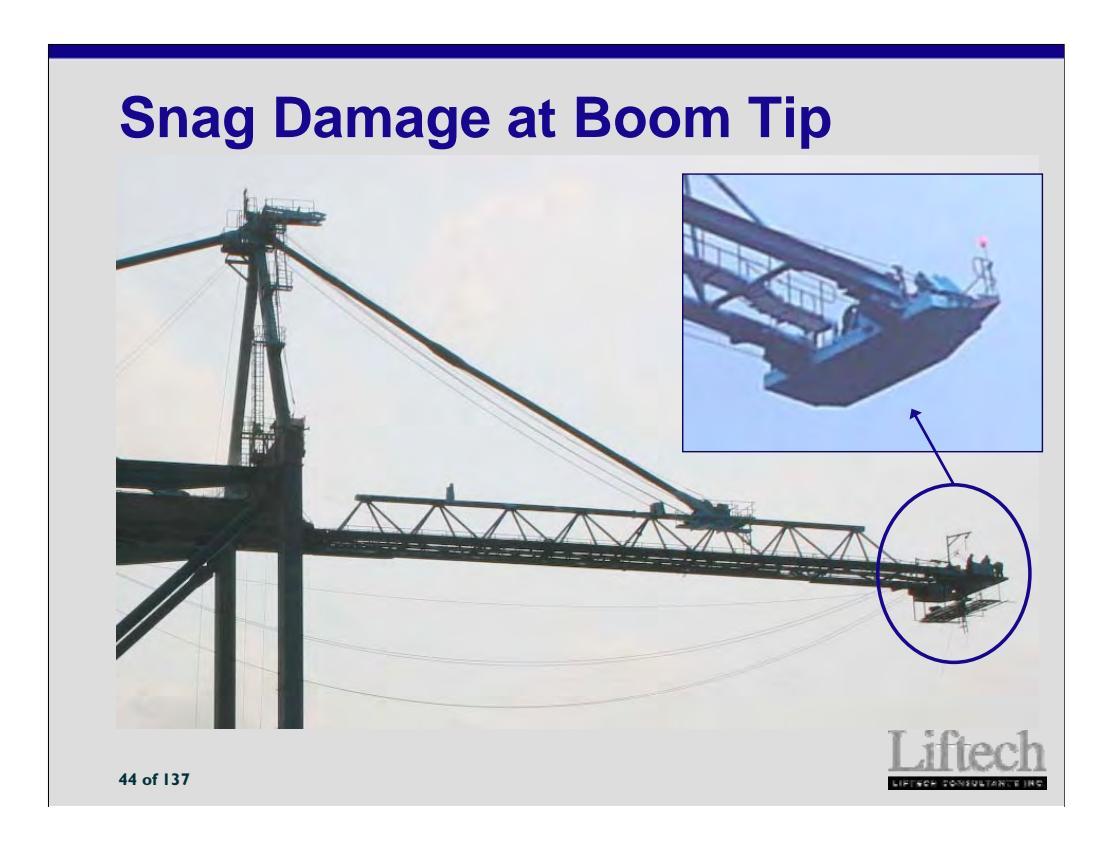
This crane experienced a snag loading that resulted in significant damage to the waterside end tie of the boom where the hoist sheaves are located.

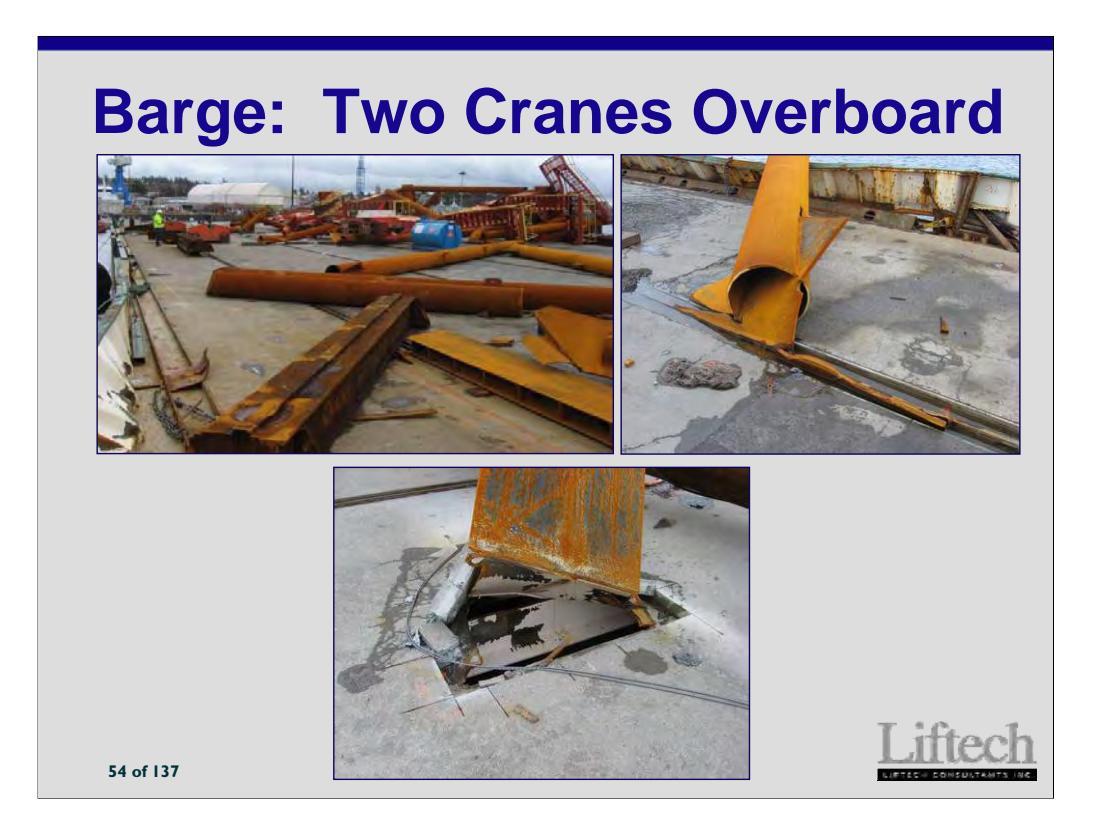
This is a photo of a barge deck after two cranes fell overboard. We do not know the circumstances of the accident, but notice that the braces are not aligned with the internal structure of the barge.

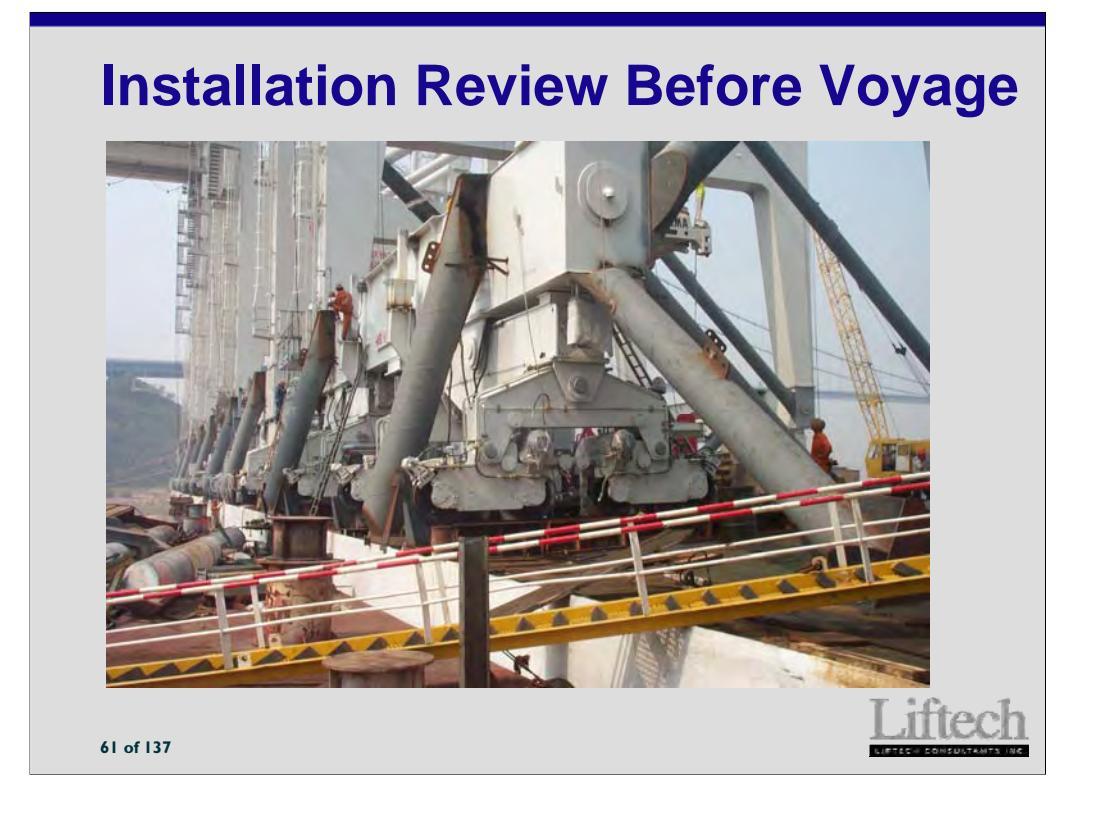
It is common to perform field reviews.

Misalignment of bracing members is common.

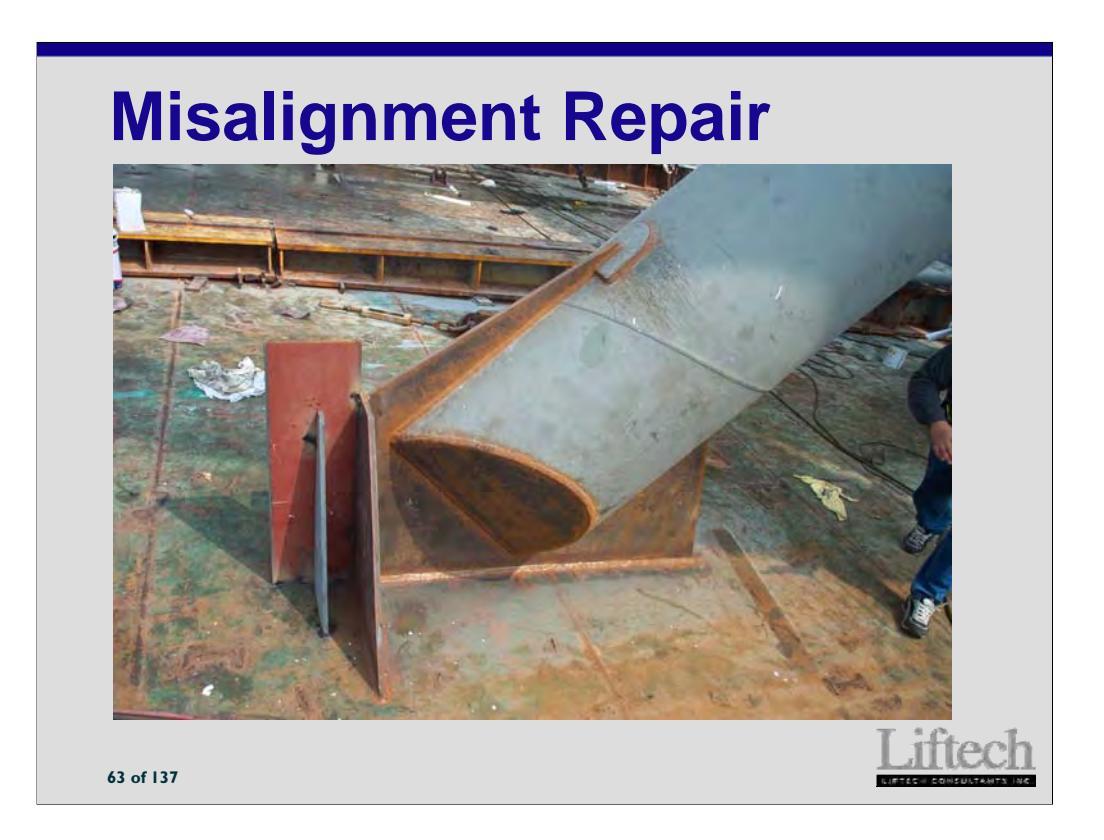
The most common mistake is improper alignment of the braces with the vessel structure.

Misalignment will result in significant bending stresses in both the bracing and vessel structure.

Typical alignment repair is to extend connection plates to transfer the bracing forces into the deck stiffeners below.

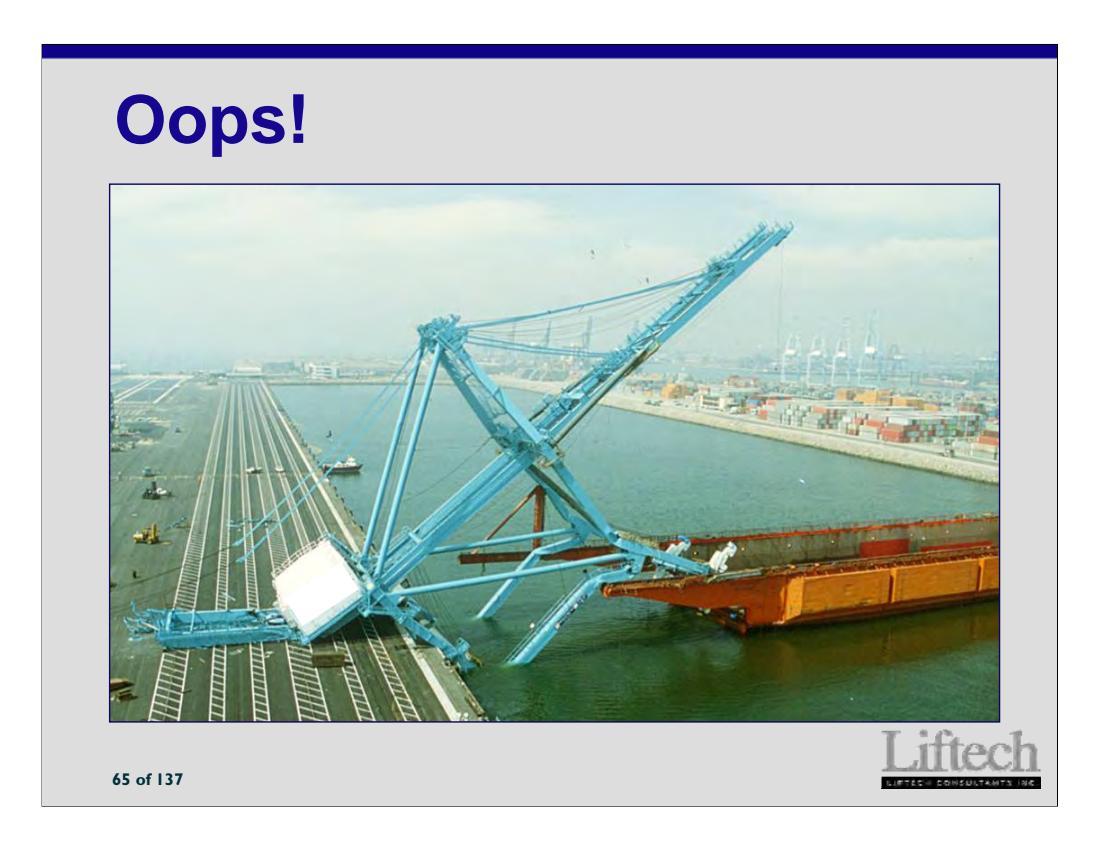
Many things can go wrong.

Just prior to delivery, the ship's captain decided to begin moving the crane without installing the "hold back" lines.

The ship pitched and the crane rolled off the ship.

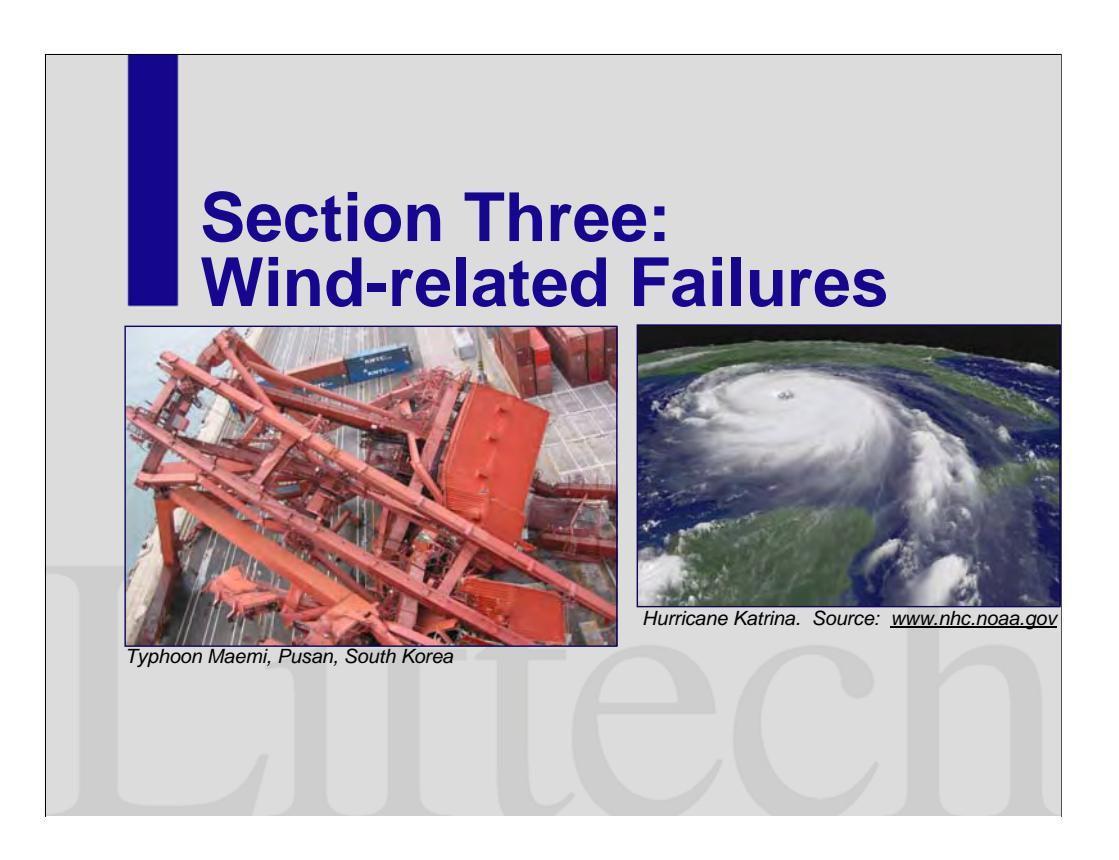
The image on the left is of damage caused by Typhoon Maemi.

The image on the right is of hurricane Katrina.

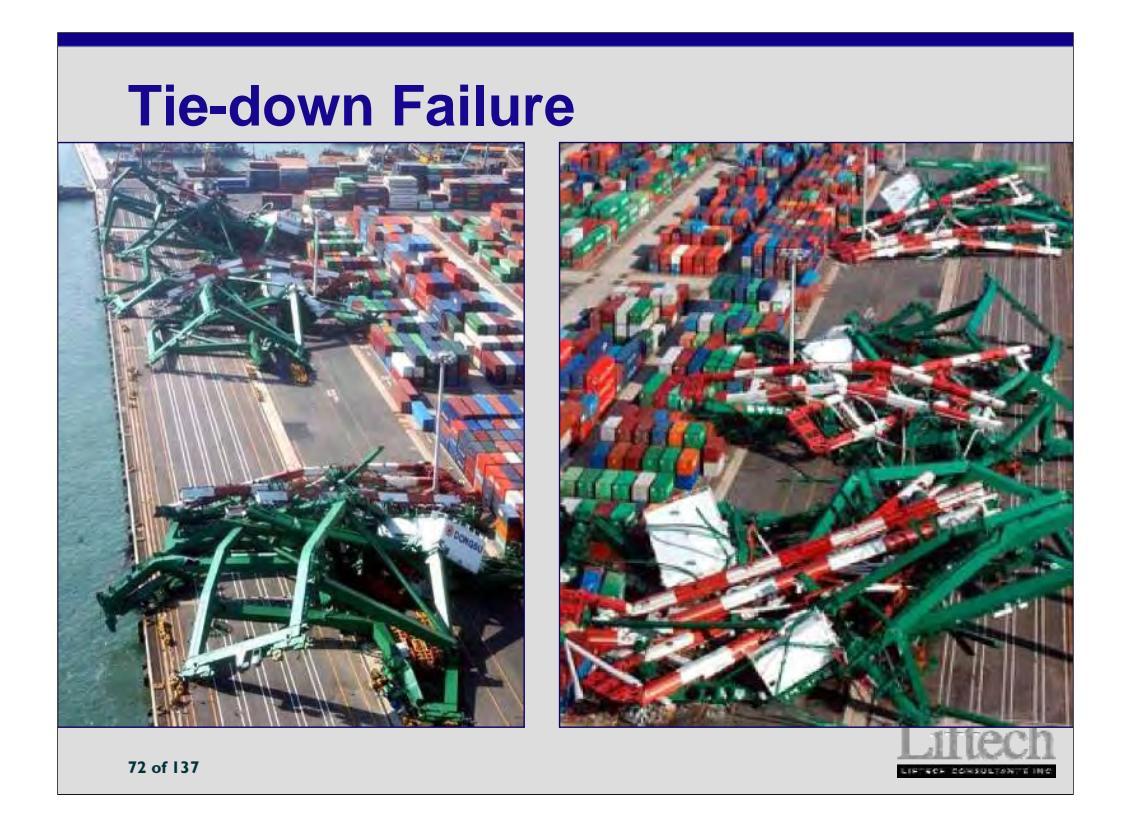
## Korea

These photographs show six collapsed cranes due to Typhoon Maemi in Pusan, South Korea. (The two photographs are taken from each end of the wharf.)

Tie-downs failed. After failing, progressive failures ensued as cranes collided with each other.

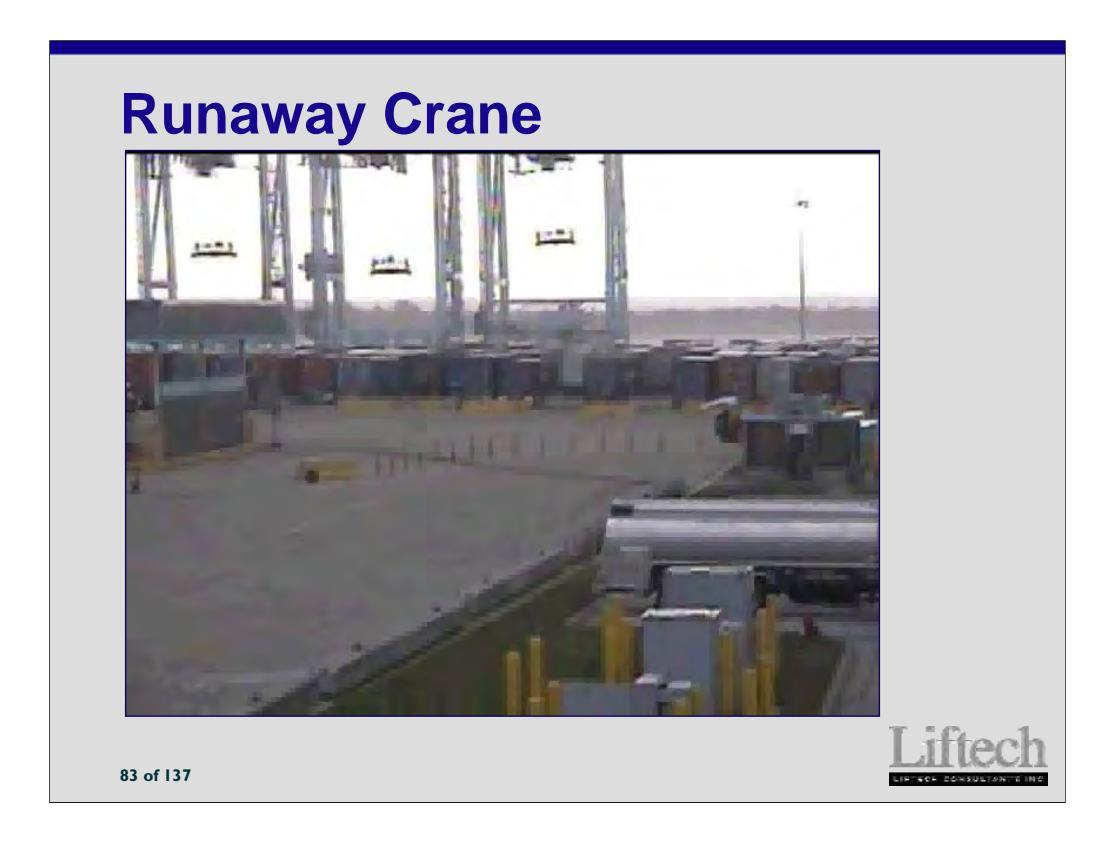
This is a video of the recent Jacksonville crane failure that occurred in August 2008.

During a storm, one crane was blown down the runway and collided with another crane, causing both to collapse.

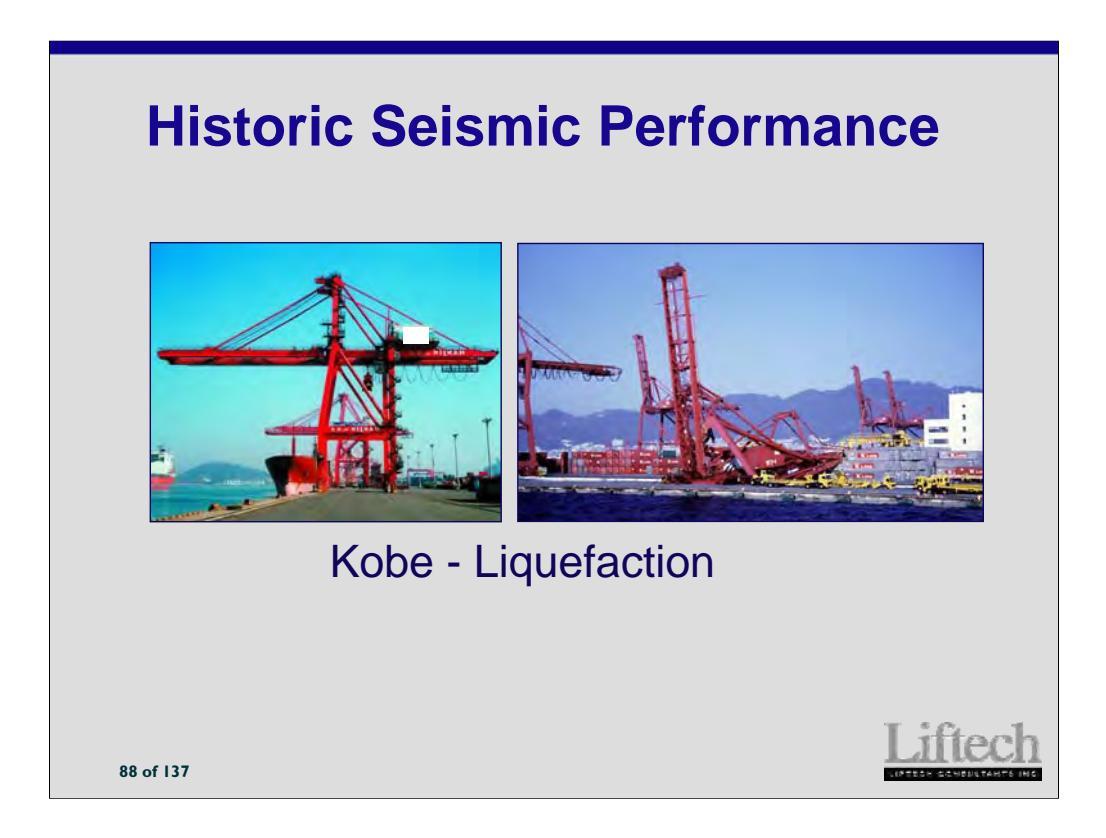
Container crane structures have performed well in earthquakes. Kobe failures occurred when rail spreading failed the crane legs.

Historically, when supports have not failed, cranes have performed well in earthquakes. The cranes lift from the rails disrupting the buildup of motion in the crane structure.

Fifty foot gage cranes have come off of their gantry rails with little damage.

In Kobe, the foundations failed causing significant damage to some cranes.

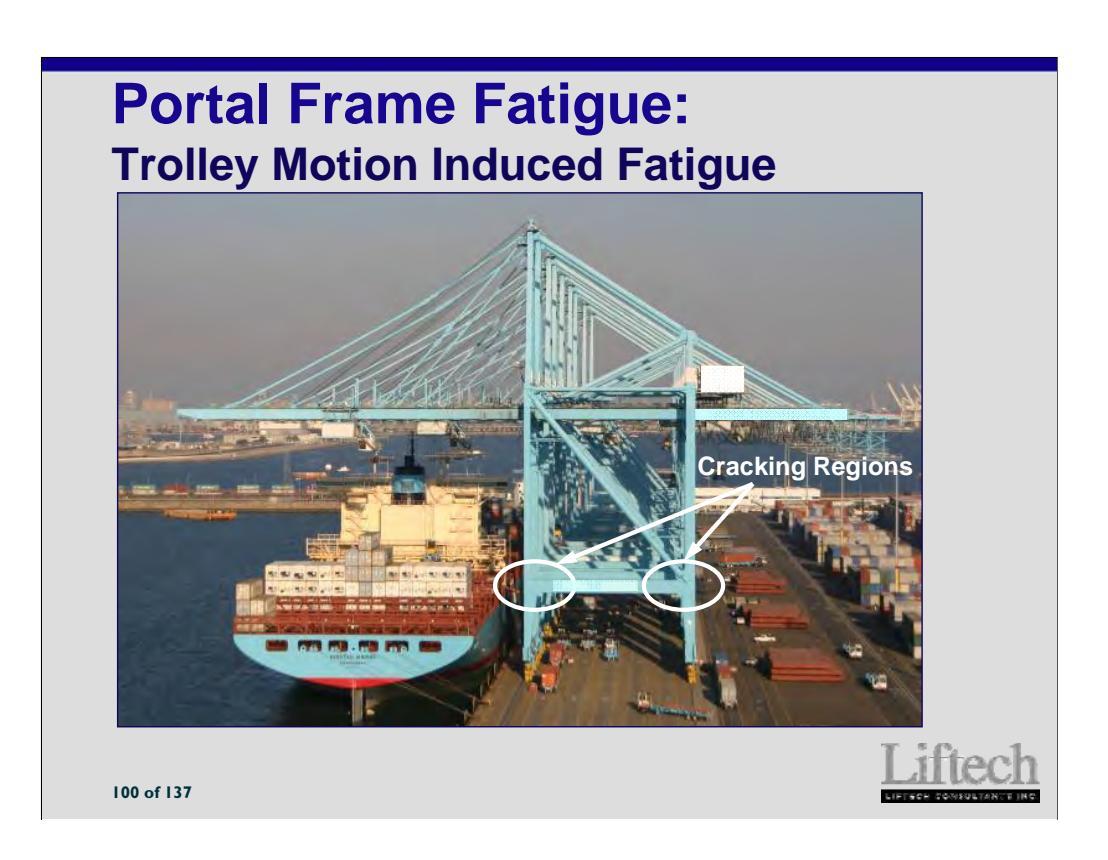
Fatigue cracking in portal frames has occurred due to crane sway in the trolley travel direction. This has occurred on a variety of cranes made by a variety of manufacturers.

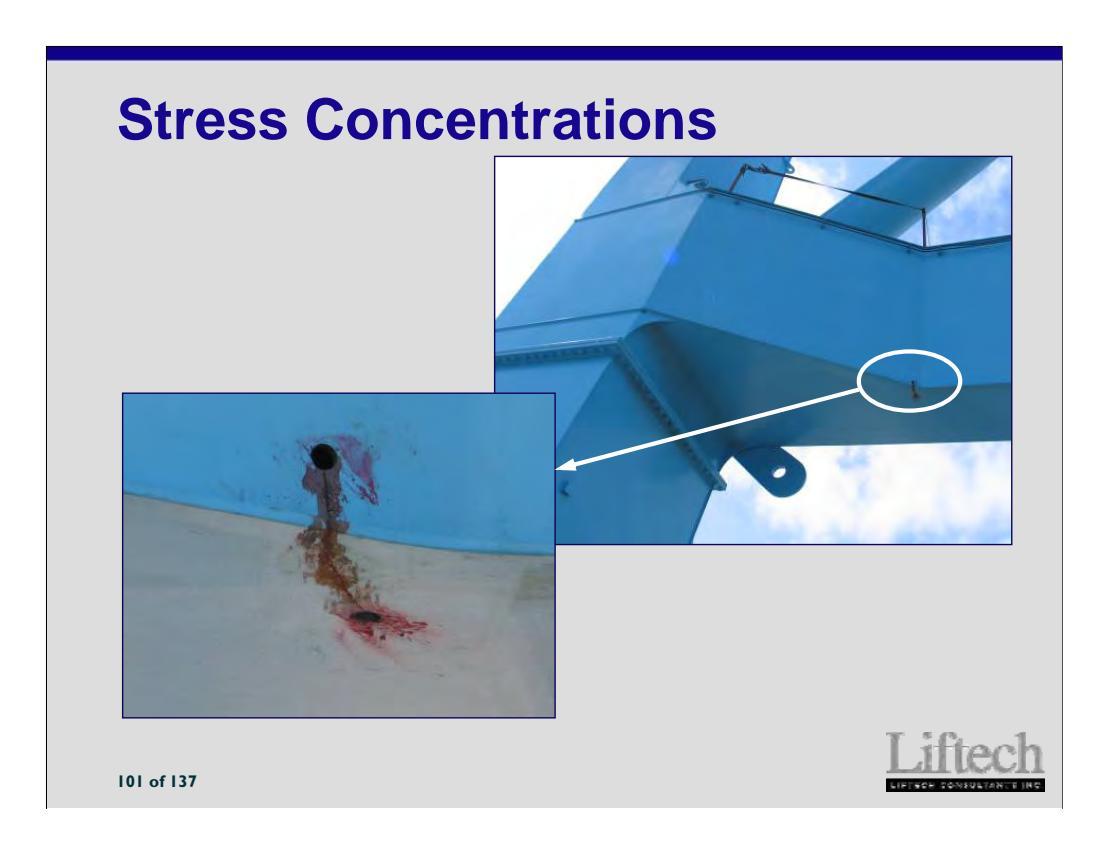
This problem has been exacerbated by stress concentrations such as tapered portal beams.

These pictures show the crack from the outside. Notice the sharp transition of the portal beam.

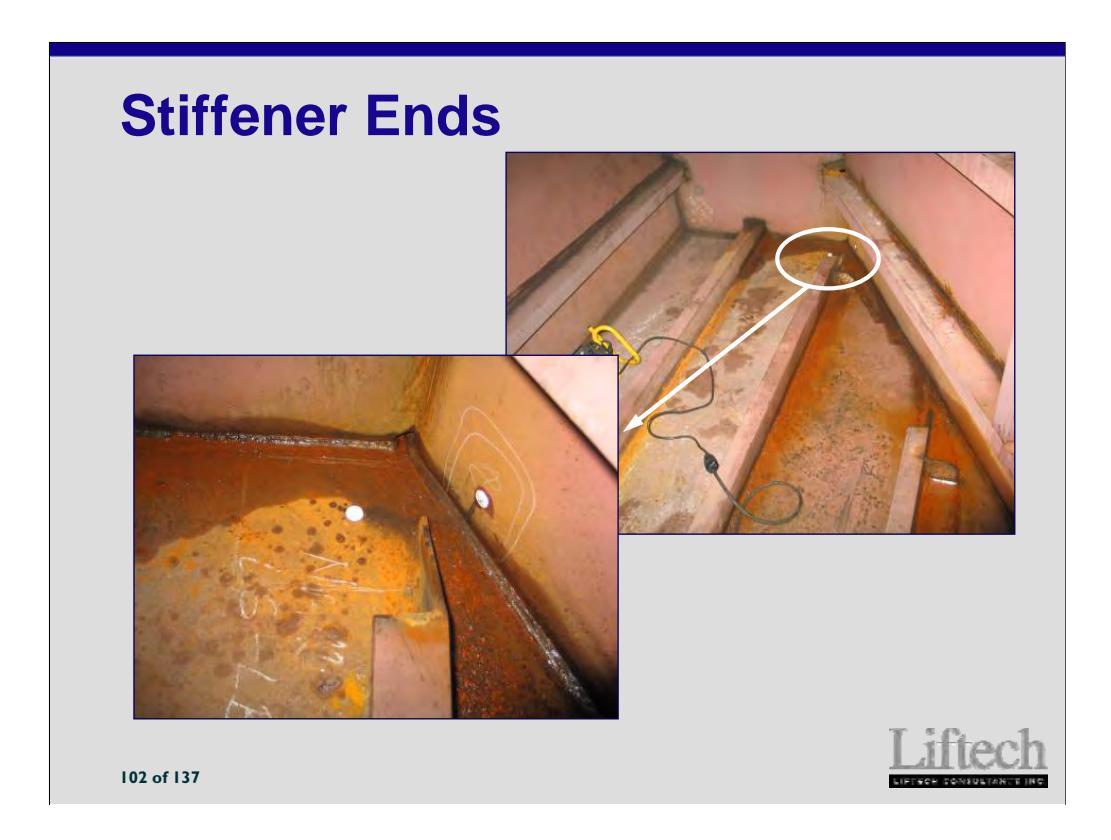
In addition to a global stress concentration due to the taper, there is a stress concentration at the stiffener ends.

The fatigue cracks initiated at the tip of the stiffener as expected.

To limit stress concentrations, the Liftech crane specification requires a clear distance of three plate thicknesses with no welding at the stiffener end.

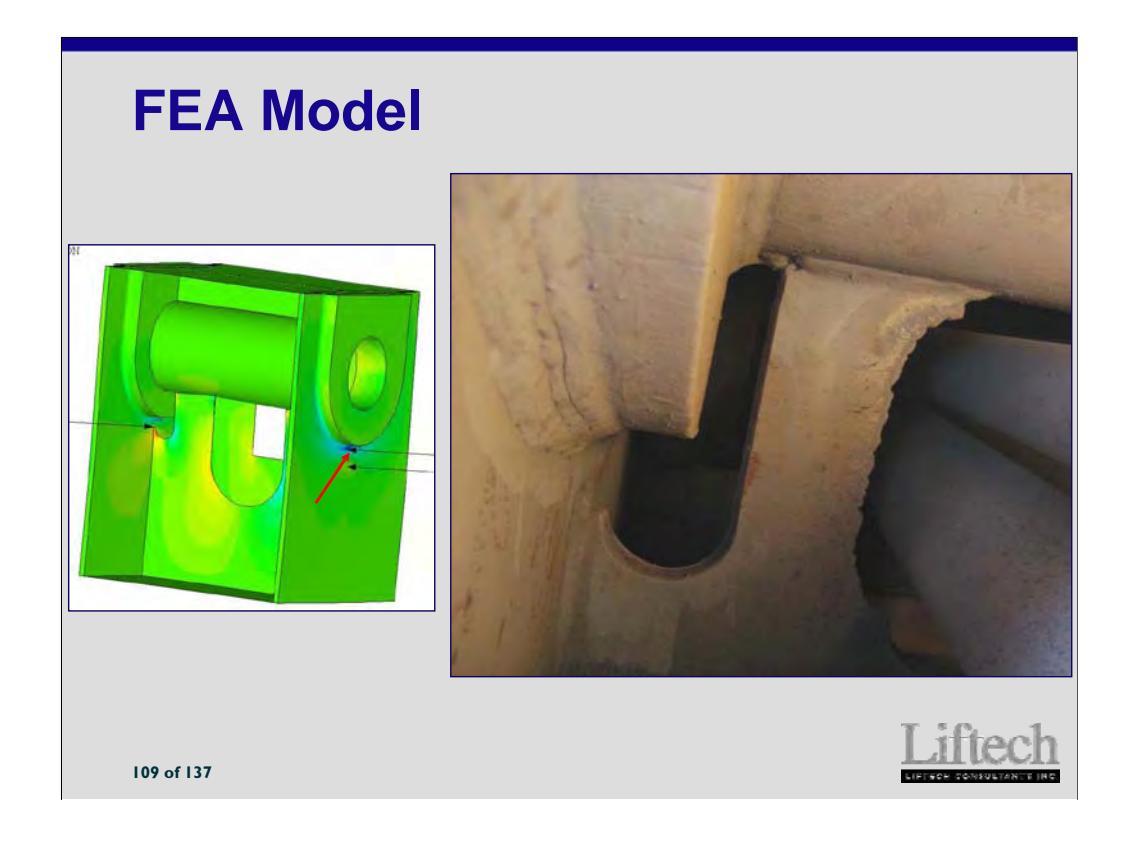
The following is a finite element analysis of one equalizer that is experiencing cracking. The analysis is consistent with expectations that significant stresses occur at the base of the thickened boss plate.

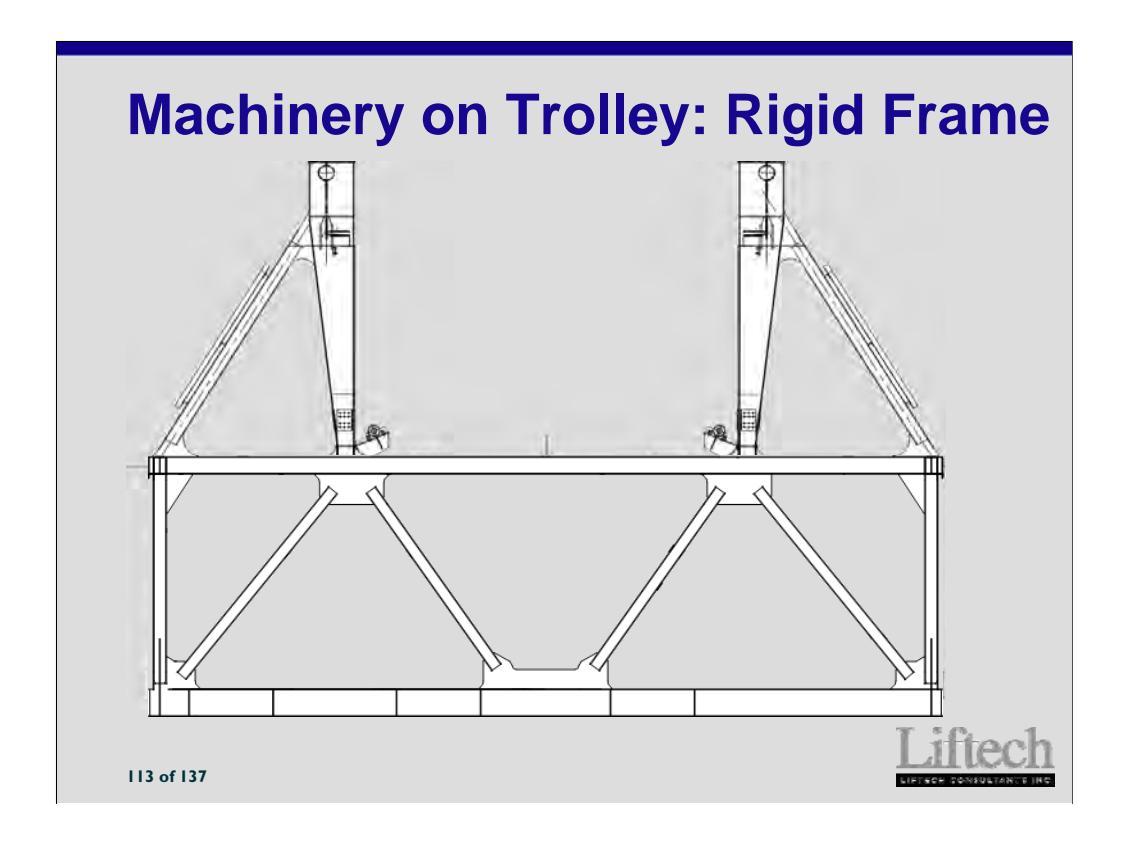
This is a section through a stiff machinery on trolley that does not easily warp that experienced premature fatigue cracking.
