Liftech engineers have been providing structural engineering services to the container crane industry for over 45 years and have experience in many crane failures.

Several catastrophic failures have occurred this year and several others nearly occurred reminding the industry of the risks.

## Accidents Related To:

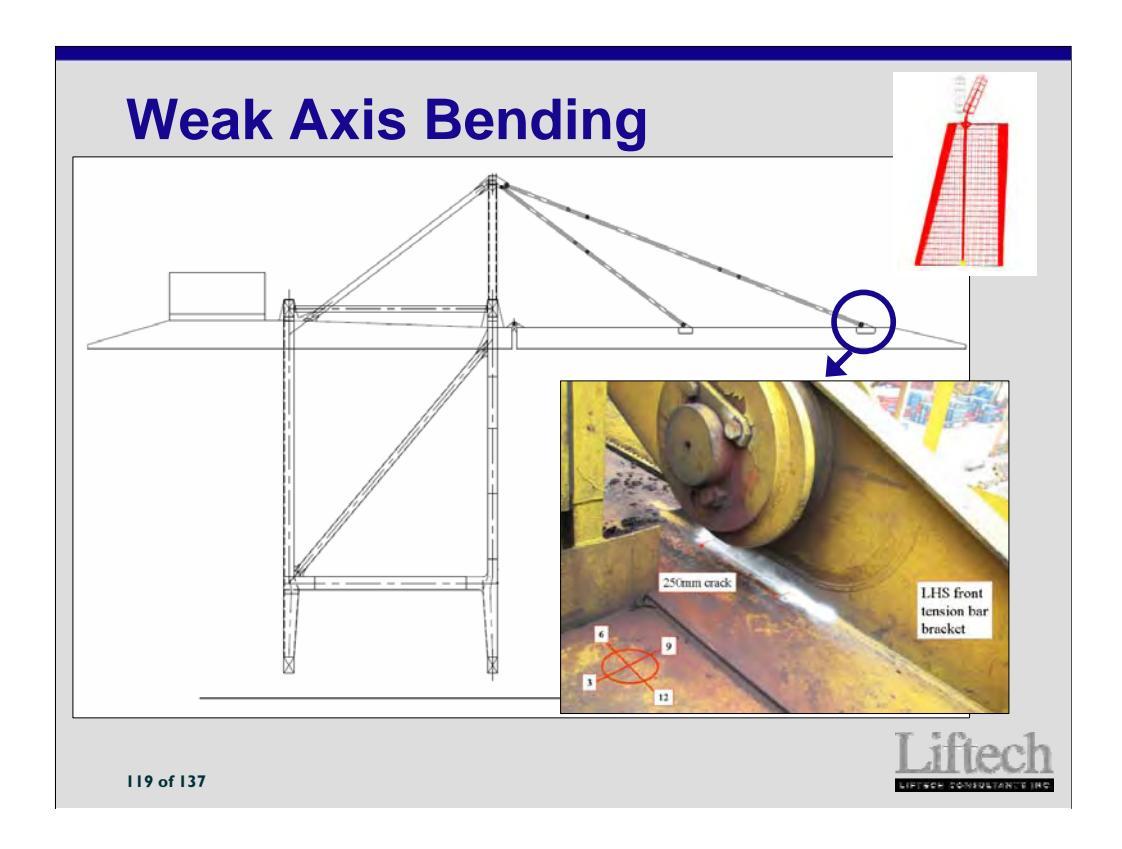
Lateral deformation of the forestay has caused lateral bending in forestay connections, and large weak axis stresses in the connection plates.
