Fatigue Investigation and Development of Structural Maintenance Program Antone Hydraulic Dredge, Dutra Dredging

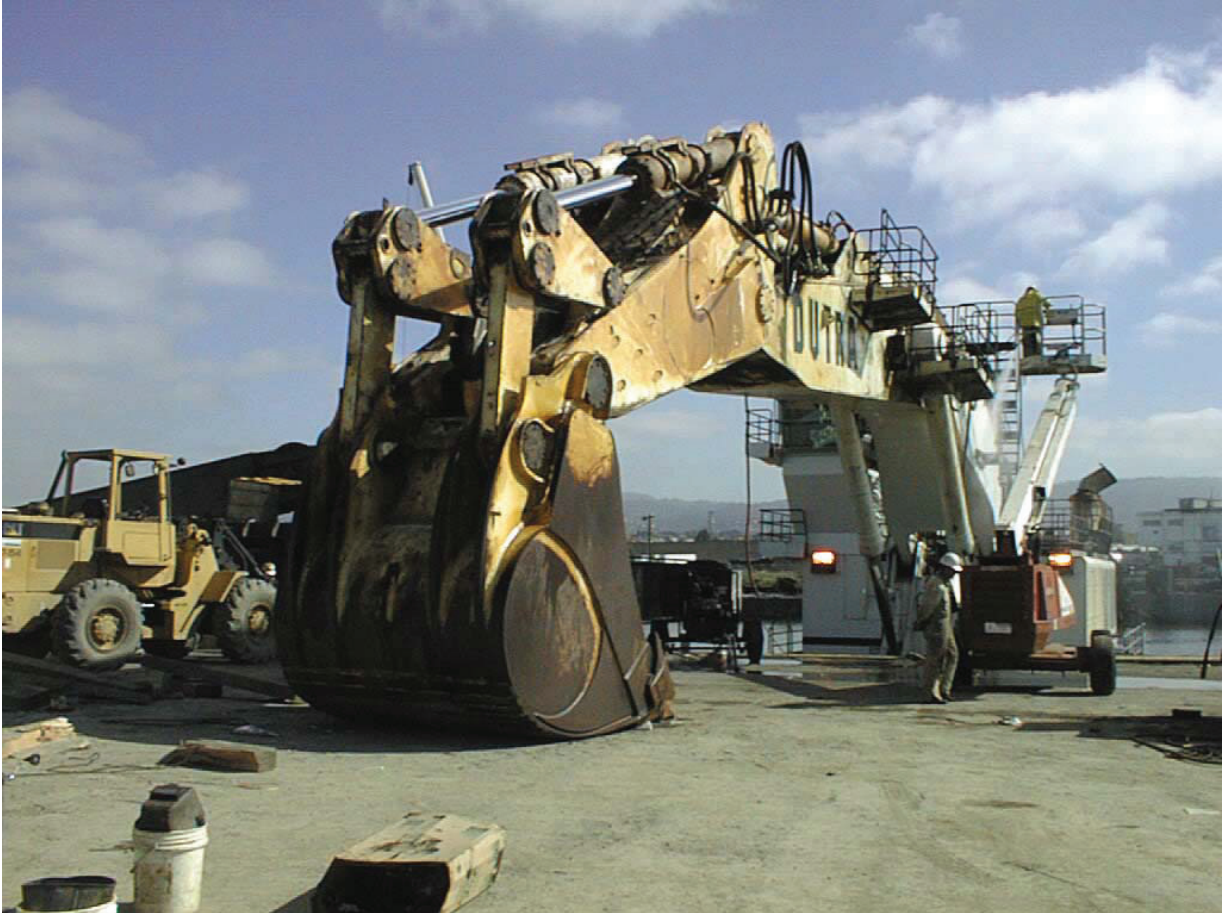
This barge-mounted Liebherr 998 hydraulic excavator experienced significant fatigue cracking during normal operations.

Liftech provided the following engineering services to mitigate the failure problem:

- 1) Reviewed the existing structural details and then monitored the manufacturer's modification of unacceptable fatigue details.
- 2) Developed a testing program to determine the magnitude of the problem.

3) Developed a structural maintenance program that included inspection and repair guidelines as well as a permanent monitoring system to track the fatigue damage occurring within the structure.
