Recovery of Stranded SSA Cranes at Port of Manzanillo Manzanillo, Mexico

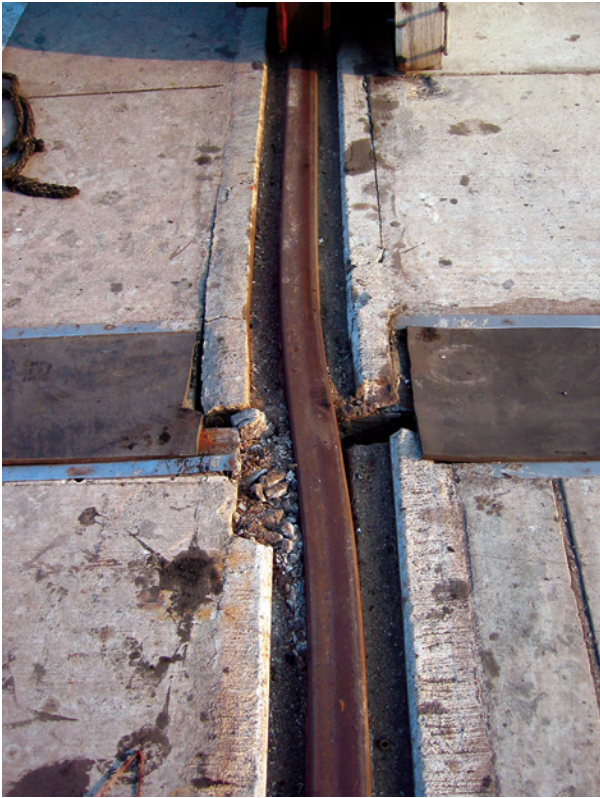
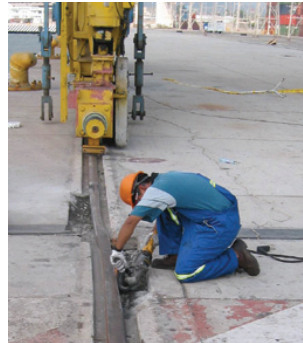
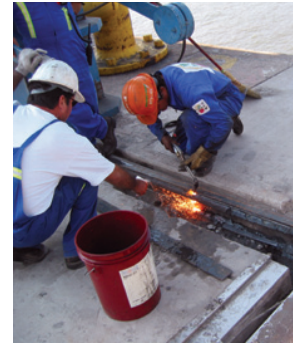
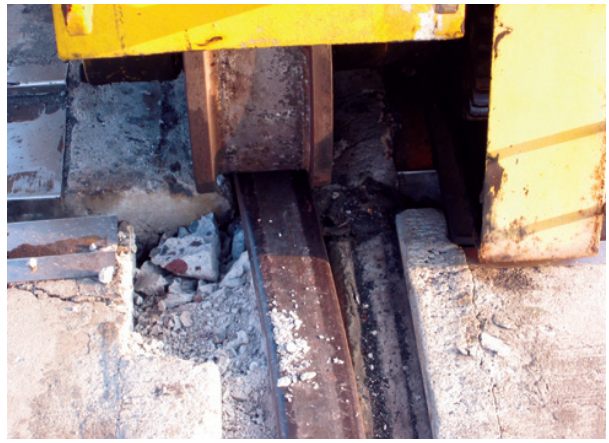
On January 22, 2003, the Port of Manzanillo, Mexico, felt the shock wave from the 7.8 magnitude earthquake centered at Colima 50 kilometers to the east. This caused a 75 mm misalignment of the adjacent OPI and SSA berths. The misalignment was at the expansion joint between the berths and distorted the crane rails so the two SSA cranes, which were parked on the OPI berth, were stranded. The wheel flanges interfered with the bent rails. One SSA crane was entirely on the OPI berth, the other straddled the expansion joint. Since neither crane could be returned to the SSA berth, the SSA facility was out of operation.

A Liftech structural engineer flew to Manzanillo and developed a simple scheme for moving the cranes from the OPI berth to the SSA berth across the bent rail: trim the rails. The cranes were back in service on the SSA wharf within a few hours. The facility was back in operation two days after the Colima earthquake struck.
