## McNear's Beach Pier Repair and Seismic Upgrade Marin County, California

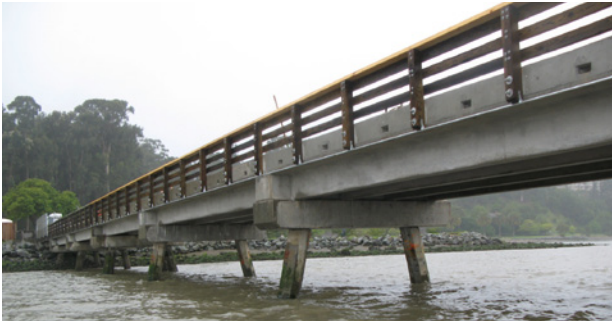
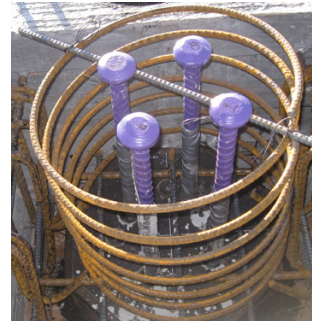
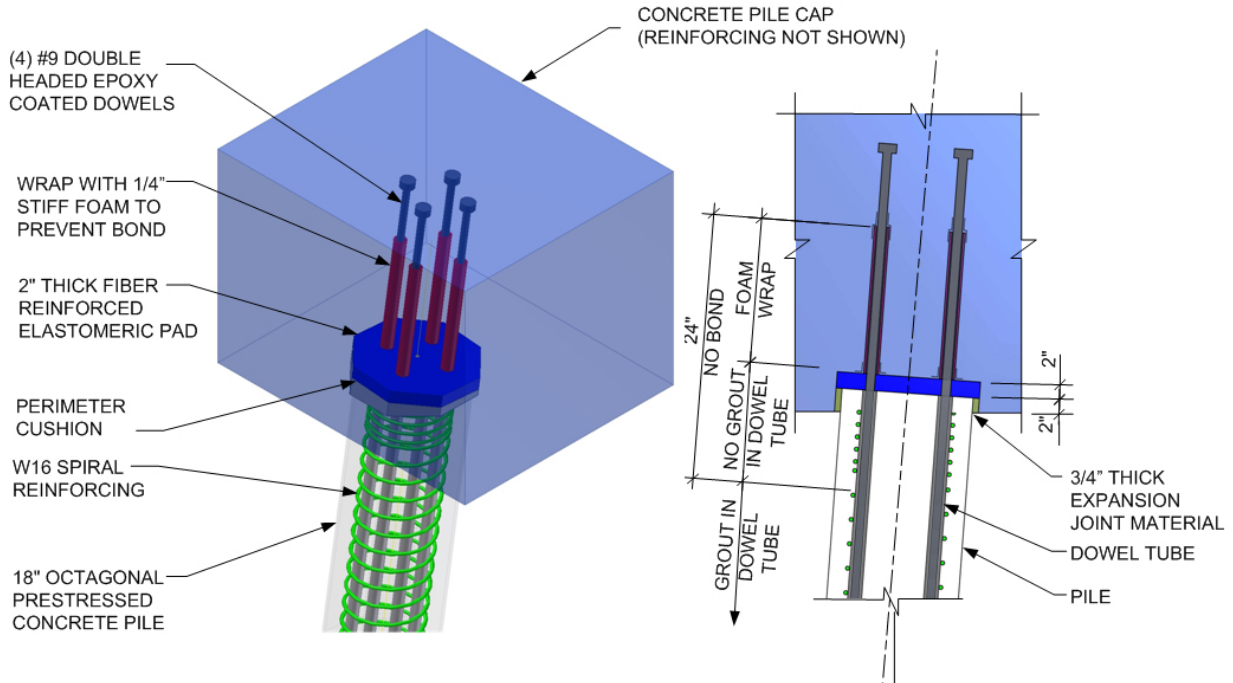
During a storm, a 100 ft by 400 ft barge broke its mooring and collided with the pier at McNear's Beach Park, damaging about half of the pier structure.

The original pier structure consisted of a precast concrete superstructure supported by slightly battered 18 inch octagonal precast, prestressed piles.

Liftech designed a replacement pier structure with details to provide significantly better seismic performance. These details included pile-to-pile cap connections designed using a fiber reinforced bearing pad, isolating the sides of the embedded pile, and unbonding the dowels for 24 inches of length. This flexible connection results in considerable elastic rotation.

Testing by the University of Washington has shown that similar connections perform significantly better during seismic loading than a classical pile connection.
